Shoreline Situation Report Henrico, Chesterfield, and Richmond

Shoreline Situation Report
HENRICO, CHESTERFIELD, AND RICHMOND

Chesapeake Research Consortium Report Number 45

Special Report In Applied Marine Science and Ocean Engineering Number 98 of the

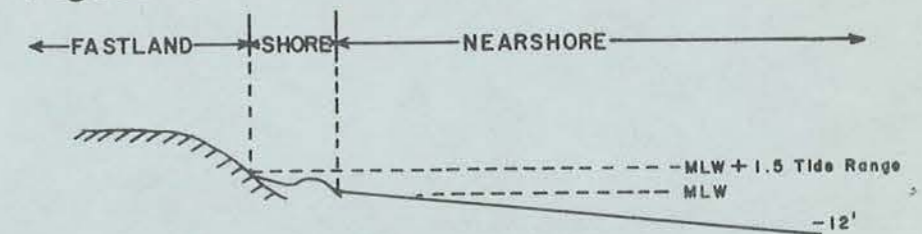
Figure 1

An illustration of the definition of the three components of the shorelands (cross-section).

be considered as being composed of three interacting physiographic elements: the fastlands, the shore and the nearshore. A graphic classification based on these three elements has been devised so that the types for each of the three elements portrayed side by side on a map may provide the opportunity to examine joint relationships among the elements. As an example, the application of the system permits the user to determine miles of high bluff shoreland interfacing with marsh in the shore zone.

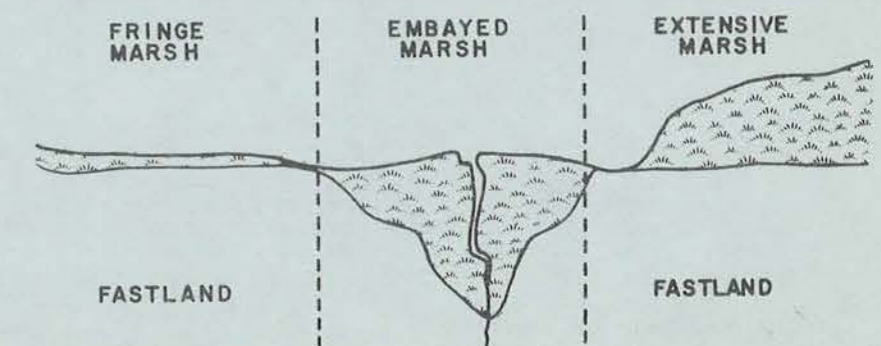
Figure 2

A generalized illustration of the three different marsh types (map view).

The physiographic character of the marshes has also been separated into three types (see Figure 2). Fringe marsh is that which is less than 400 feet in width and which runs in a band parallel to the

shore. Extensive marsh is that which has extensive acreage projecting into an estuary or river. An embayed marsh is a marsh which occupies a reentrant or drowned creek valley. The purpose in delineating these marsh types is that the effectiveness of the various functions of the marsh will, in part, be determined by type of exposure to the estuarine system. A fringe marsh may, for example, have maximum value as a buffer to wave erosion of the fastland. An extensive marsh, on the other hand, is likely a more efficient transporter of detritus and other food chain materials due to its greater drainage density than an embayed marsh. The central point is that planners, in the light of ongoing and future research, will desire to weight various functions of marshes and the physiographic delineation aids their decision making by denoting where the various types exist.

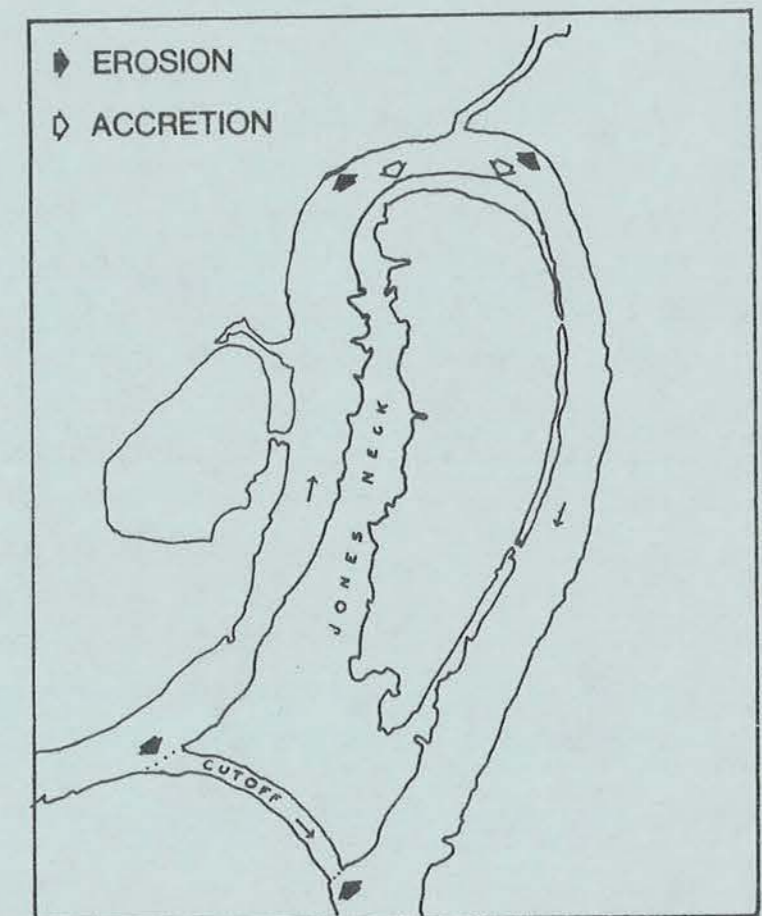
FIGURE 3. TYPICAL RIVER MEANDER

Most of the erosion and accretion found along the upper James occurs at the bends in the river. The river current is fastest on the outside of the meanders and is much less on the inside. As a result, the outside bends erode while the inside bends accrete. Figure 3 is a drawing of a typical river meander. The amount and rate of erosion depends upon both the composition of the land in the bends and the speed of the current there. (The dotted line in Figure 3 represents pre-existing land.)

In summary, erosion is not a critical problem along the upper James River. The normal river current is a primary agent of erosion. In the meanders, the outside of the bends are eroded. This erosion, plus erosion caused by flood waters, tend to cut a new channel across the narrow neck of land in the meanders. This occurred at Dutch Gap in 1870, though the other cutoffs were man-made. Table 1 is a summary of flood levels at several stations along the river. Weathering of the bluffs by rain runoff is another type of erosion common along the James River.

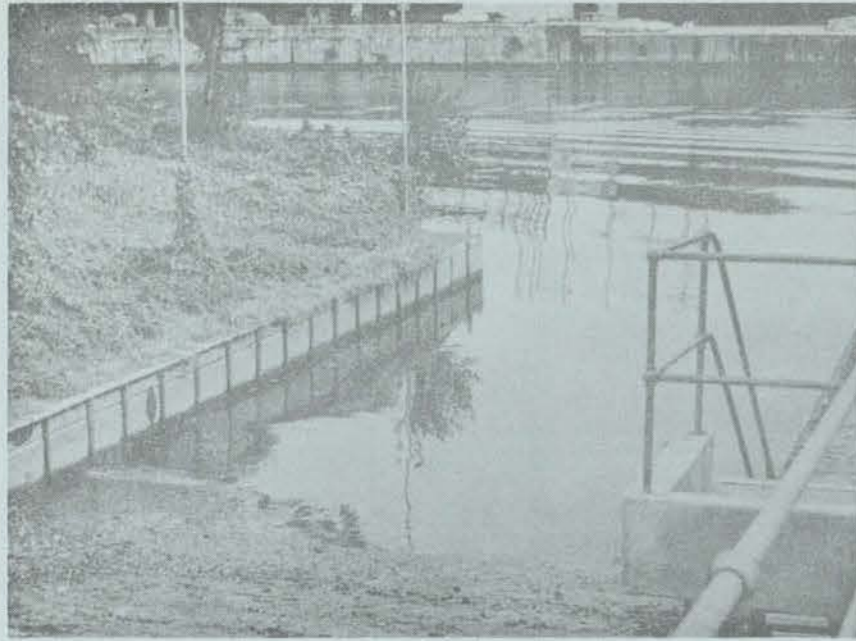
Figure 4

FIGURE 4: Concrete and steel boat ramp facility near Richmond. This marina, seriously damaged from flood waters in the Camille storm of August, 1969, has never reopened. Across the river is the Richmond Upper Marine Terminal.

SHORE PROTECTIVE STRUCTURES: 1,400 feet of effective bulkheading, mostly at the Richmond Deepwater Terminal. Some bulkheading of steel interlocking sheet pile is located at the entrance to an unused concrete boat ramp - marina facility. This is mainly to combat boat wake erosion which could cause washing behind the marina's structures.

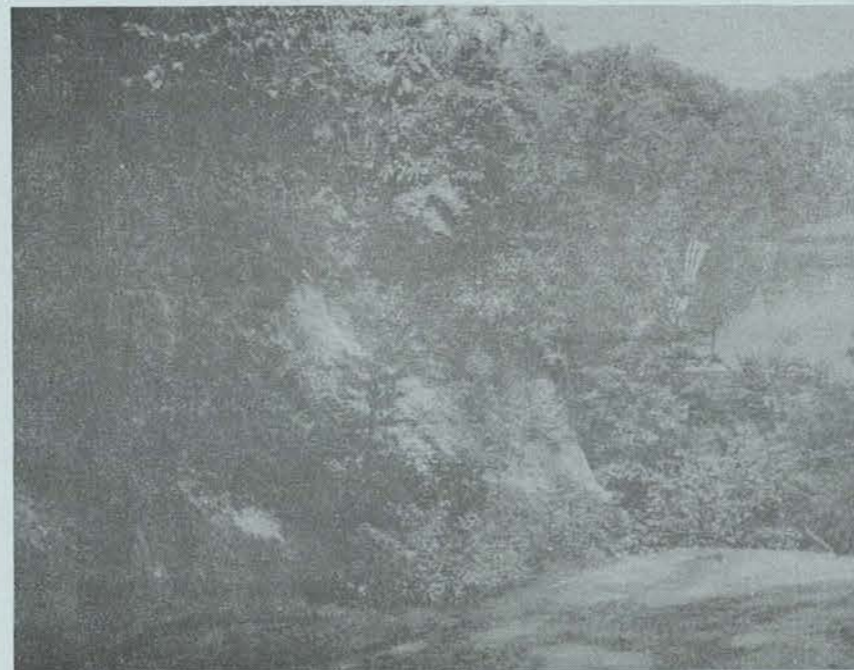
Figure 6

FIGURE 6: Drewrys Bluff area, Chesterfield County. Cliff erosion here is caused by down-hill rain runoff.

Suggested Action: None. The cost of protecting the eroding marsh areas would probably be prohibitive. Erosion to the fastland here is mainly due to rain runoff down the steep cliffs found along much of the shorelands.

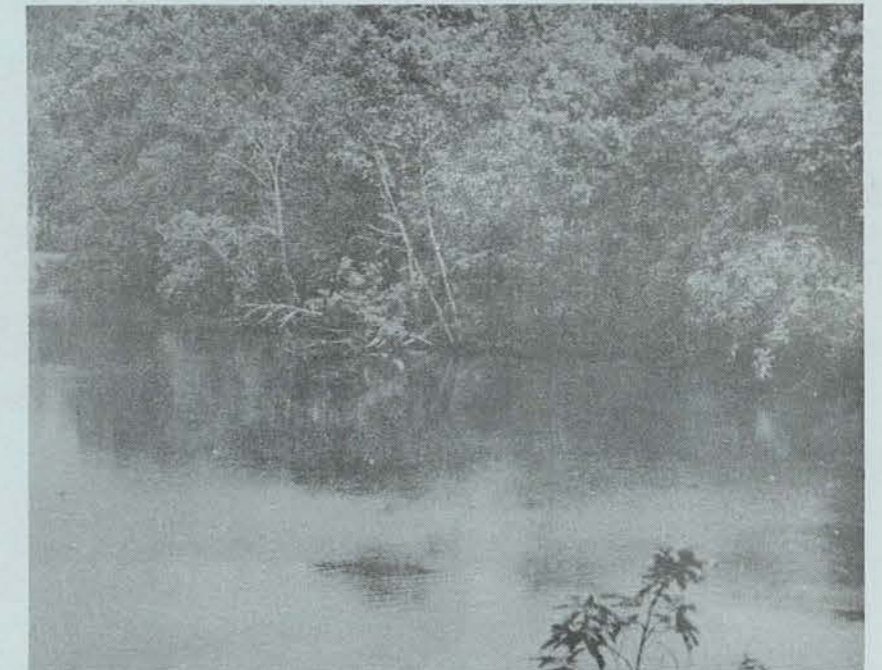
Figure 7

FIGURE 7: Across from Drewrys Bluff, Henrico County. This area is experiencing moderate erosion, as evidenced by the falling trees.

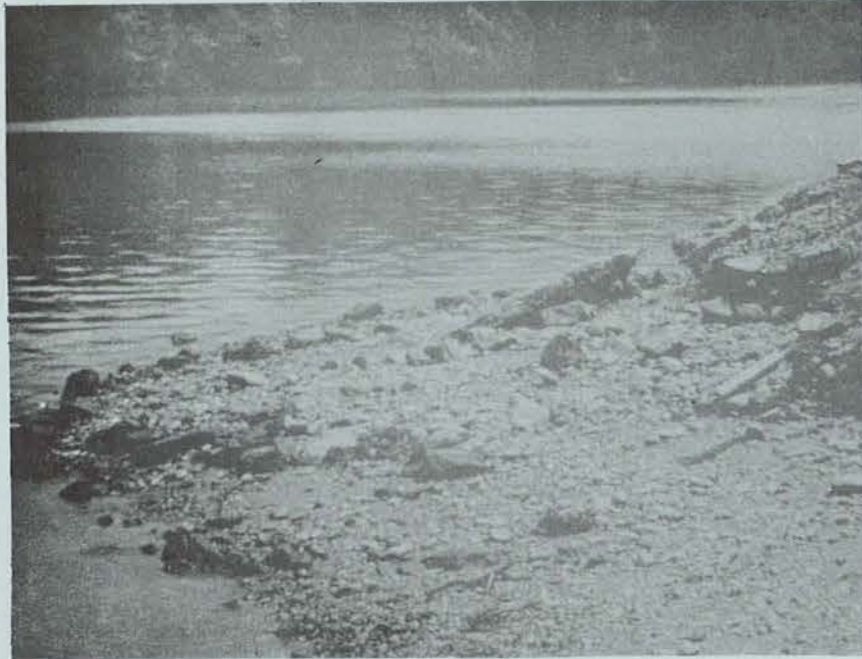
Figure 8

FIGURE 8: Close-up of beach material, Dutch Gap, Chesterfield County.

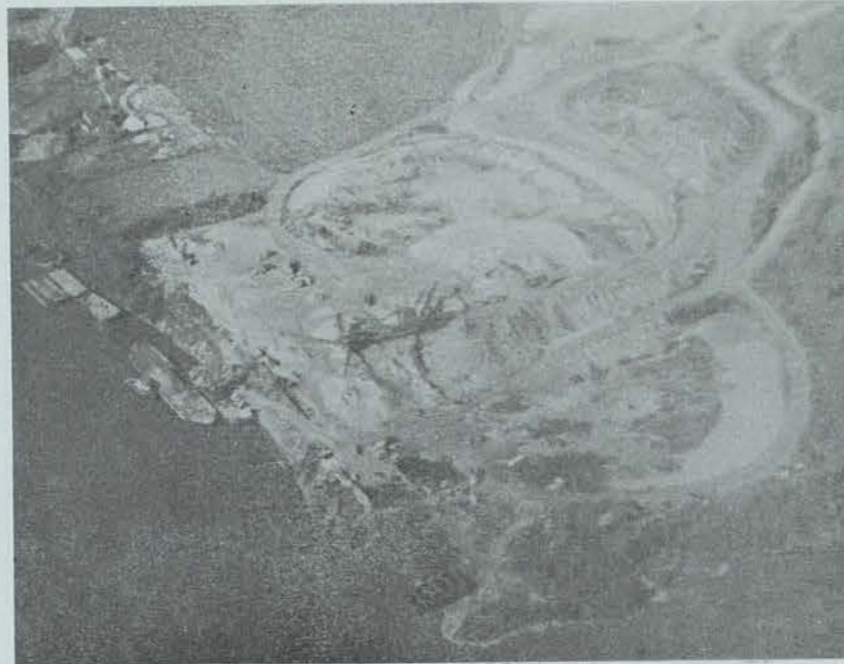
Figure 9

FIGURE 9: Aerial view of gravel pits, west of Turkey Island Creek, Henrico County.

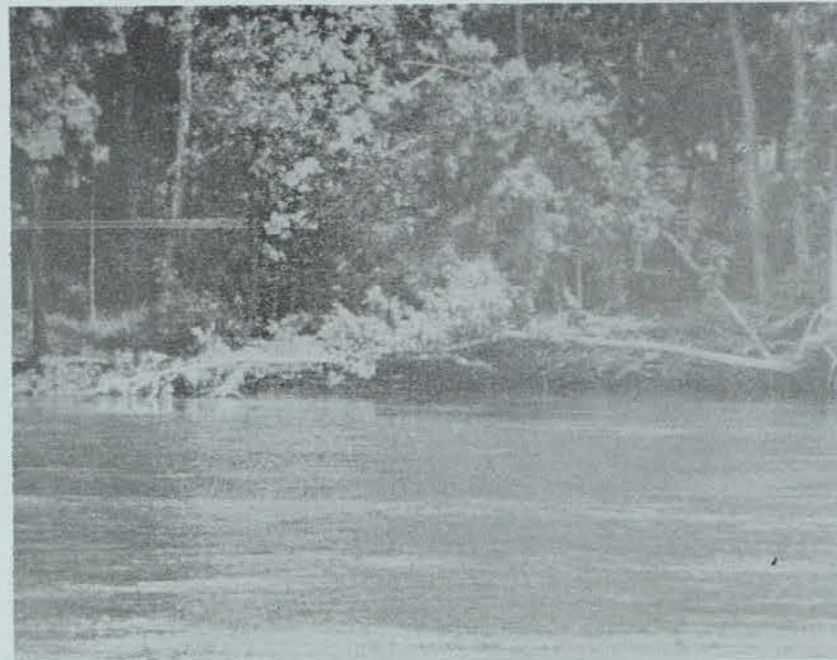
Figure 10

FIGURE 10: Shoreline of Presquile National Wildlife Refuge bordering Turkey Island Cutoff. This stretch of shoreline has recently been experiencing severe erosion.

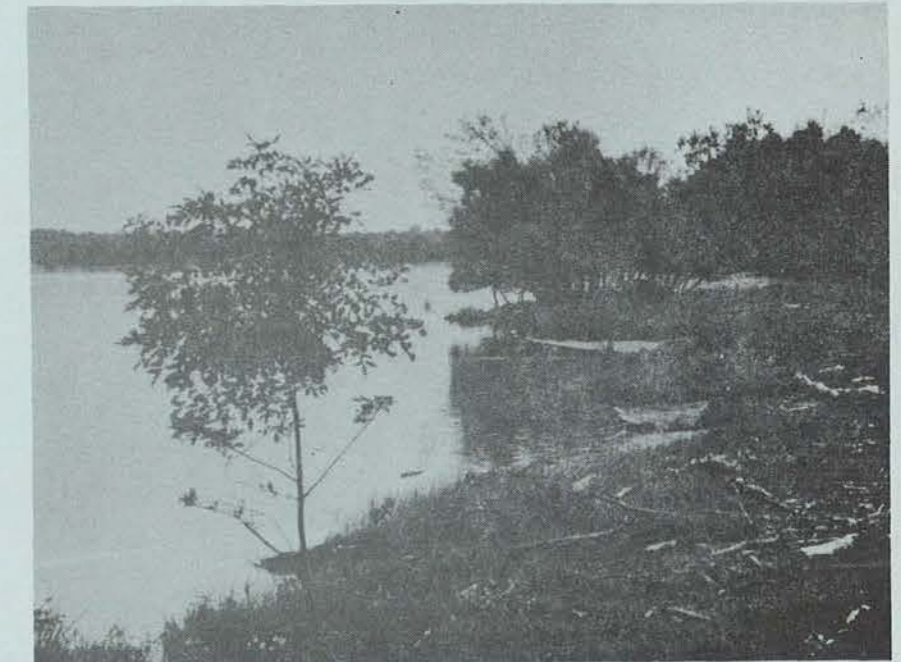
Figure 11

FIGURE 11: Across Turkey Island Cutoff from Presque Isle. Erosion here is very minor and is not a problem.
