# Shoreline Situation Report Mathews County, Virginia

Hobbs, C. H., Anderson, G. F., Byrne, R. J., & Zeigler, J. M. (1975) Shoreline Situation Report Mathews County, Virginia. Special Report In Applied Marine Science and Ocean Engineering No. 77. Virginia Institute of Marine Science, College of William and Mary. <https://doi.org/10.21220/V5W44B>

Chesapeake Research Consortium Report Number 12

Special Report In Applied Marine Science and Ocean Engineering Number 77 of the

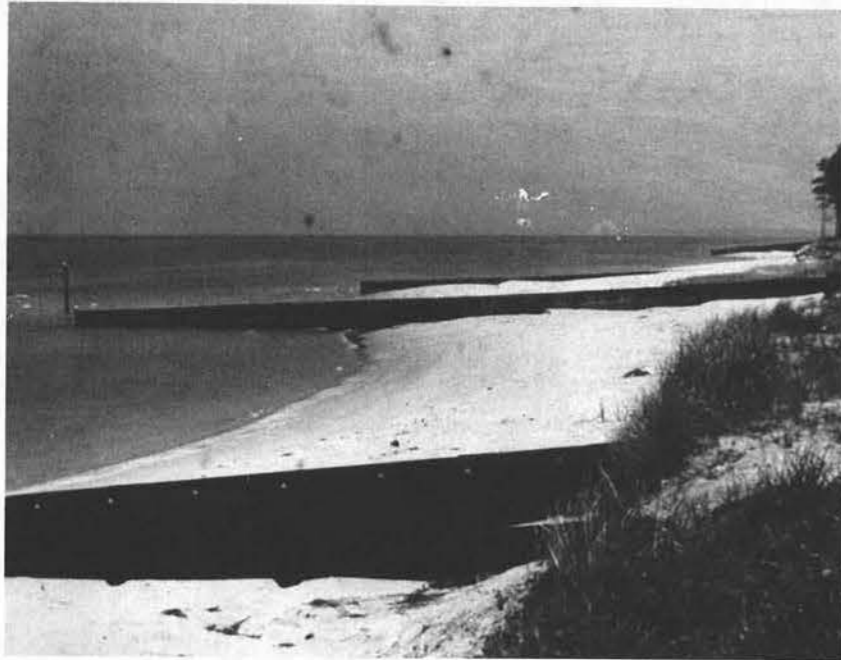
FIGURE 5

5: Beach along the Chesapeake Bay shore of Gwynn Island, Subsegment 3B.

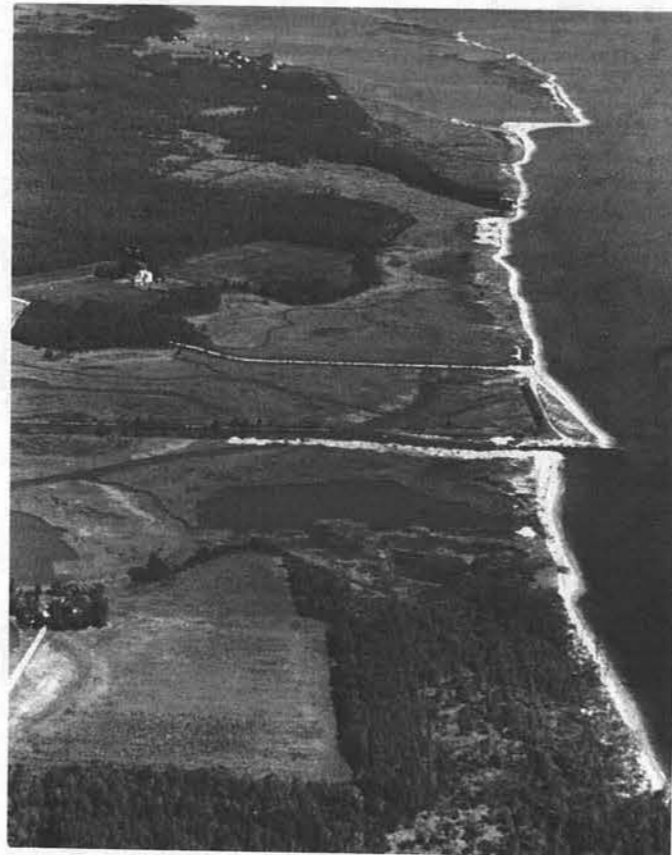
FIGURE 8

8: View north up Bethel Beach and Rigby Island. Note that this photograph shows Rigby Island (upper right) connected to Bethel Beach whereas the topographic maps (dated 1965) show them separated. The maintained inlet is Garden Creek.

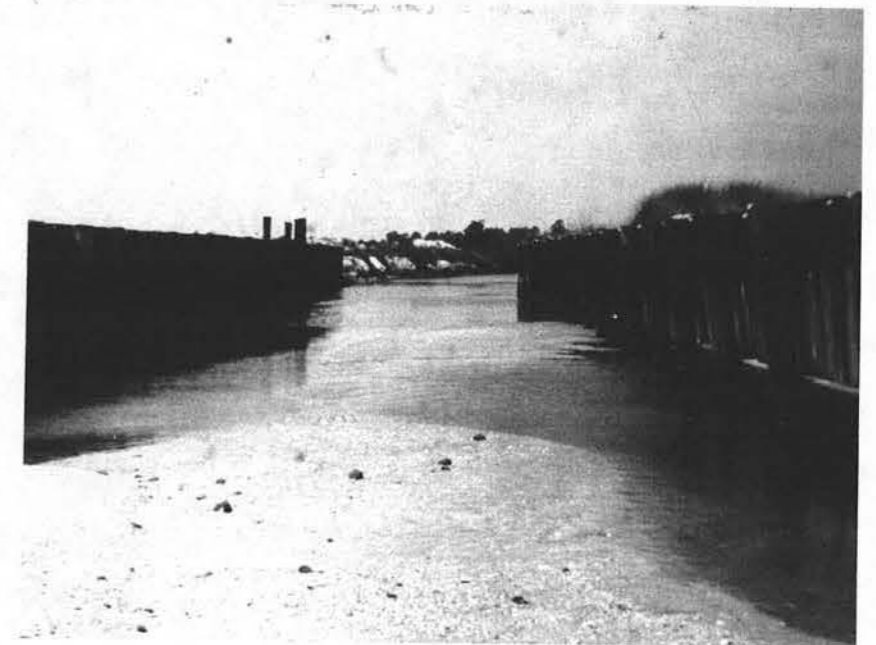
FIGURE 9

9: Garden Creek inlet, the jetties are nearly closed by sand, the inlet is usable only at high tide.

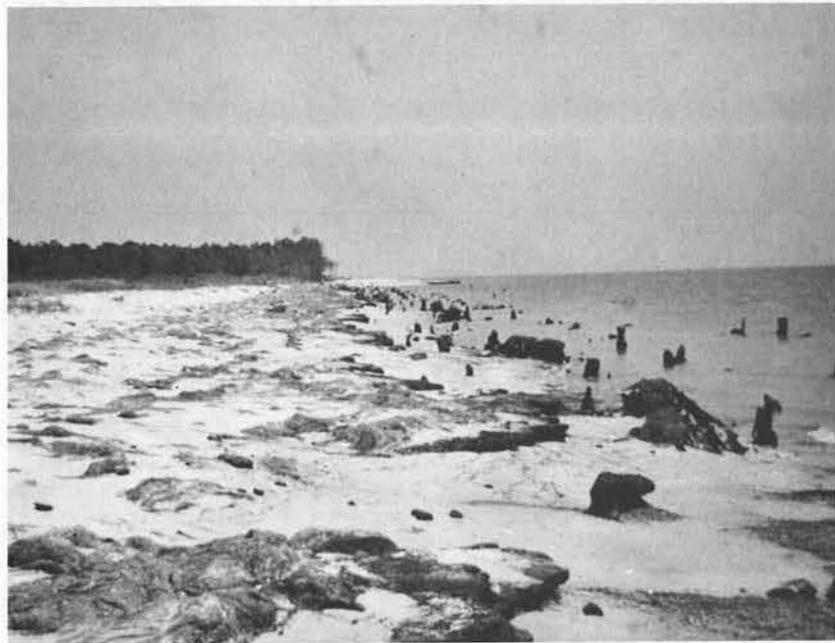
FIGURE 10

10: Bethel Beach near Onemo. The beach is subject to severe erosion. There is a very small quantity of sand above the eroding marsh peats.
