Shoreline Situation Report YORK COUNTY, VIRGINIA

Chesapeake Research Consortium Report Number 16

Special Report In Applied Marine Science and Ocean Engineering Number 82 of the

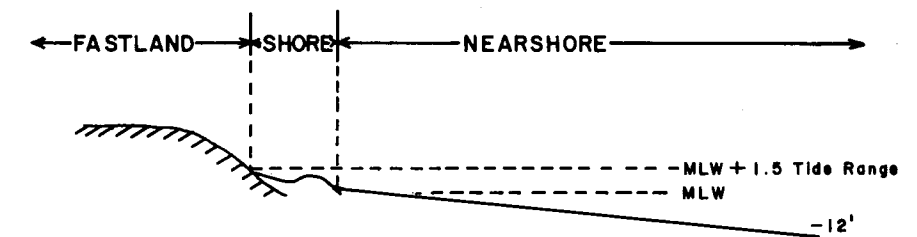
Figure 1A

An illustration of the definition of the three components of the shorelands.

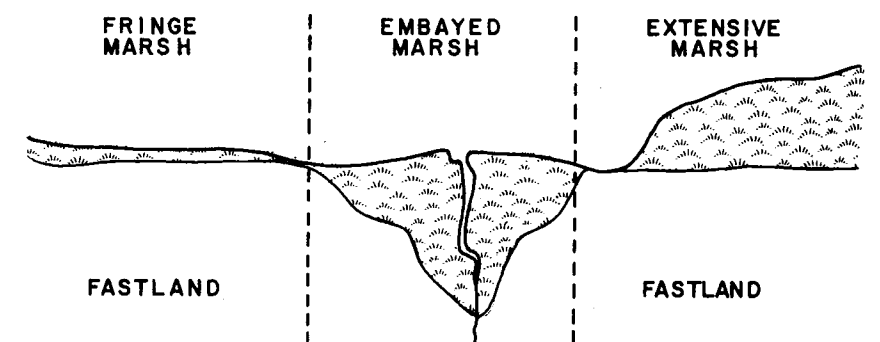
Figure 1B

A generalized illustration of the three different marsh types.

The physiographic character of the marshes has also been separated into three types (see Figure 1B). Fringe marsh is that which is less than 400 feet in width and which runs in a band parallel to the shore. Extensive marsh is that which has extensive acreage projecting into an estuary or river. An embayed marsh is a marsh which occupies a reentrant or drowned creek valley. The purpose in delineating these marsh types is that the effectiveness of the various functions of the marsh will, in part, be determined by type of exposure to the estuarine system. A fringe marsh

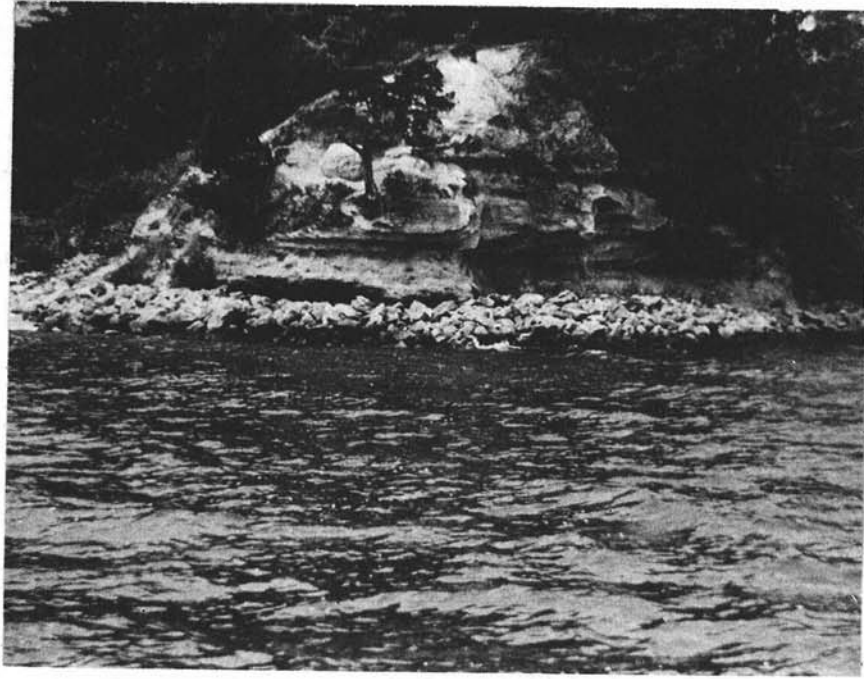
Figure 2

FIGURE 2: Large stone riprap which protects much of the nonmarsh York River shoreline. However, there is no beach along these sections at high tide.

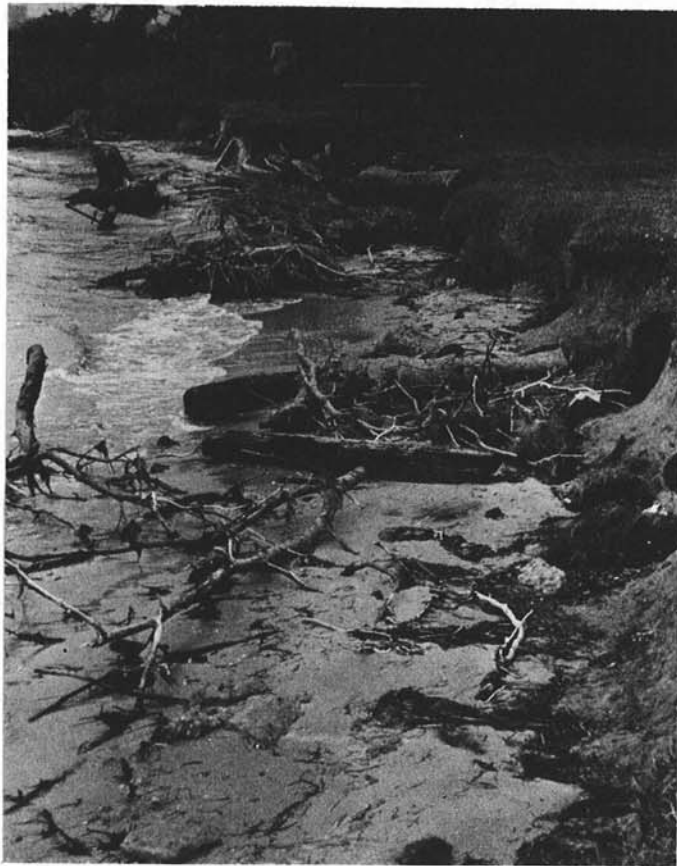
Figure 4

FIGURE 4: Wave erosion at the Park Service picnic grounds in Yorktown.

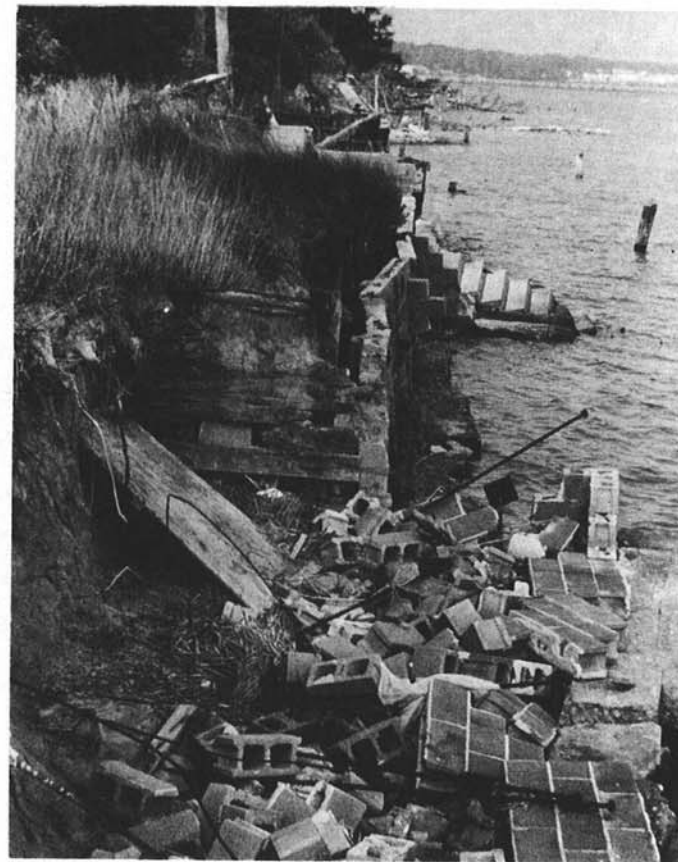
Figure 5

FIGURE 5: One example of the many poorly designed and constructed bulkheads in York County.

Suggested Action: To avert additional damage, the York River bulkheads should be either replaced or repaired. Those individuals whose bulkheads are destroyed or in disrepair might consider the use of properly placed, adequate size riprap, if they are only concerned with stopping erosion. However, the enhancement of a beach in this area would require groins. Due to the extensive amount of shoreline protection in this segment and that a significant amount of the beach sand is supplied by local sources of erosion, only properly designed and constructed groins would be of any value.

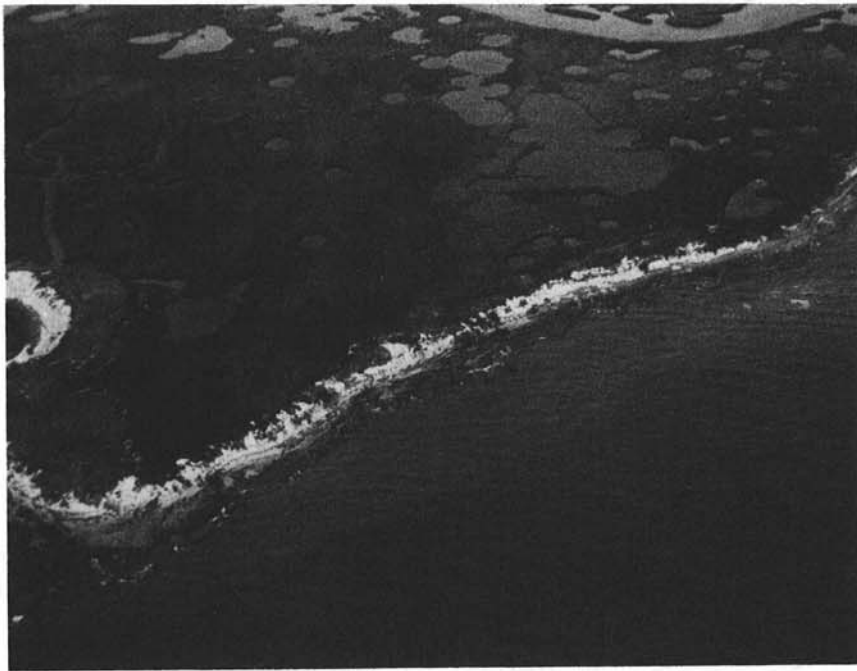
Figure 6

FIGURE 6: The Plumtree Island Wildlife Refuge marsh with its small barrier beach.

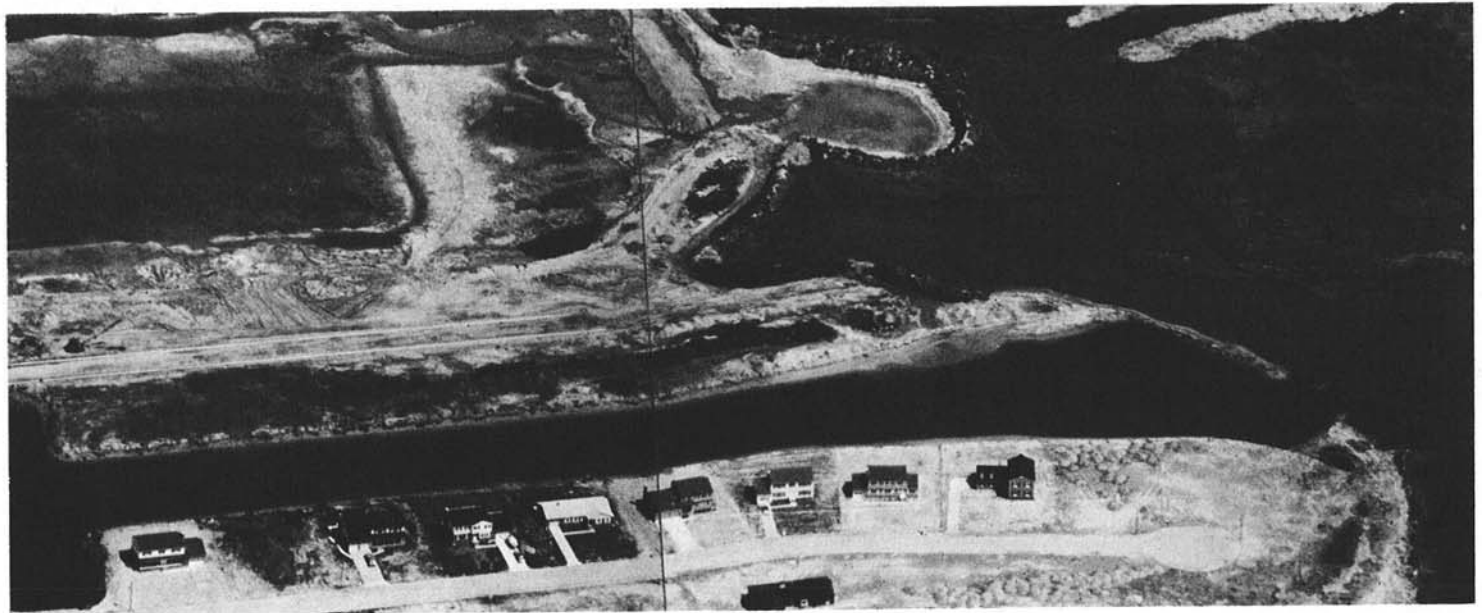
Figure 8

FIGURE 8: Another example of a dead end canal and spoiled marsh. Such practices are environmentally unsound in addition to placing homes in high flood hazard areas.

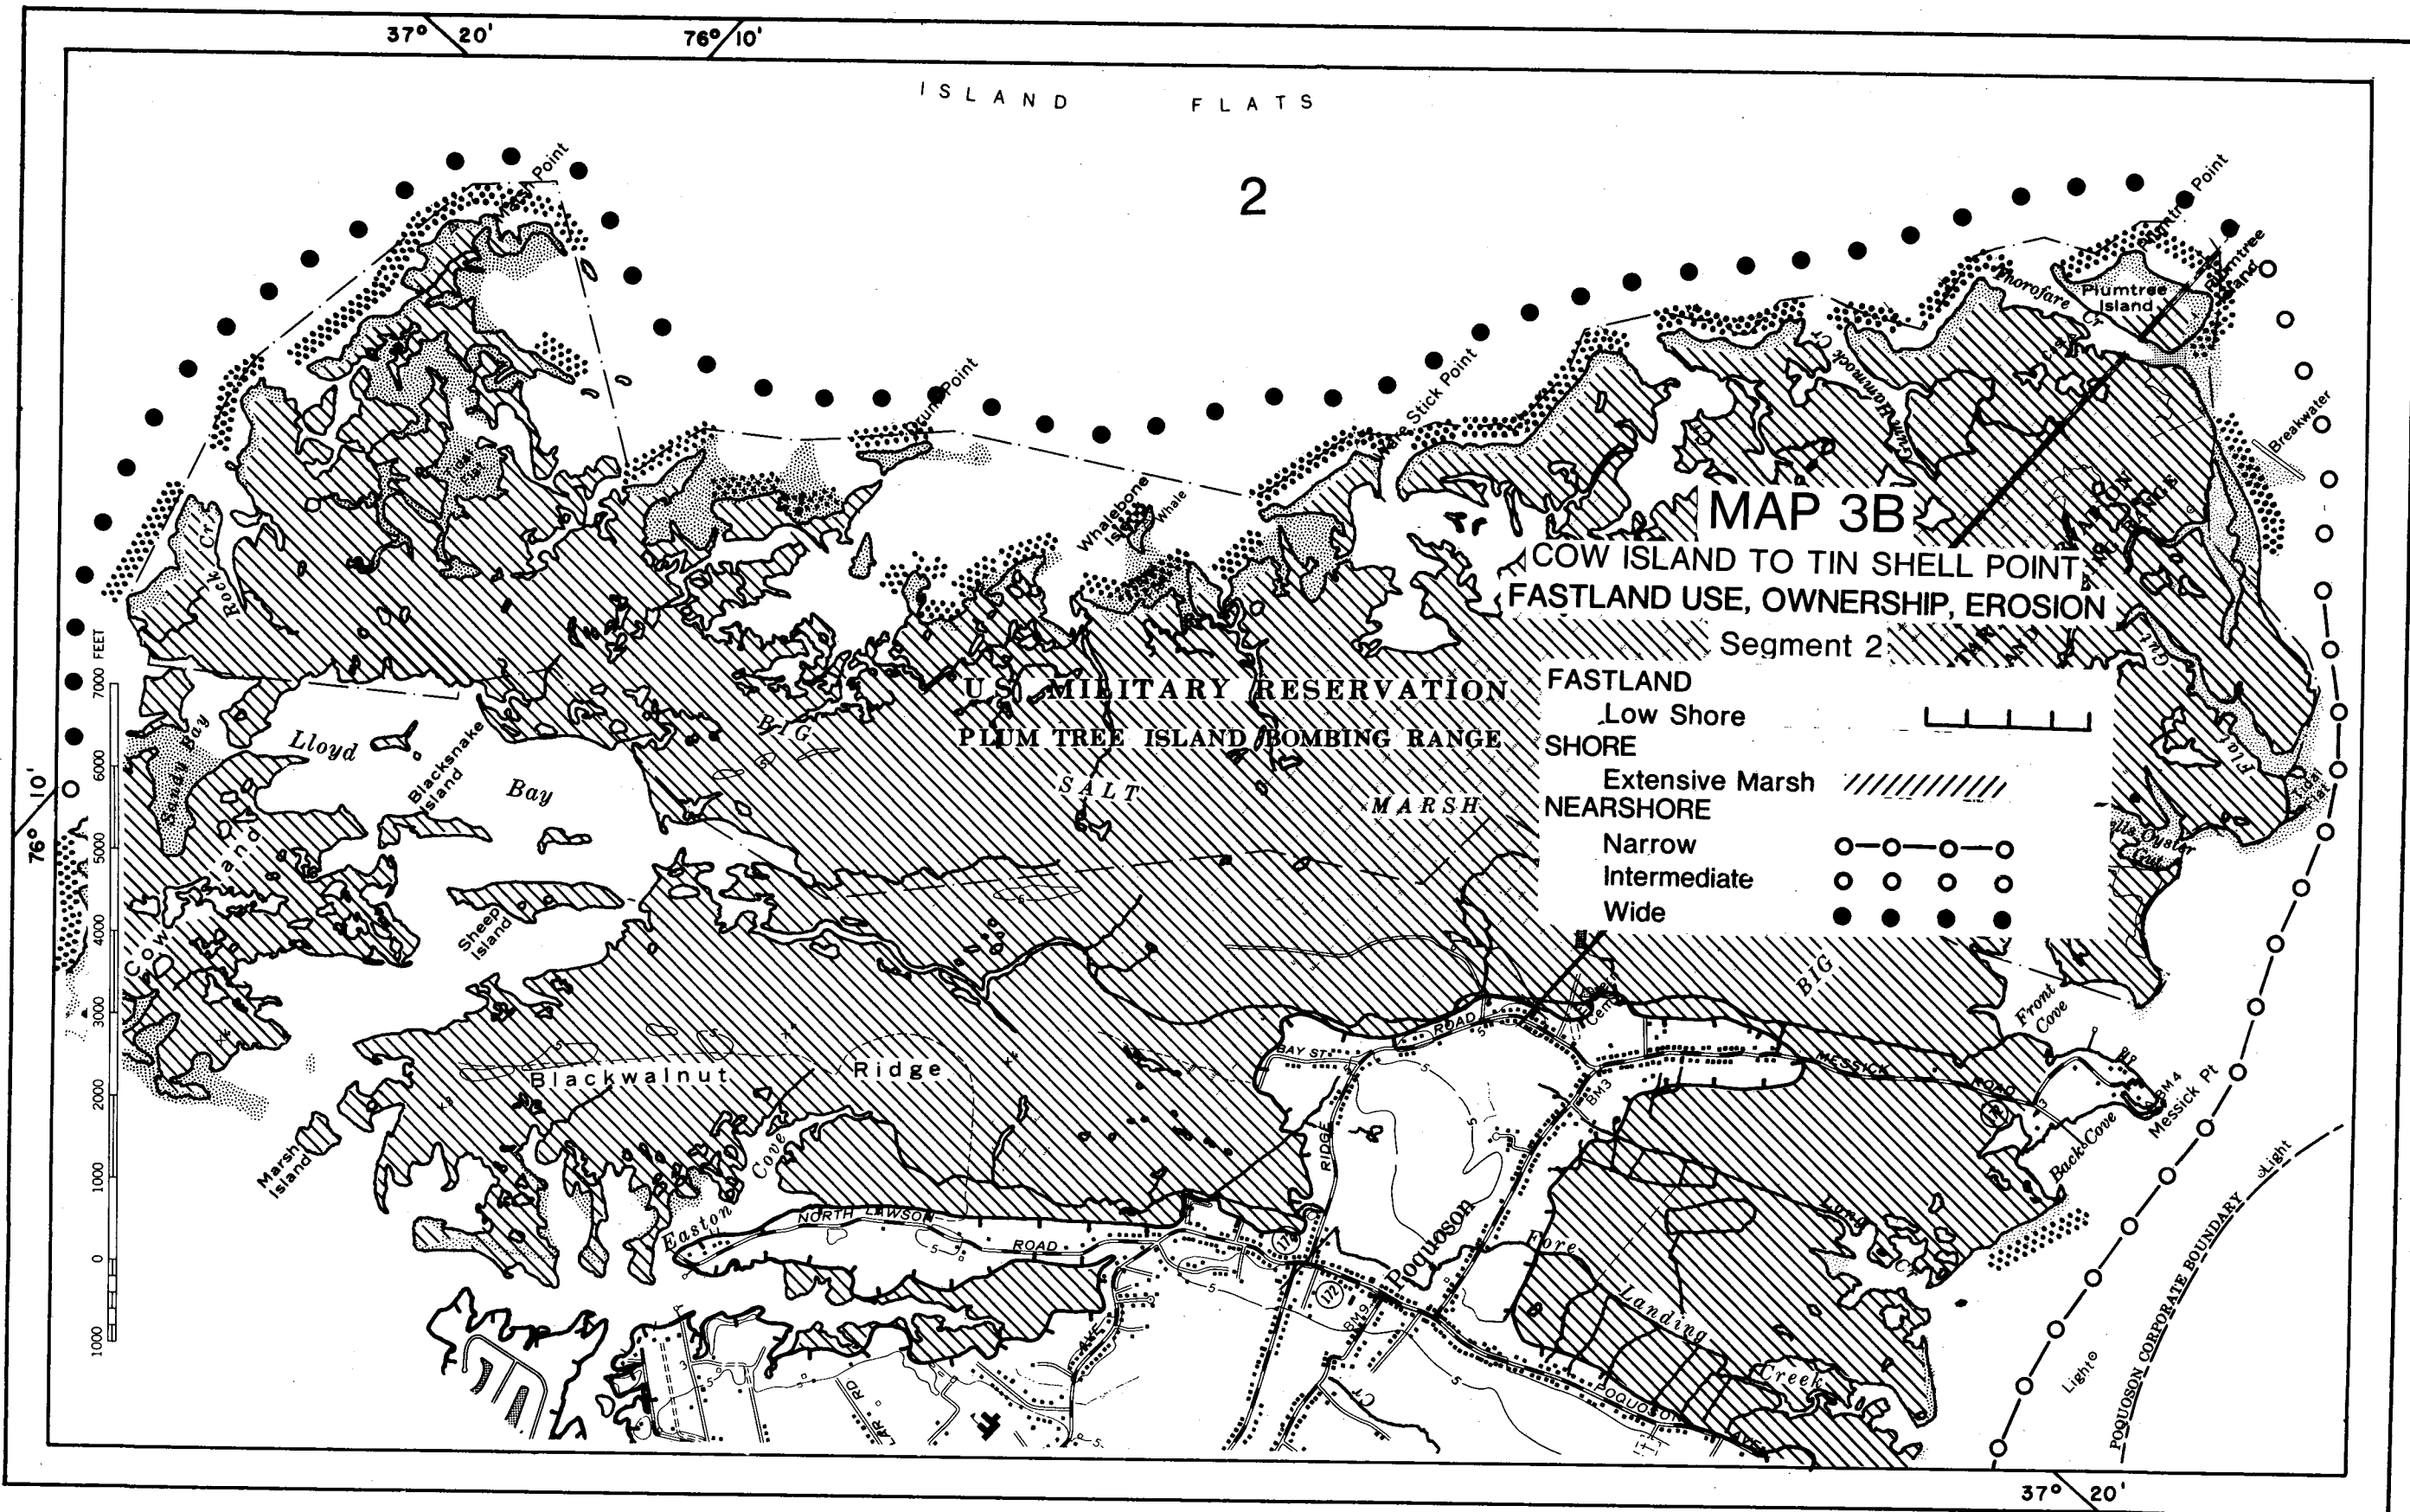
MAP 3B
 COW ISLAND TO TIN SHELL POINT
 FASTLAND USE, OWNERSHIP, EROSION
 Segment 2

FASTLAND
 Low Shore
SHORE
 Extensive Marsh
NEARSHORE
 Narrow
 Intermediate
 Wide

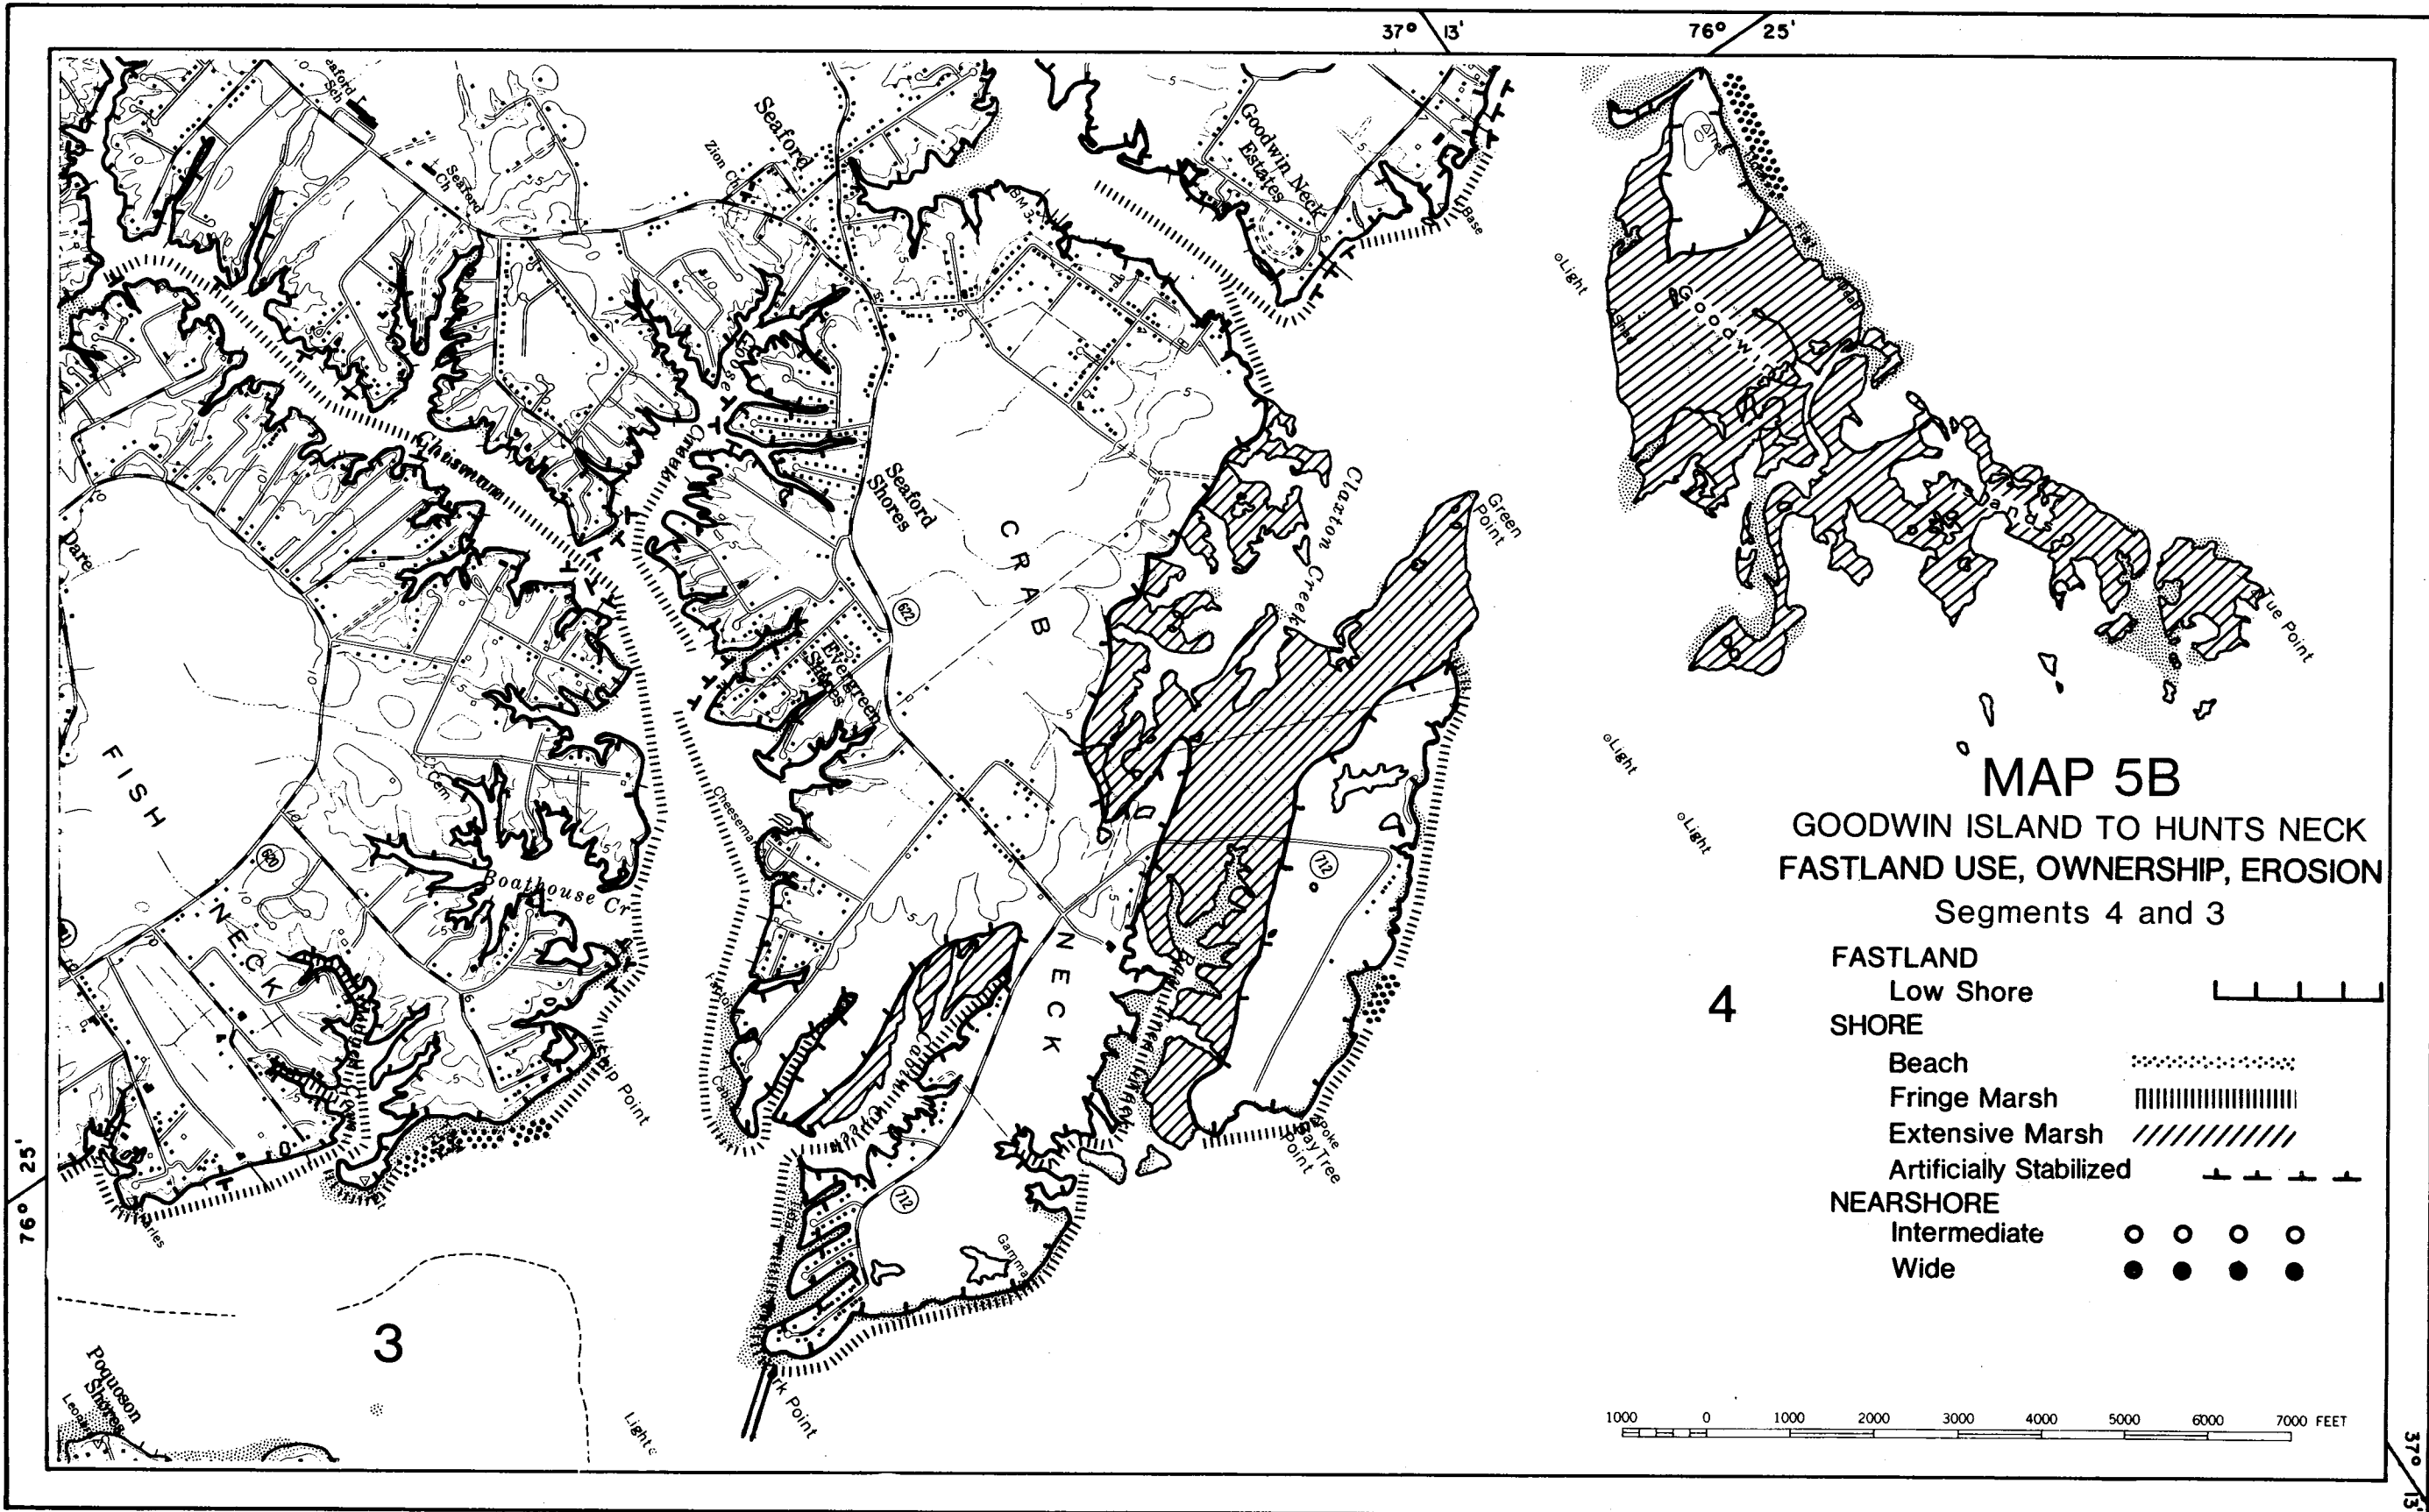
MAP 5B
 GOODWIN ISLAND TO HUNTS NECK
 FASTLAND USE, OWNERSHIP, EROSION
 Segments 4 and 3

- 4**
- FASTLAND**
 - Low Shore
 - SHORE**
 - Beach
 - Fringe Marsh
 - Extensive Marsh
 - Artificially Stabilized
 - NEARSHORE**
 - Intermediate
 - Wide

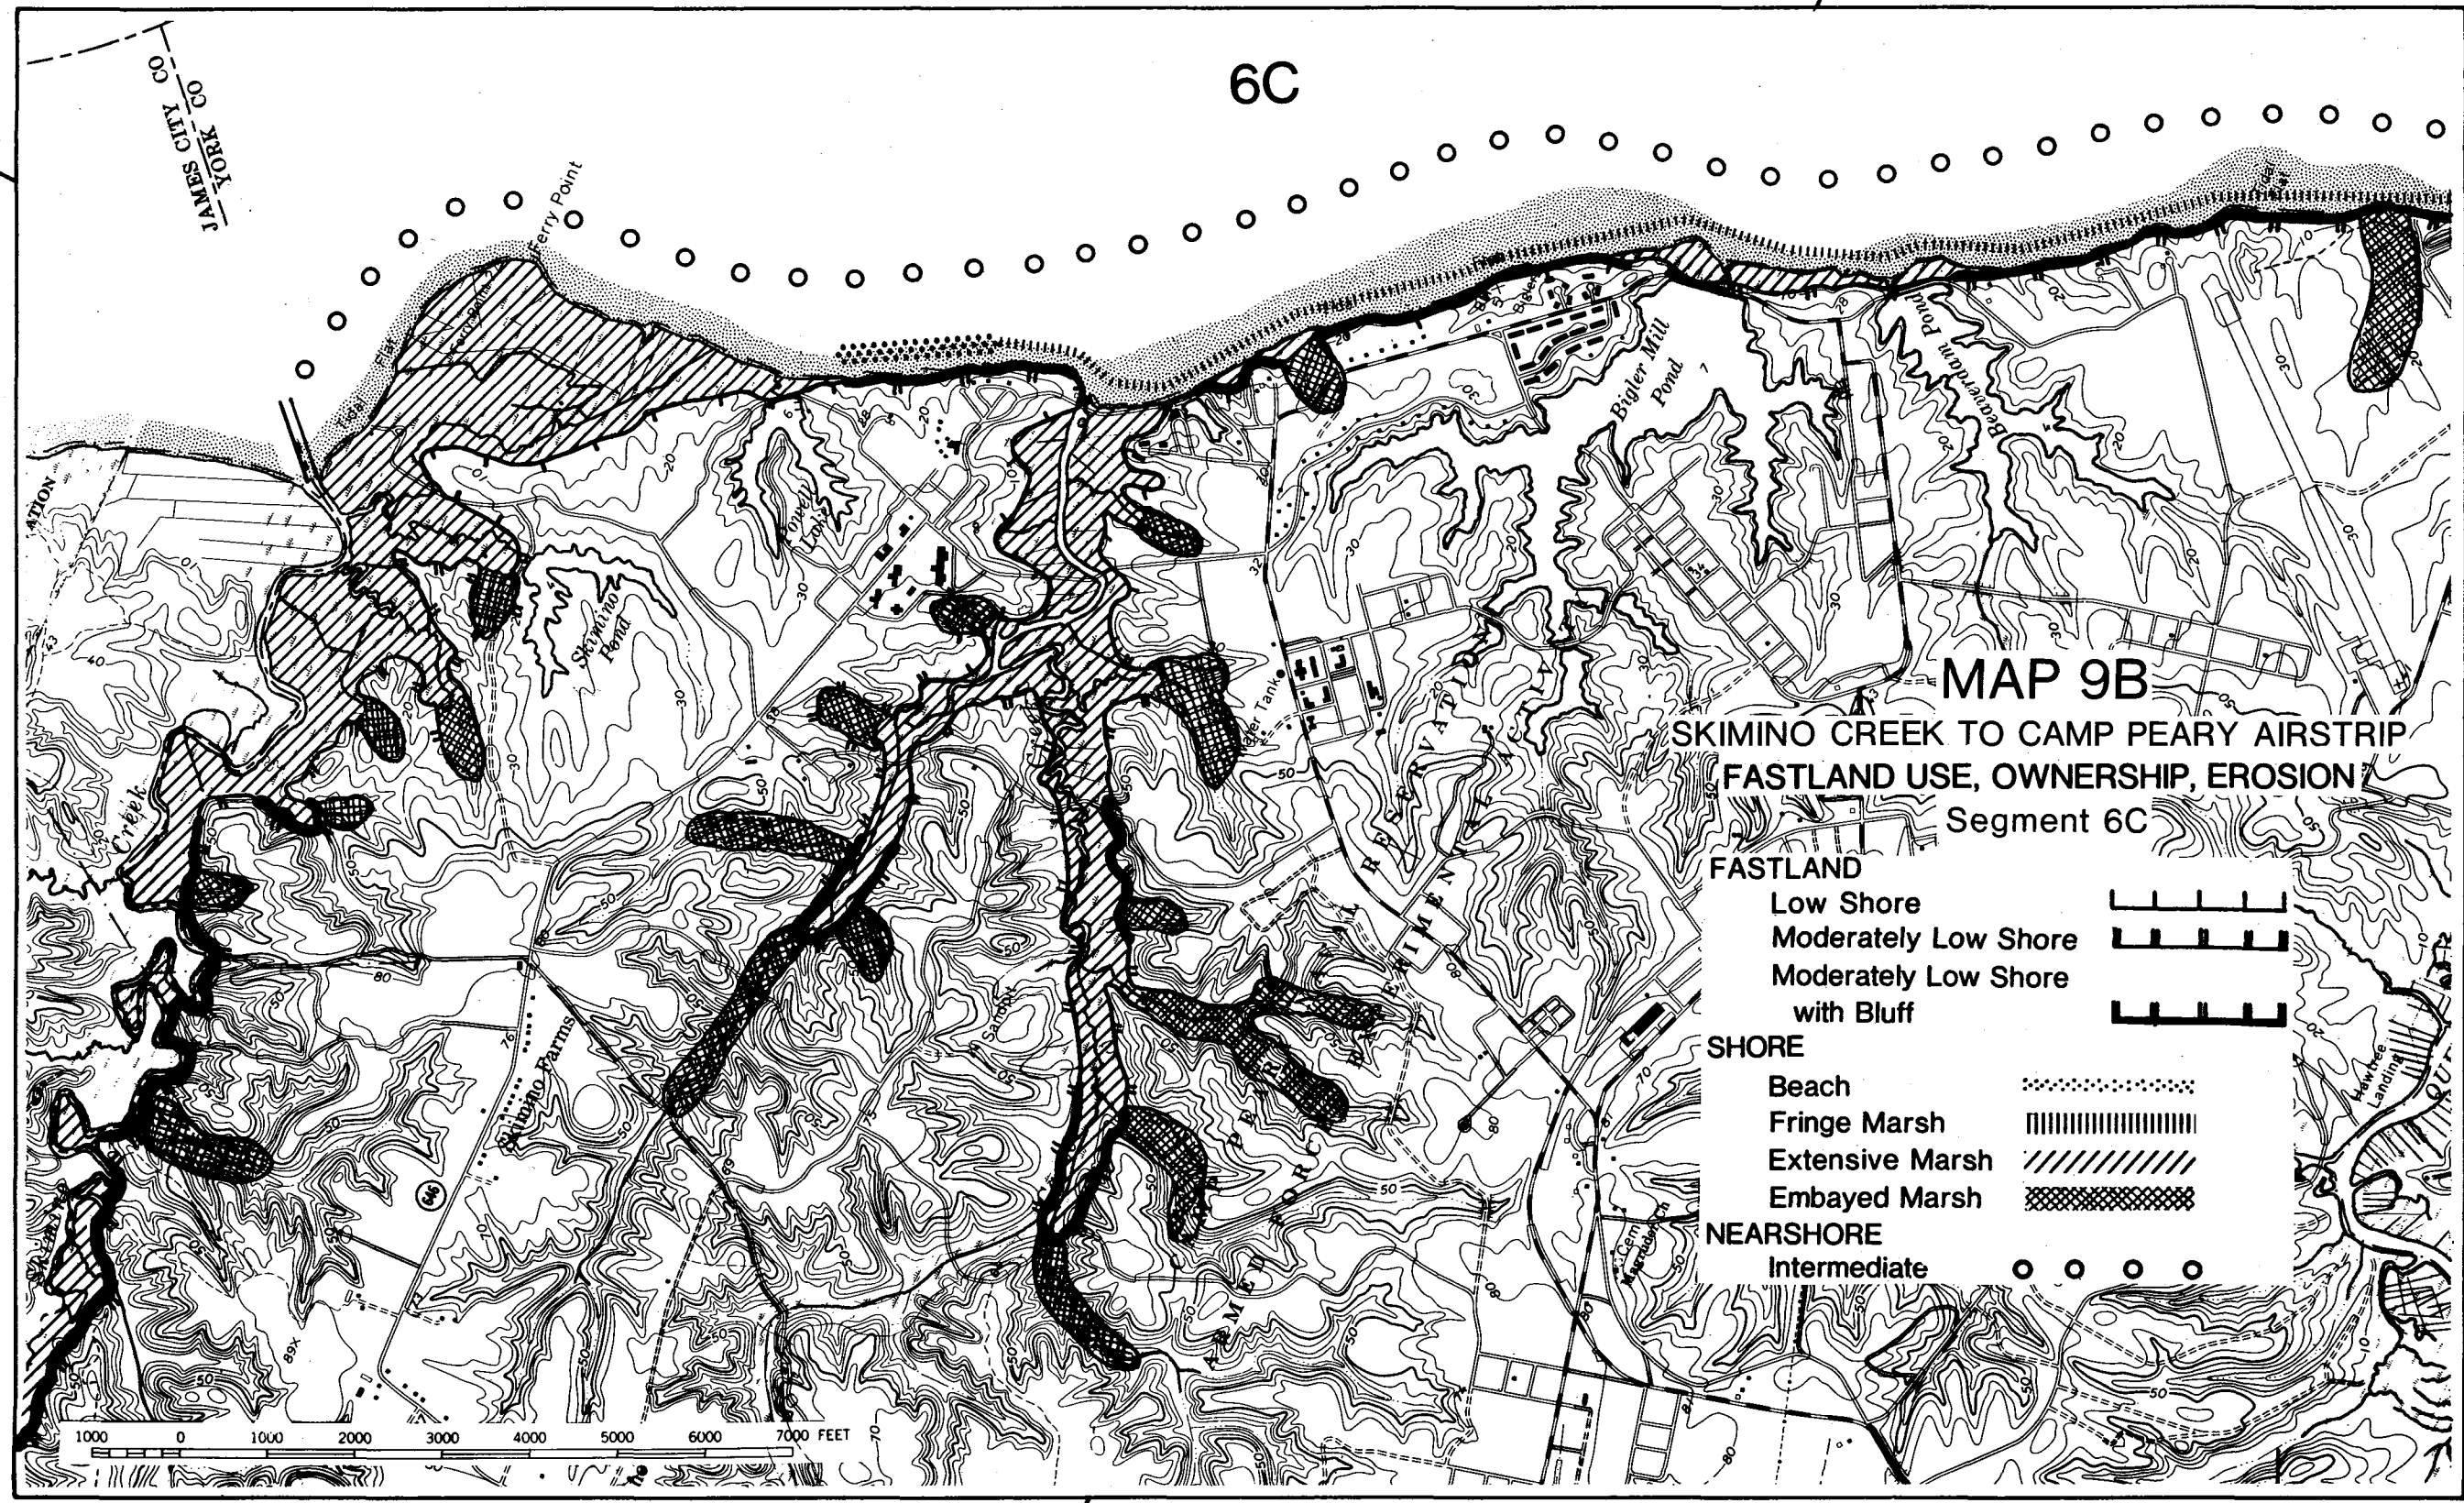
MAP 9B

SKIMINO CREEK TO CAMP PEARY AIRSTRIP
 FASTLAND USE, OWNERSHIP, EROSION
 Segment 6C

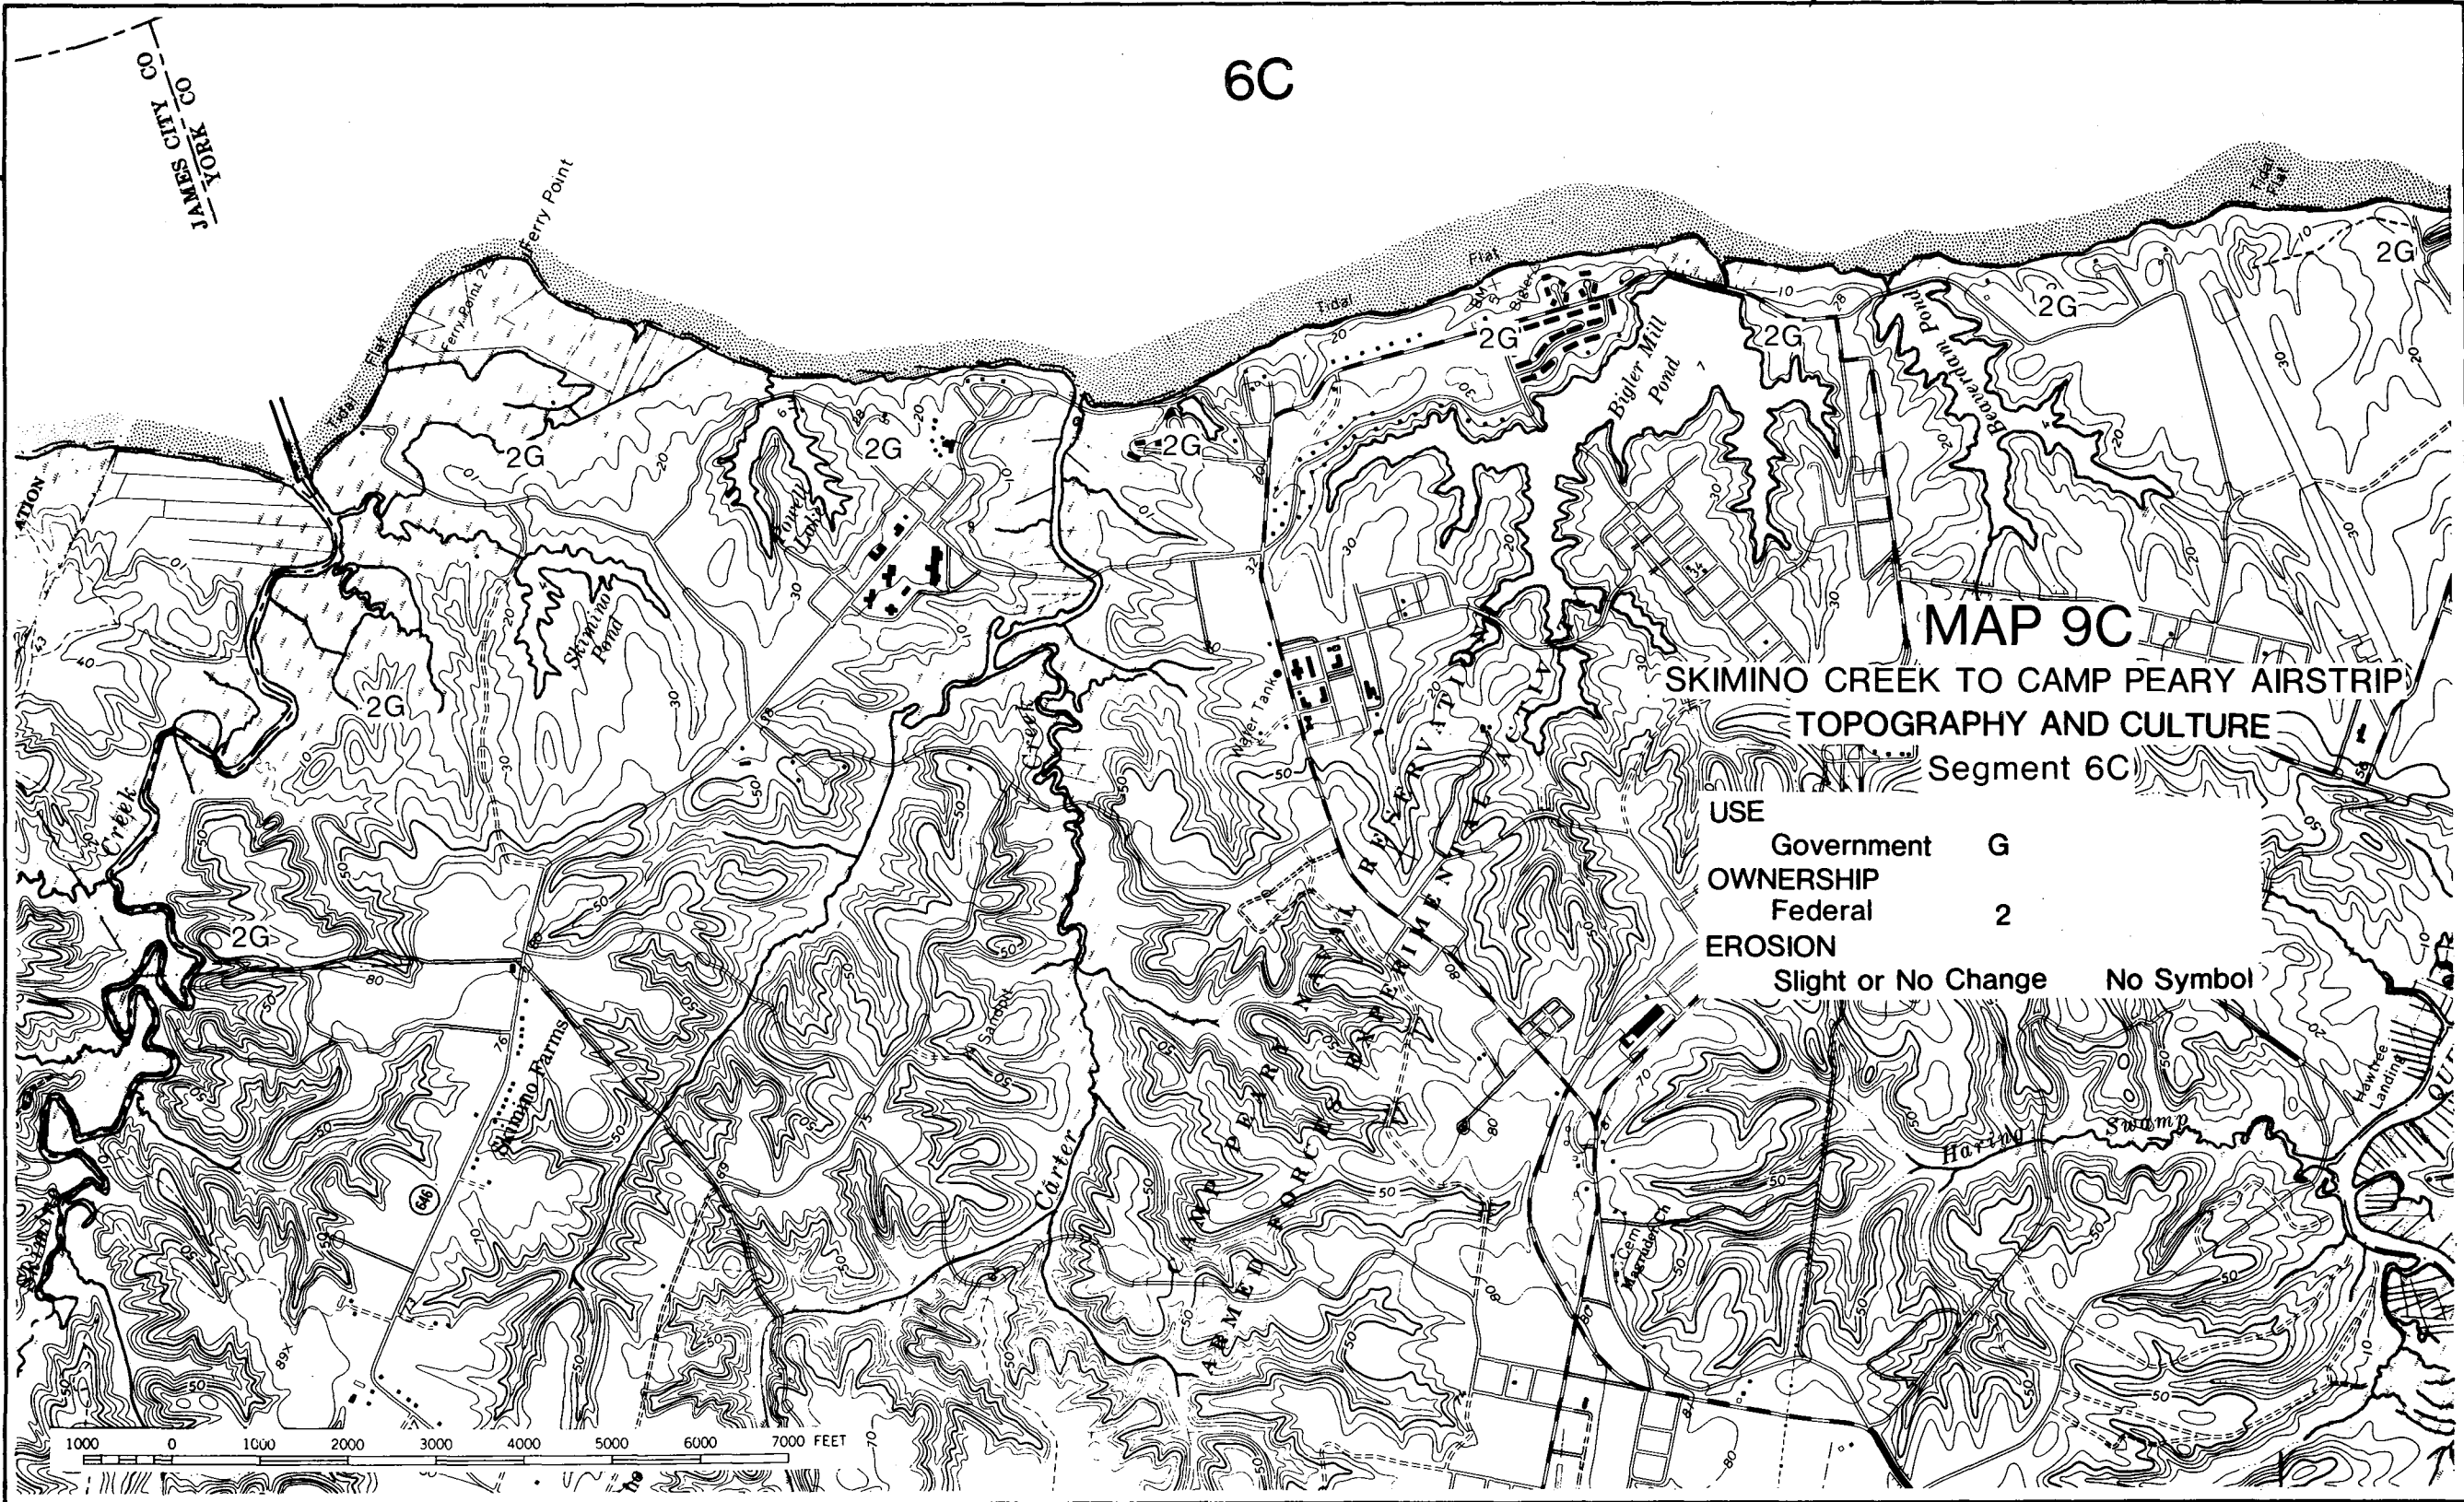
MAP 9C
SKIMINO CREEK TO CAMP PEARY AIRSTRIP
TOPOGRAPHY AND CULTURE
 Segment 6C

USE
 Government G
 OWNERSHIP
 Federal 2
 EROSION
 Slight or No Change No Symbol
