# Shoreline Situation Report Northampton County, Virginia

Shoreline Situation Report  
NORTHAMPTON COUNTY, VIRGINIA

Special Report In Applied Marine Science and Ocean Engineering Number 54 of the

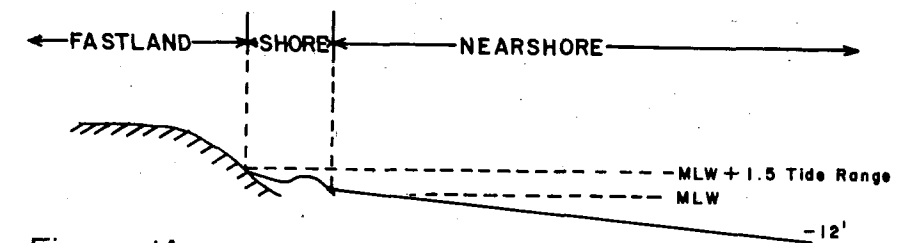
Figure 1A

An illustration of the definition of the three components of the shorelands.

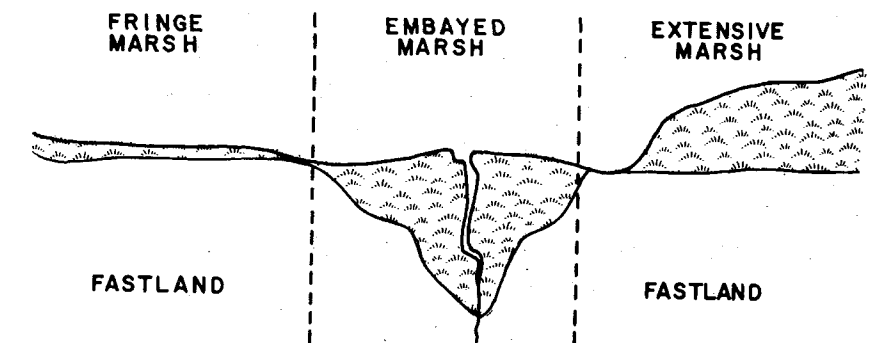
Figure 1B

A generalized illustration of the three different marsh types.

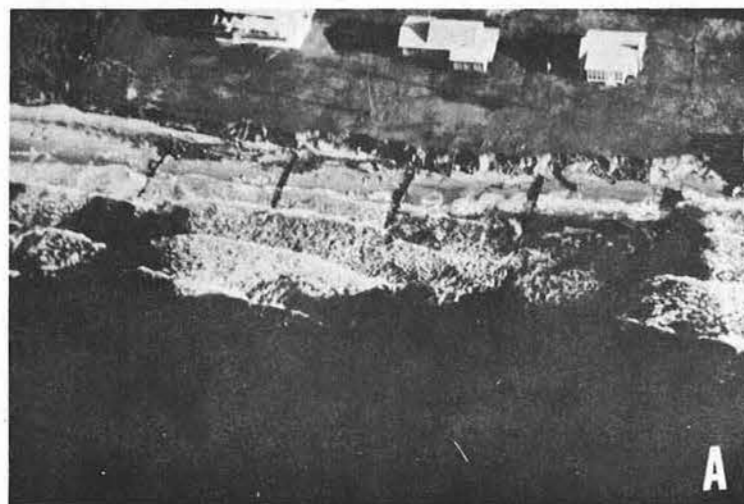
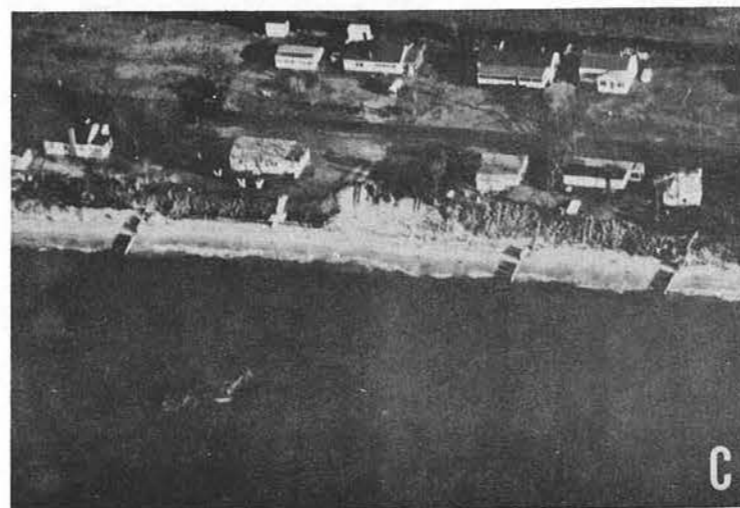
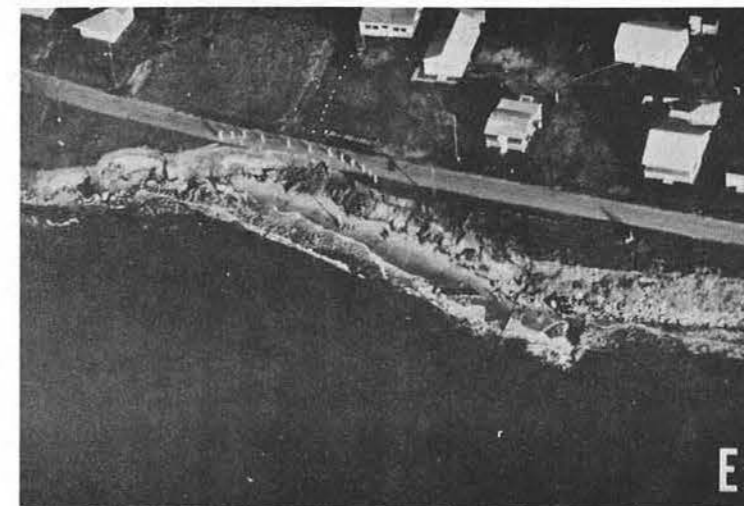
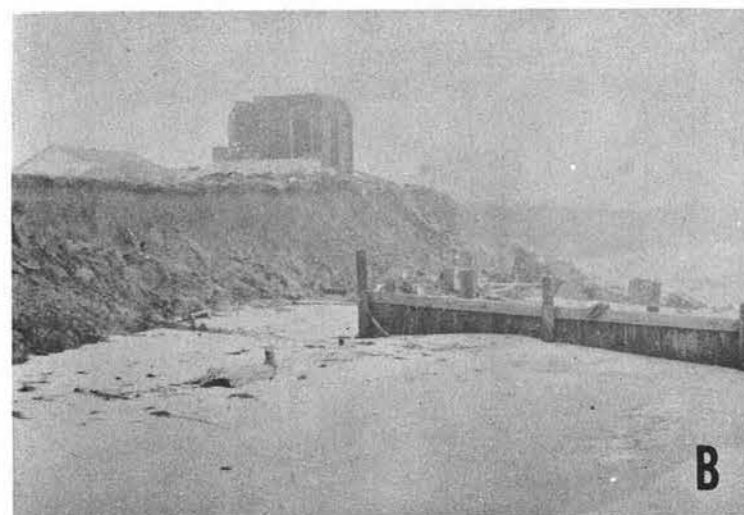
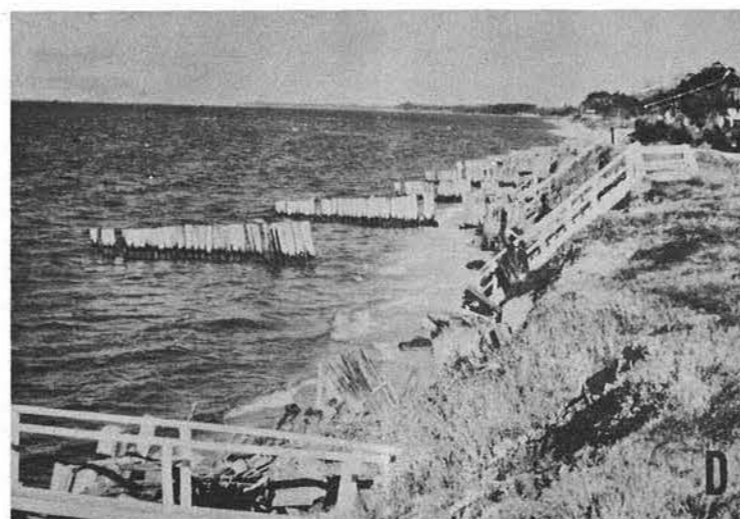
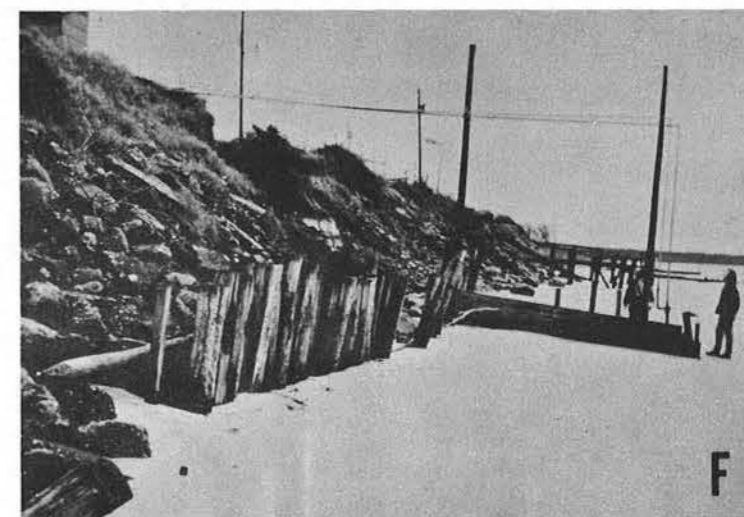
**A** Tankards Beach Groin System

**B** Tankards Beach May 8, 1973

- c) If possible the individual groins in a groin system should be placed in a time sequential manner with the most down-drift groin being the first installed. In those cases where groins alone are being utilized, this procedure will reduce the likelihood of flanking. Furthermore, the observed trapping characteristics will assist in the determination of the spacing between groins.

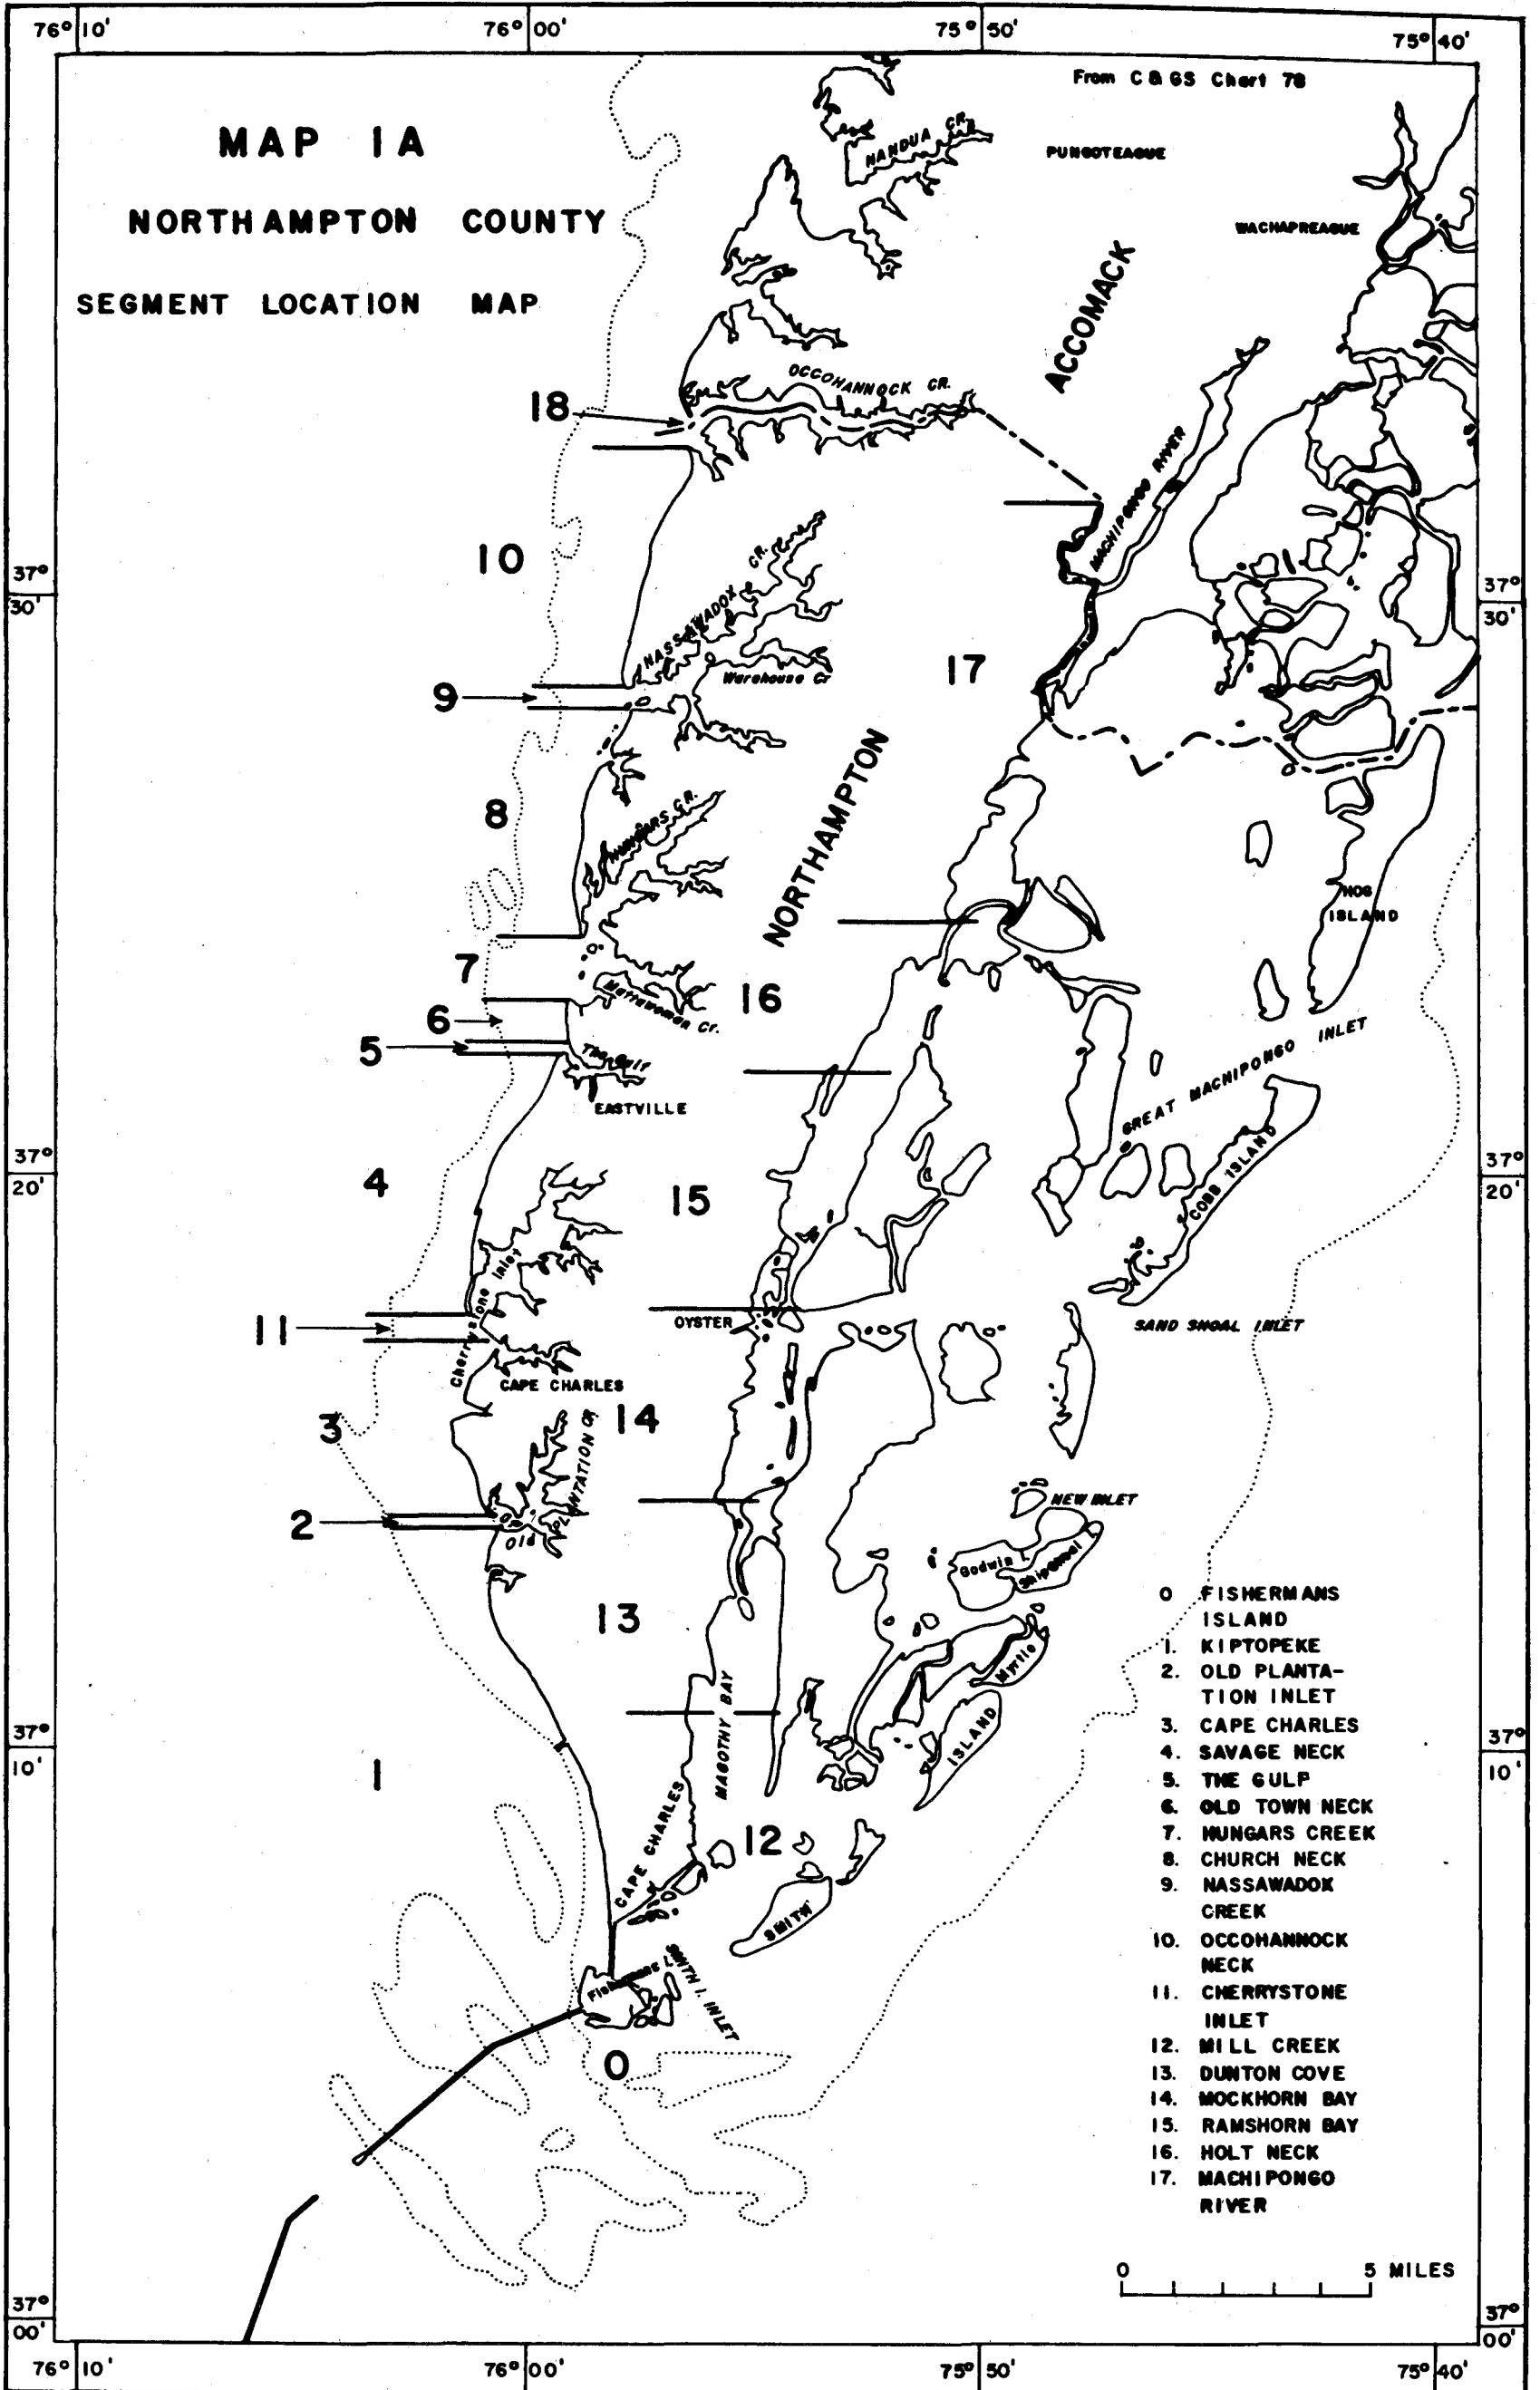
**MAP I B**  
**NORTHAMPTON COUNTY**  
**SHORELANDS TYPES**

- FASTLANDS**
- Low Shore
  - Low Shore with Bluff
  - Mod. Low Shore with Bluff
  - Mod. High Shore with Bluff
  - Dune

- NEARSHORE**
- Narrow
  - Intermed.
  - Wide

- SHORE**
- Beach
  - Extensive Marsh
- 0 5 MILES

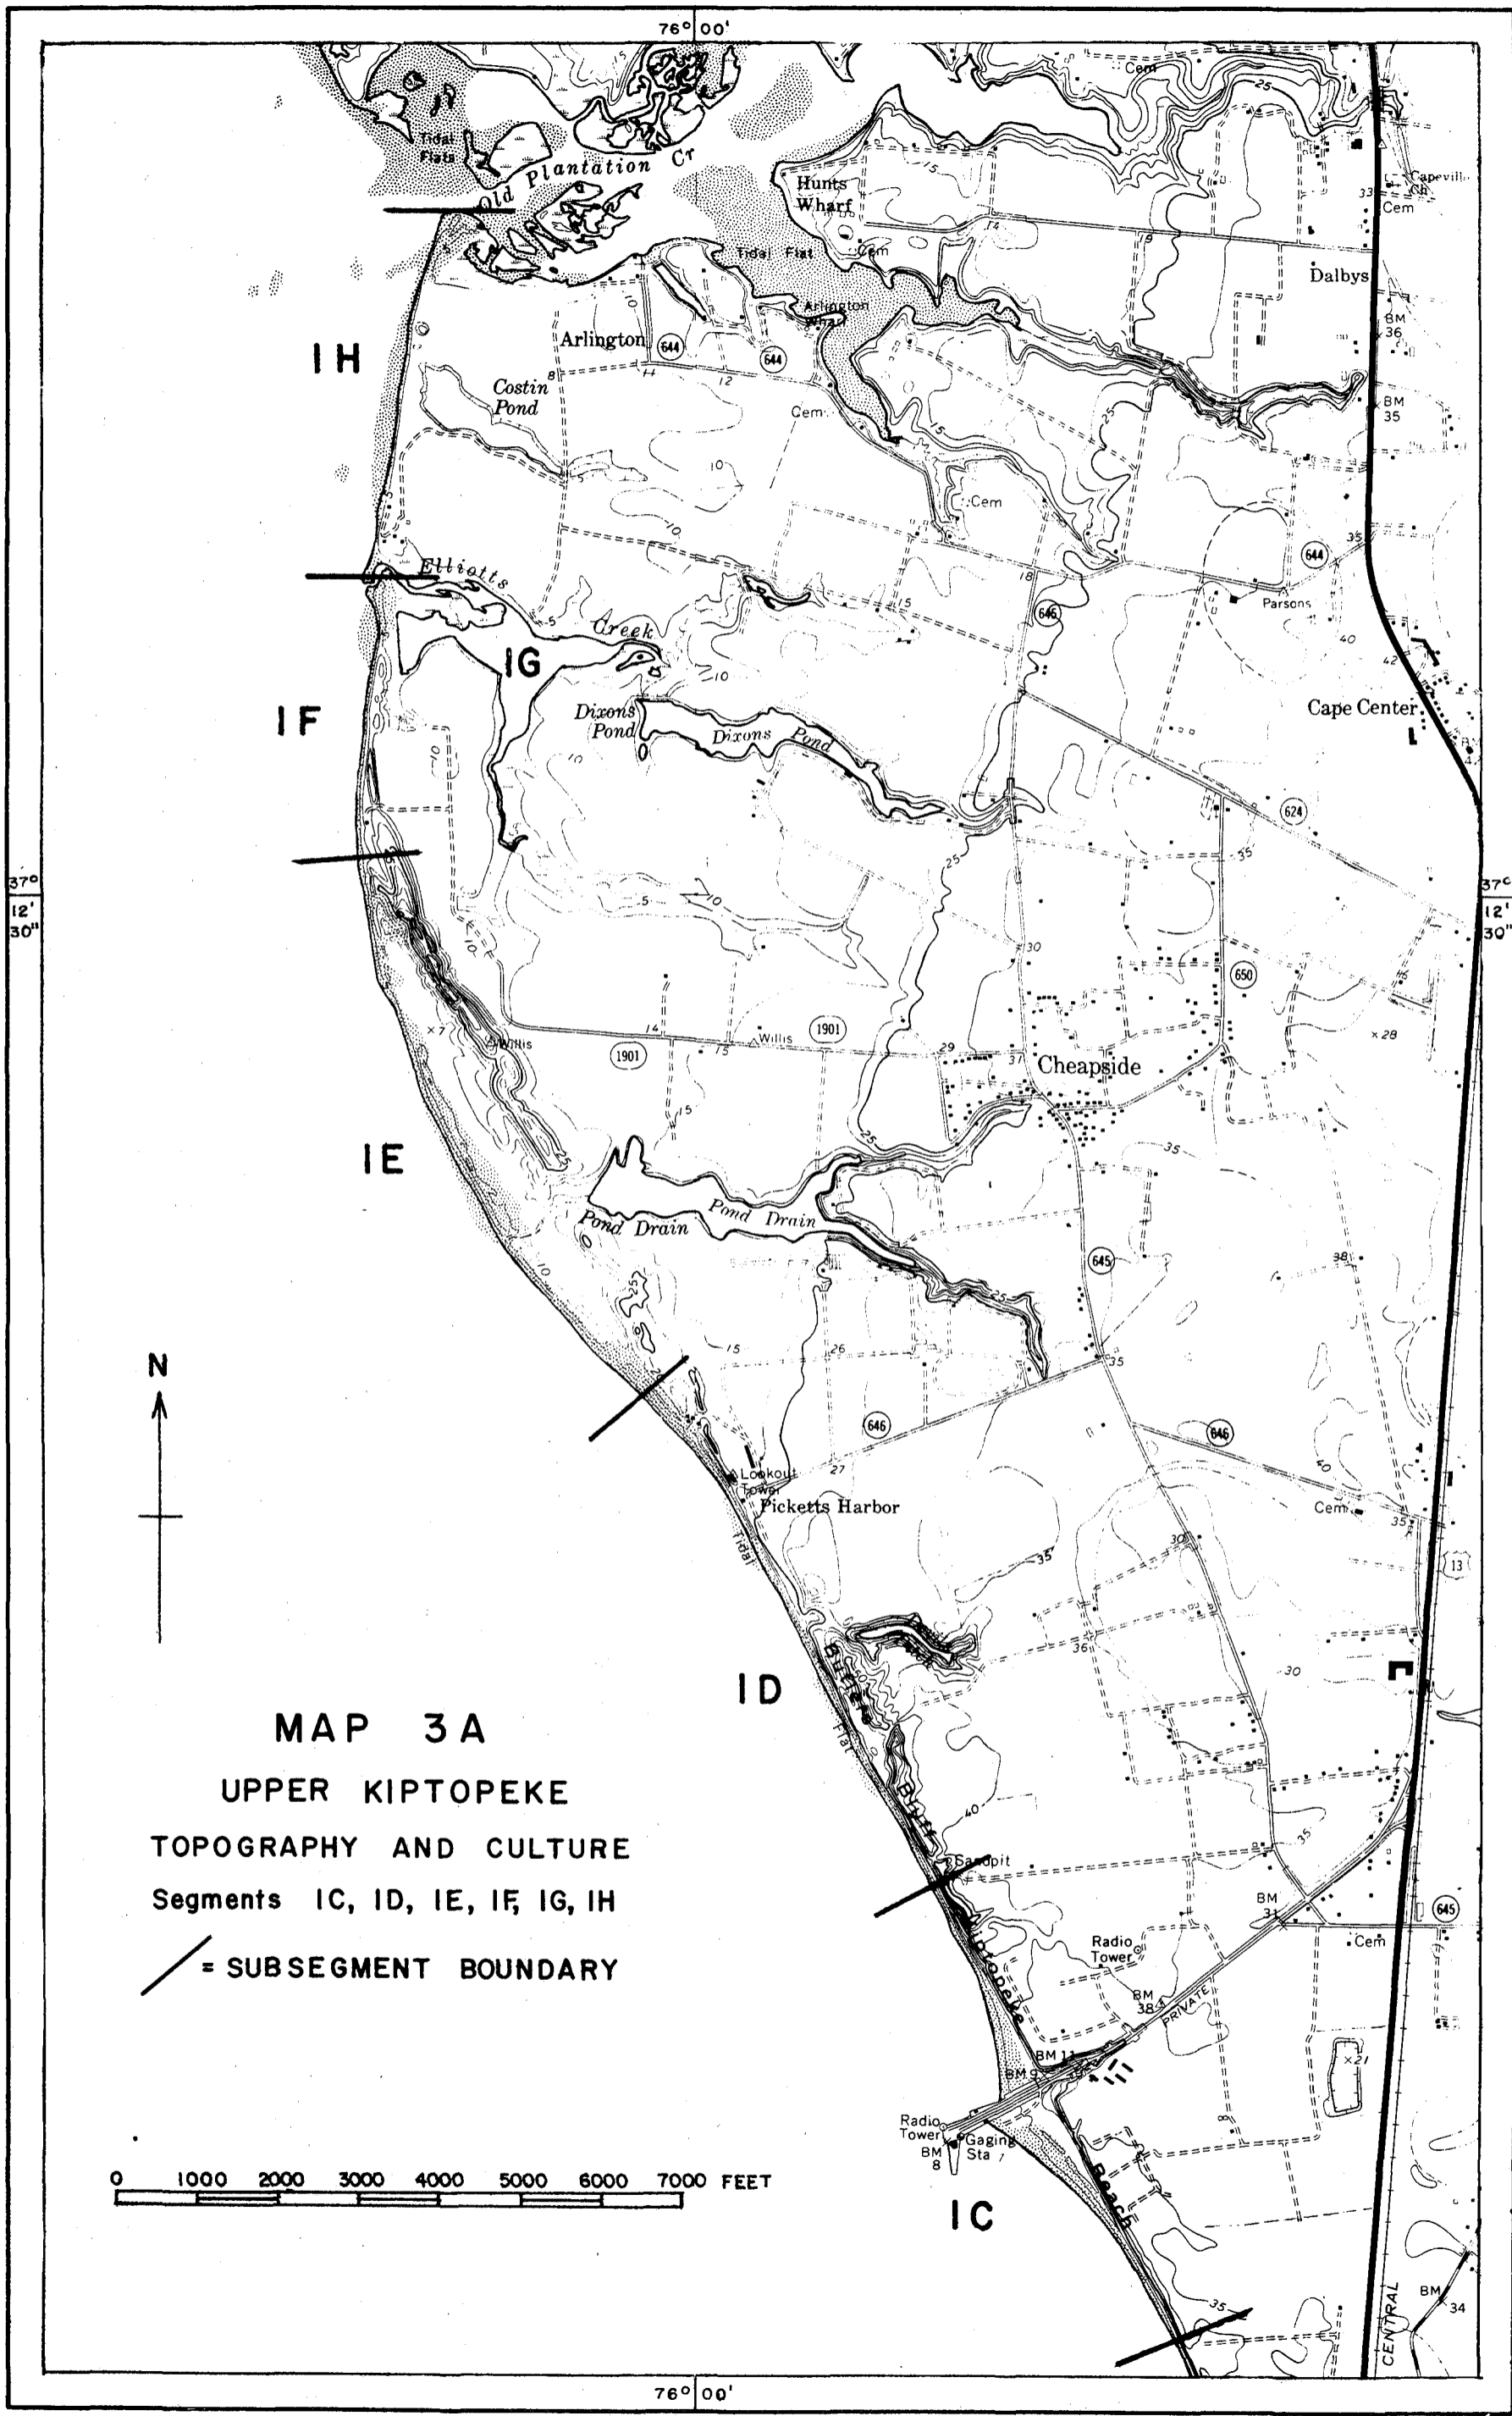
**MAP 3A**

**UPPER KIPTOPEKE  
TOPOGRAPHY AND CULTURE  
Segments IC, ID, IE, IF, IG, IH**

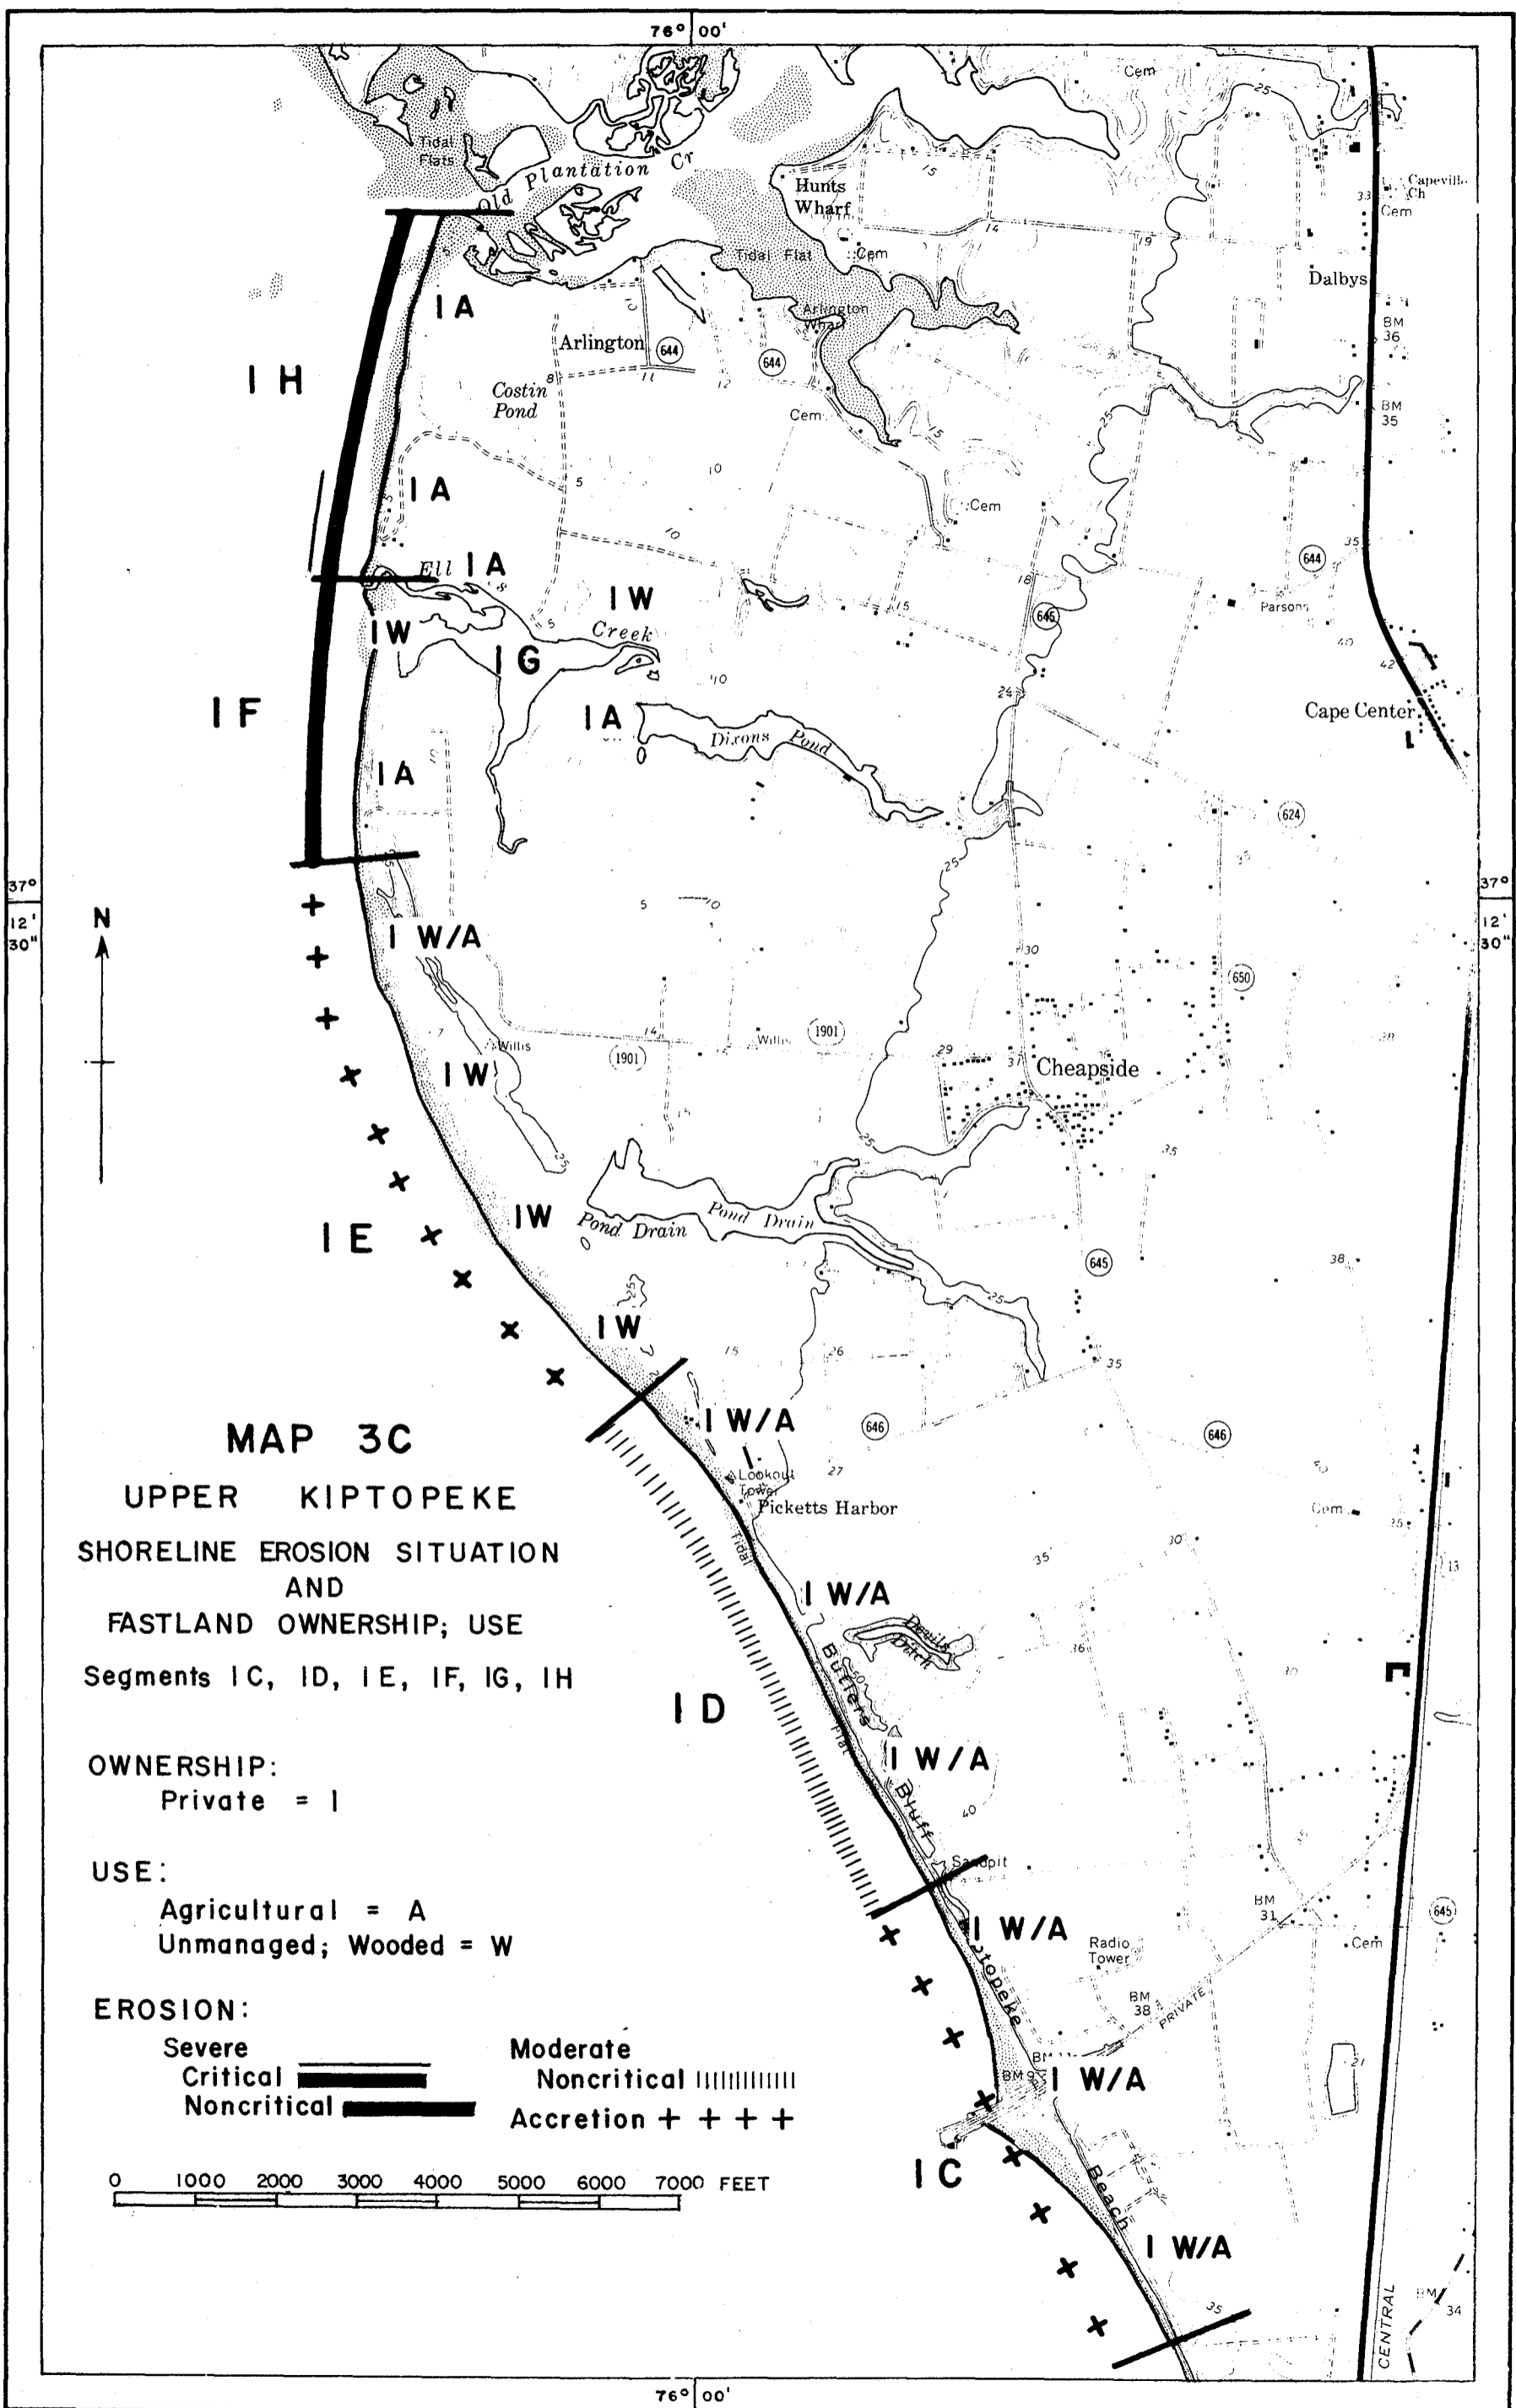
**MAP 3C**

**UPPER KIPTOPEKE  
SHORELINE EROSION SITUATION  
AND  
FASTLAND OWNERSHIP; USE**  
Segments IC, ID, IE, IF, IG, IH

**EROSION:**  
Severe Moderate   
Critical Noncritical   
Noncritical Accretion + + + +

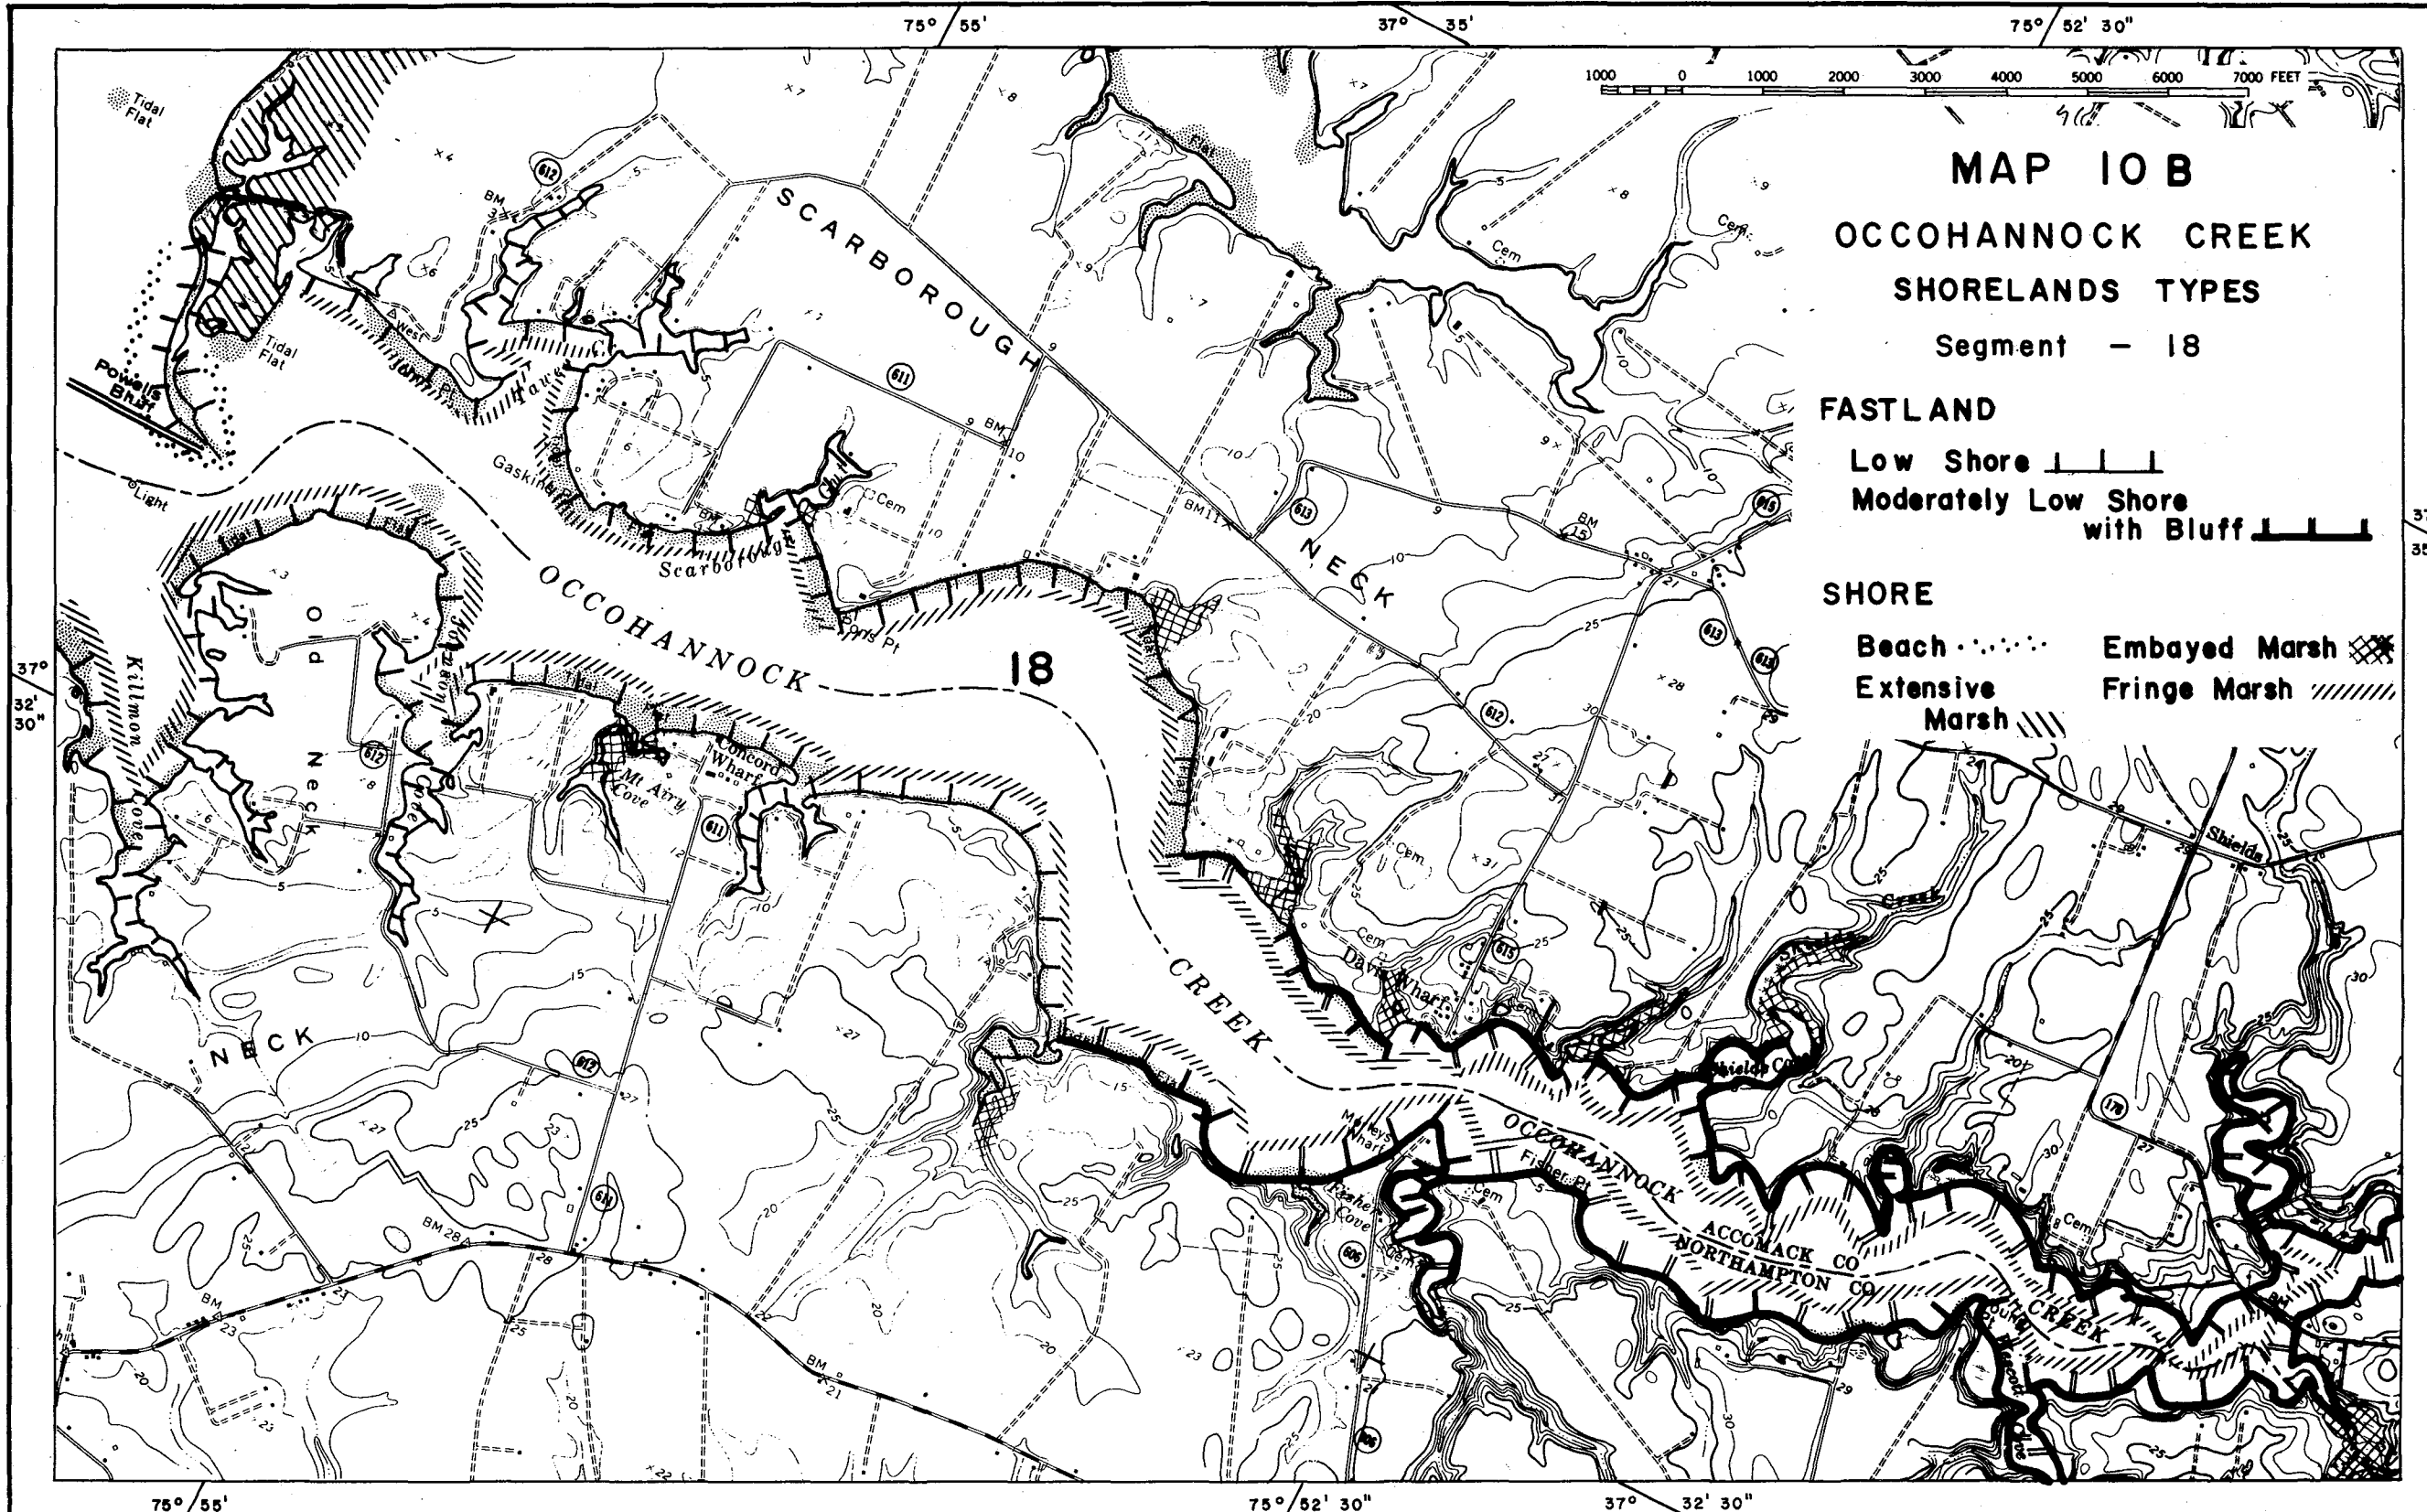
**MAP 10 B**  
**OCCOQUAN CREEK**  
**SHORELANDS TYPES**  
 Segment - 18

- FASTLAND**  
 Low Shore

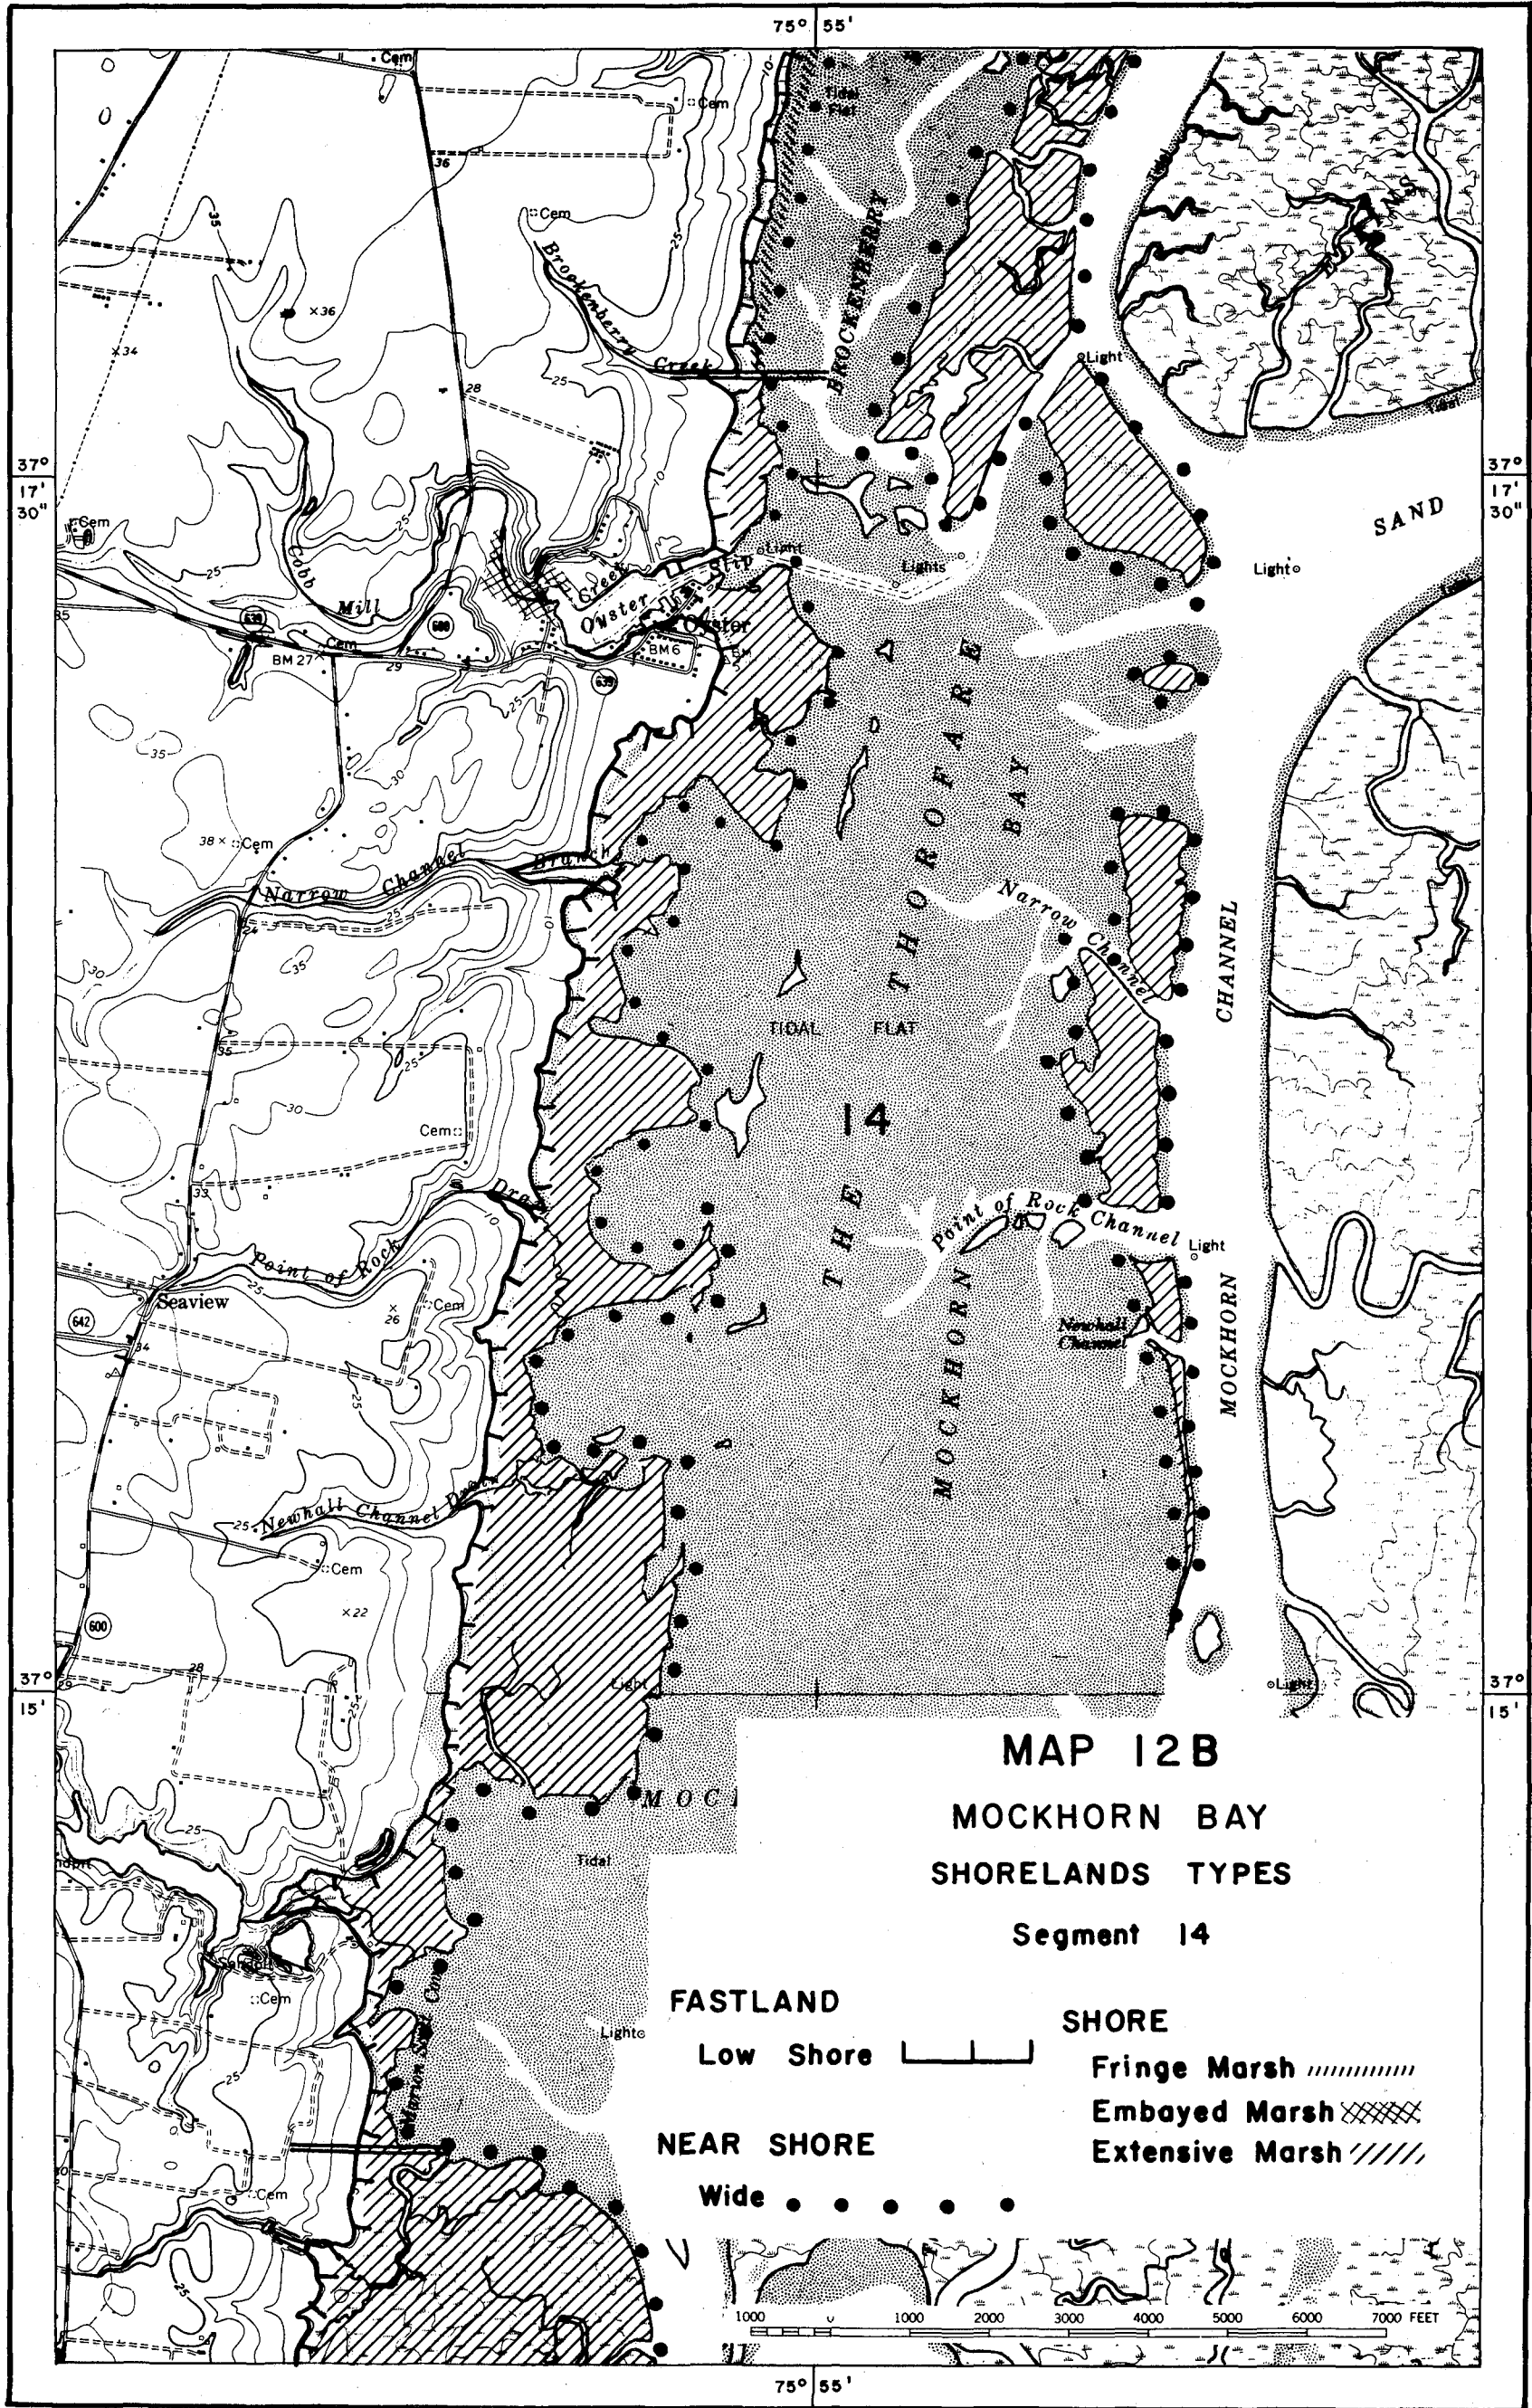
**MAP 12B**  
**MOCKHORN BAY**  
**SHORELANDS TYPES**  
**Segment 14**

**FASTLAND**  
 Low Shore
