# Shoreline Situation Report Northampton County, Virginia

Shoreline Situation Report  
NORTHAMPTON COUNTY, VIRGINIA

Special Report In Applied Marine Science and Ocean Engineering Number 54 of the

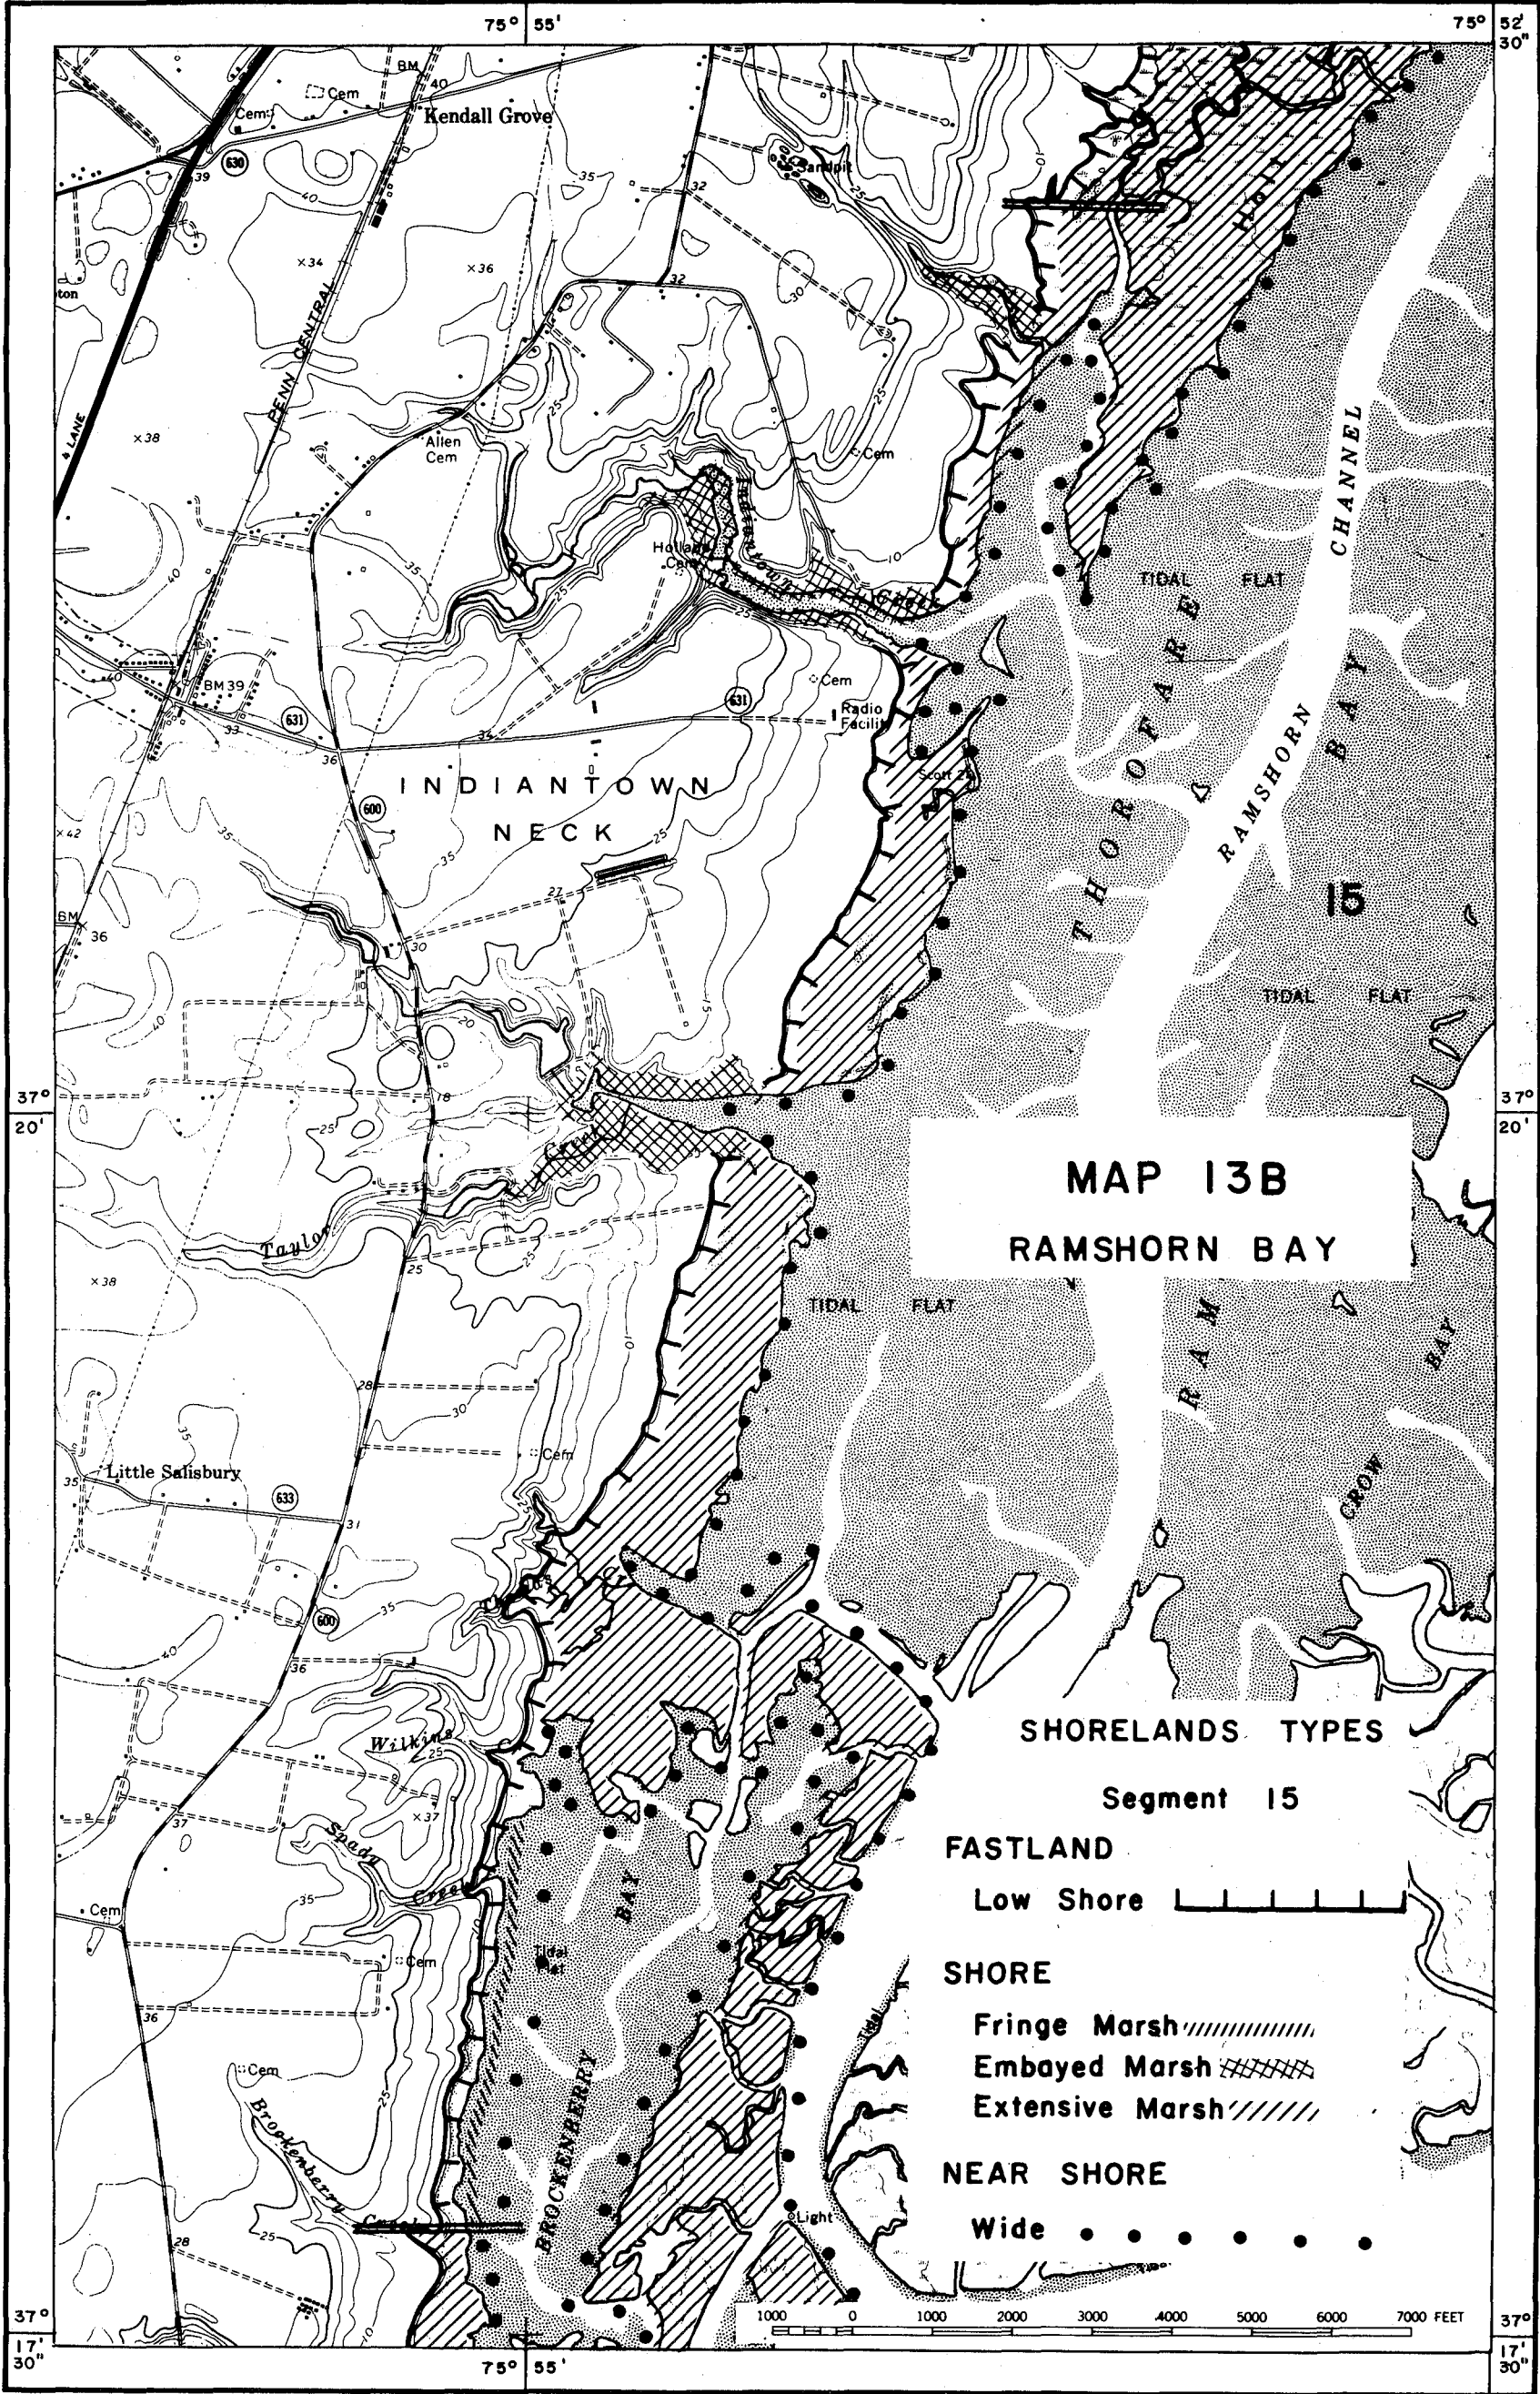
**MAP 13B**  
**RAMSHORN BAY**

**SHORELANDS TYPES**

- FASTLAND**
- Low Shore
- SHORE**
- Fringe Marsh
- Embayed Marsh
- Extensive Marsh
- NEAR SHORE**
- Wide

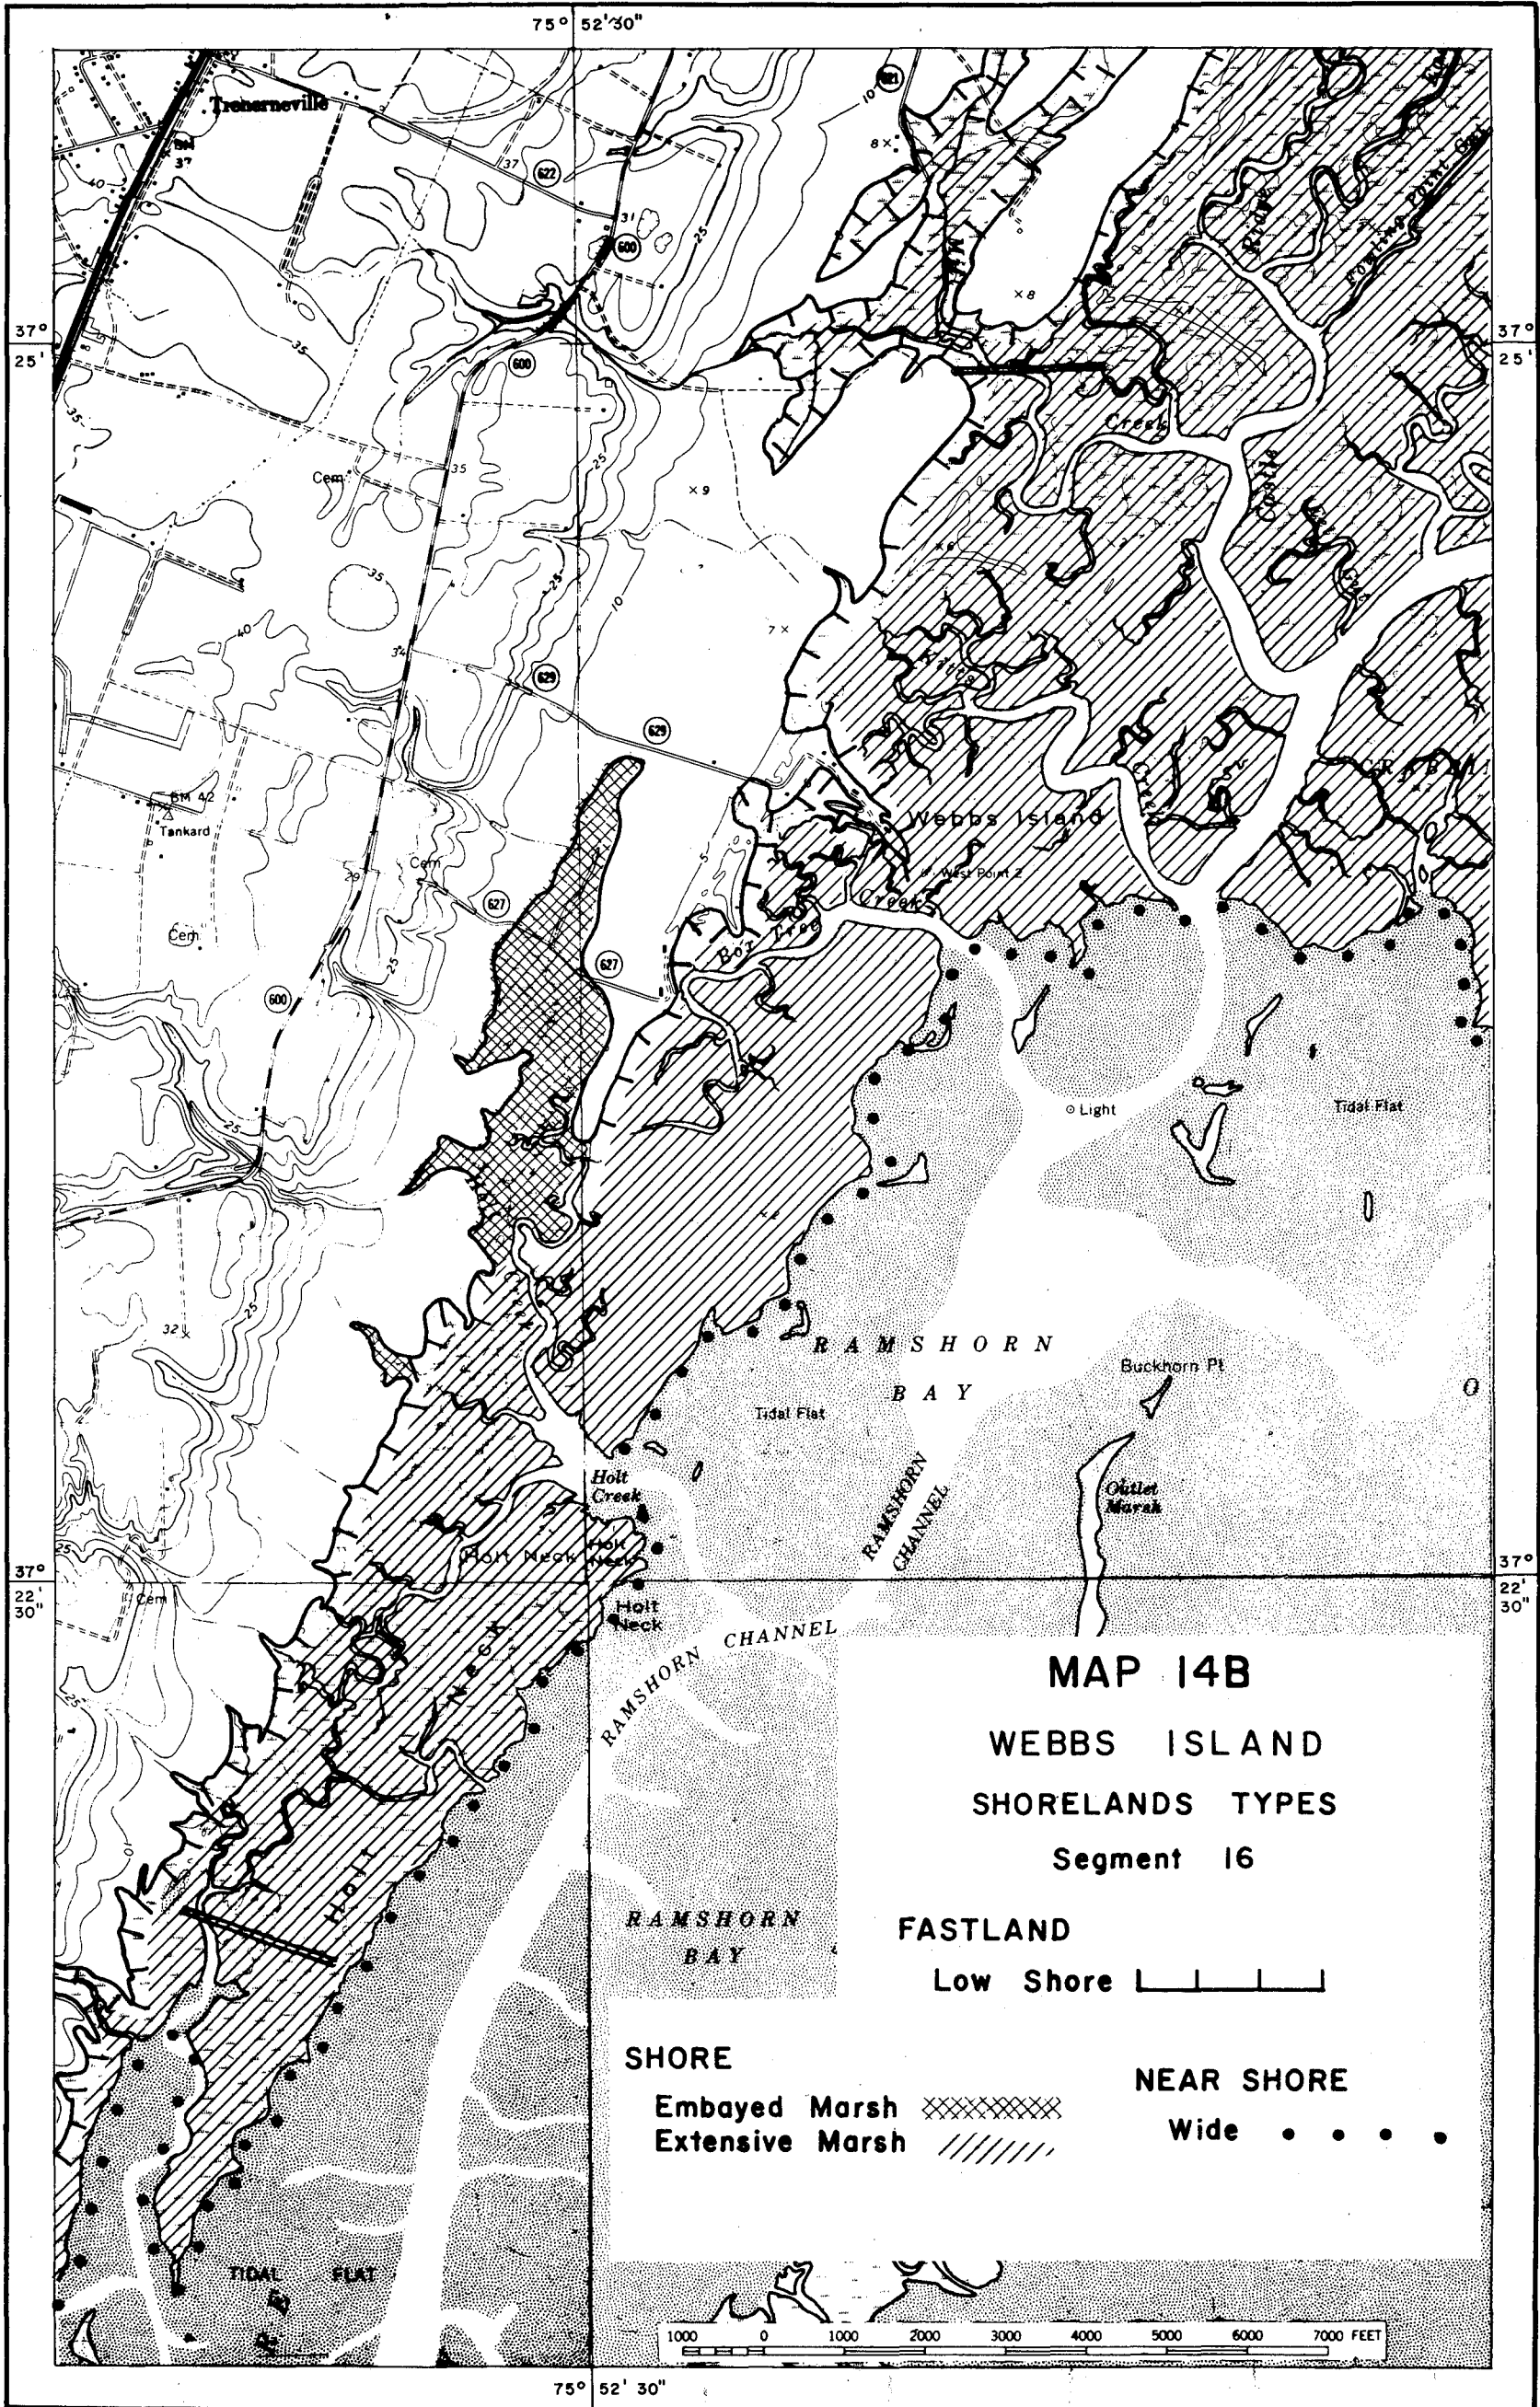
**MAP 14B**  
**WEBBS ISLAND**  
**SHORELANDS TYPES**  
**Segment 16**

**FASTLAND**  
 Low Shore

**NEAR SHORE**  
 Wide

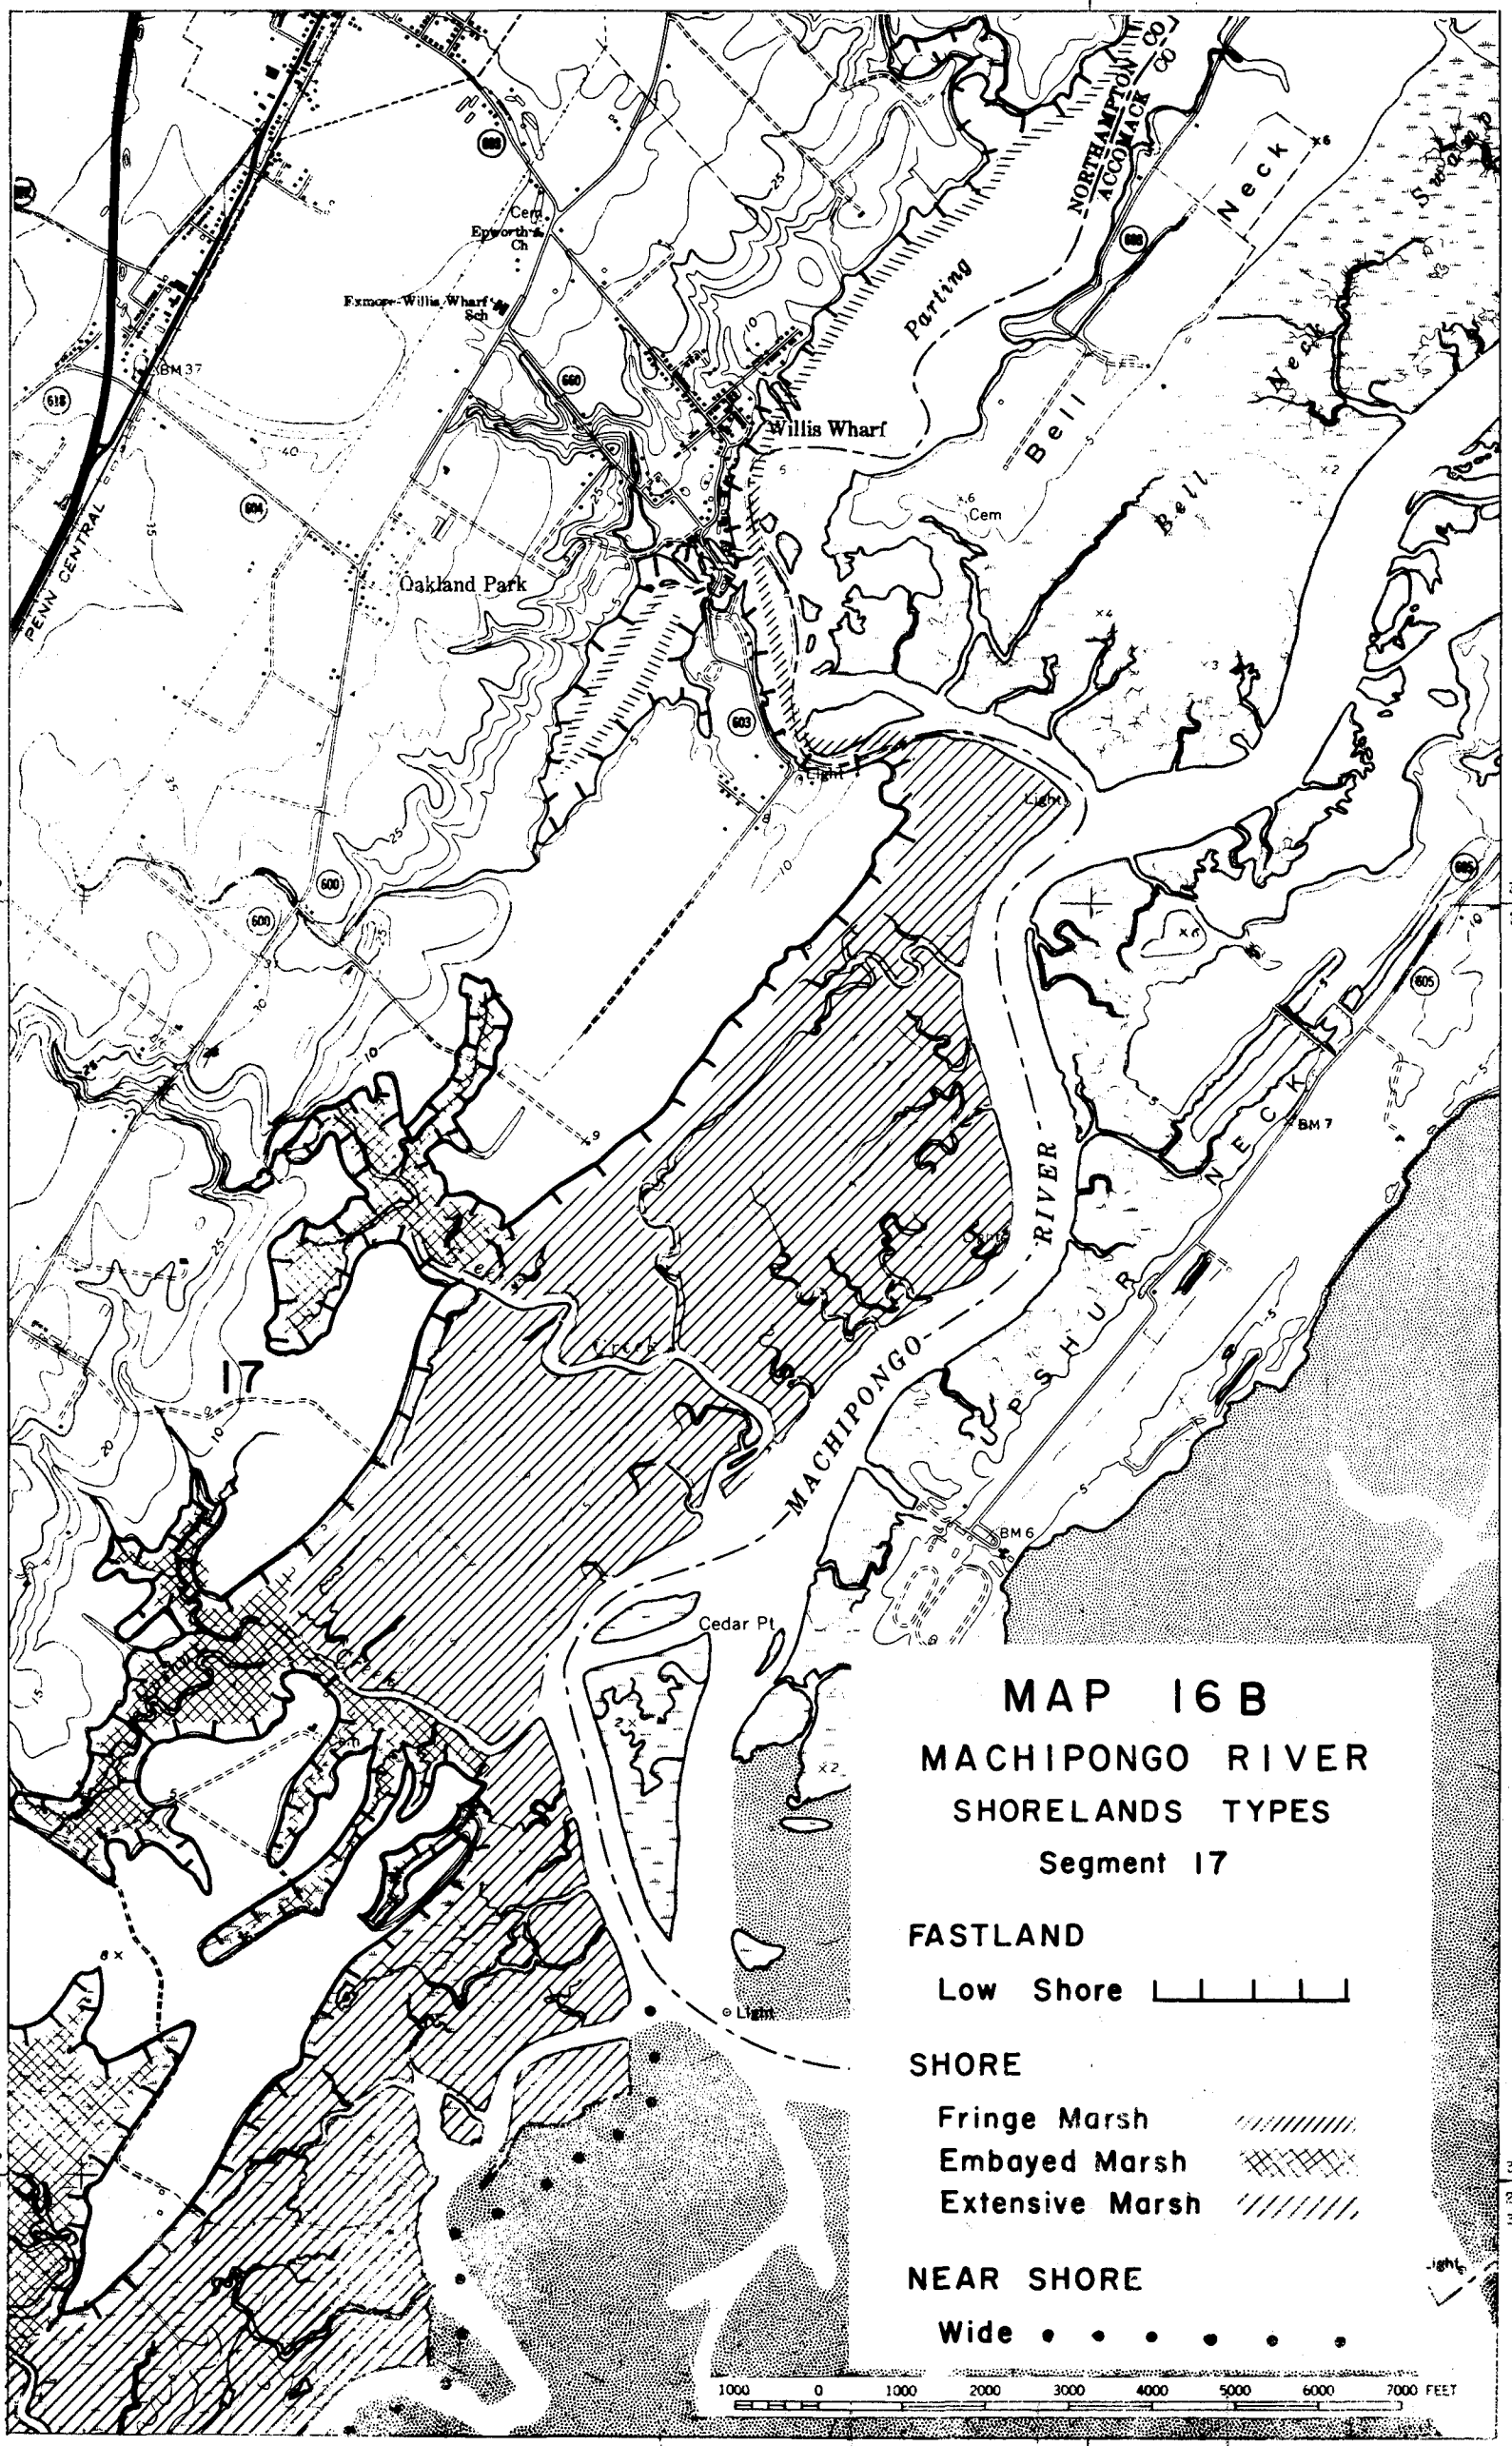
**MAP 16 B**  
**MACHIPONGO RIVER**  
**SHORELANDS TYPES**  
 Segment 17

**FASTLAND**

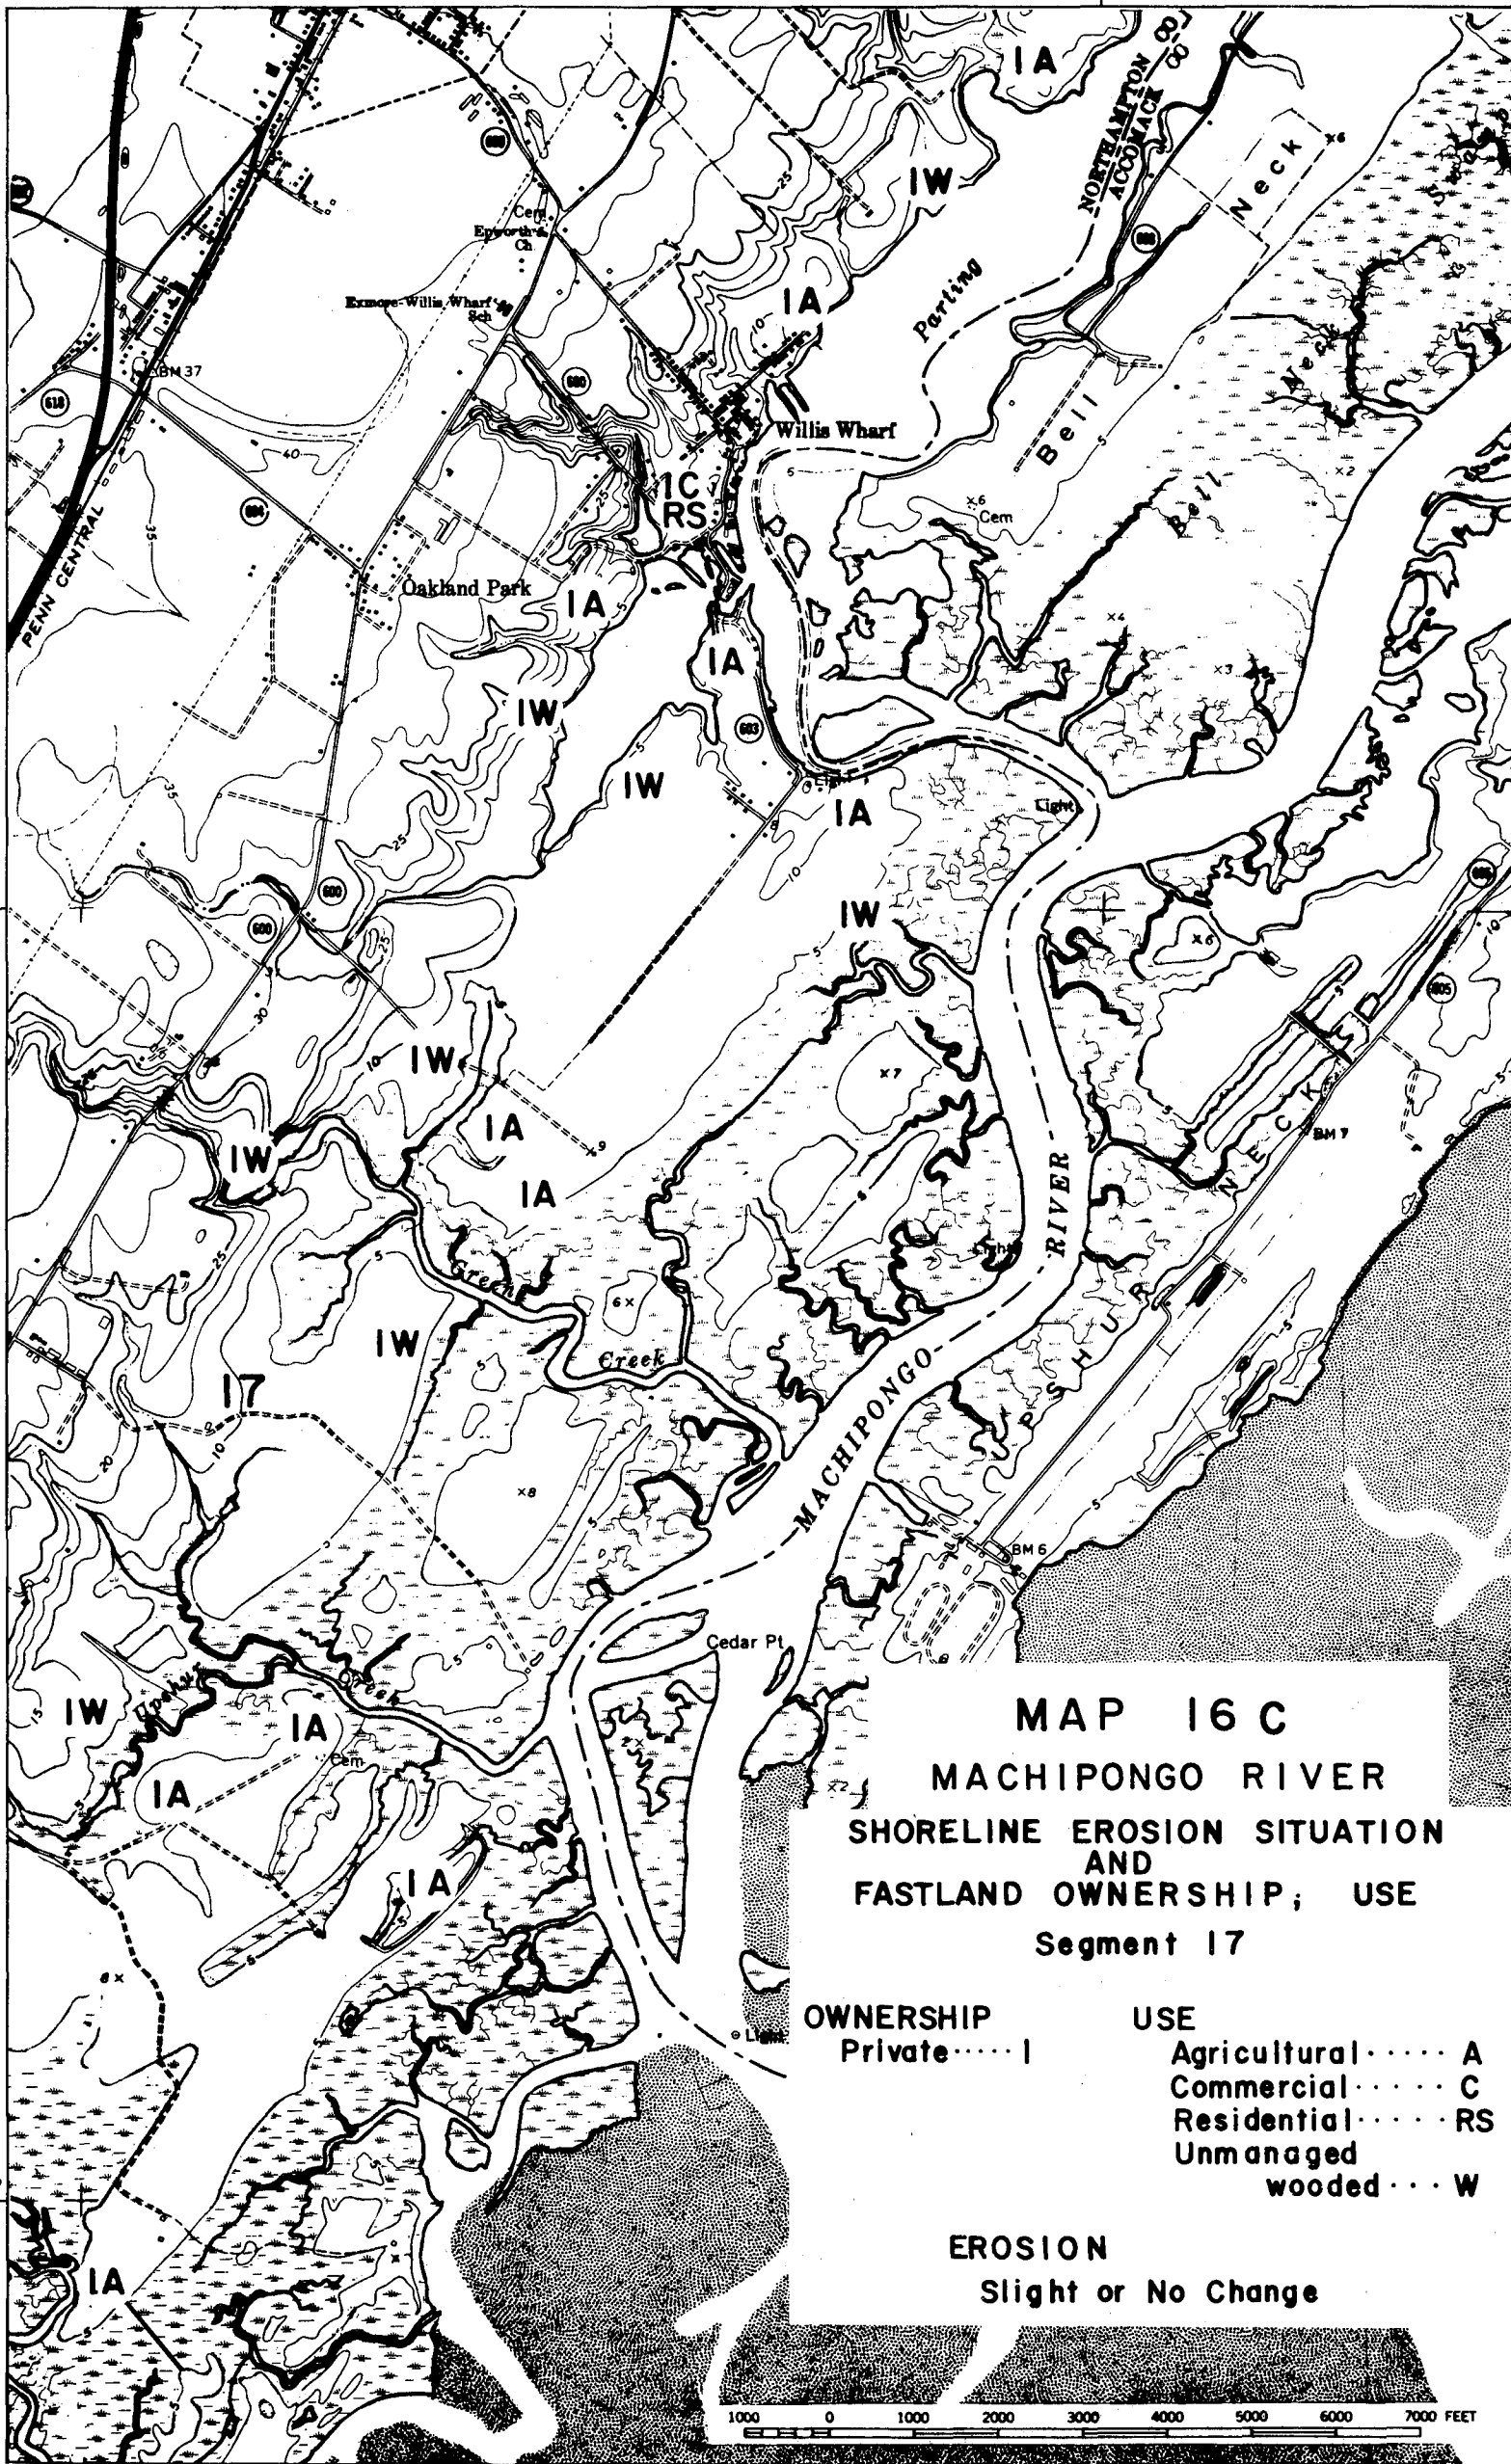
**MAP 16 C**  
**MACHIPONGO RIVER**  
**SHORELINE EROSION SITUATION**  
**AND**  
**FASTLAND OWNERSHIP; USE**  
**Segment 17**

<b>OWNERSHIP</b>	<b>USE</b>
Private..... I	Agricultural..... A
	Commercial..... C
	Residential..... RS
	Unmanaged wooded..... W
