Shoreline Situation Report Newport News, Virginia

Shoreline Situation Report NEWPORT NEWS, VIRGINIA

Special Report In Applied Marine Science and Ocean Engineering Number 55
Chesapeake Research Consortium Report Number 10

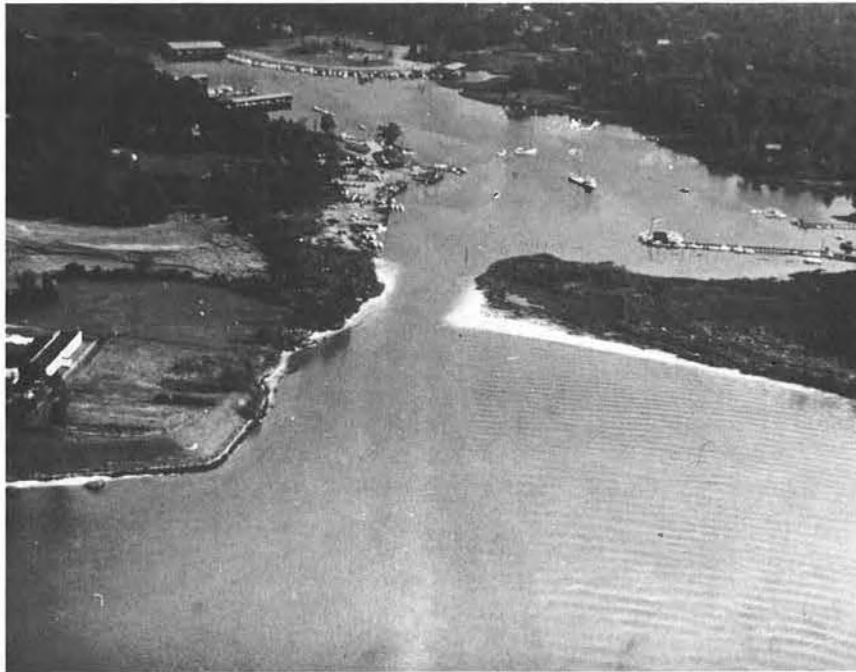
Figure 3

Figure 3: Deep Creek, a major commercial and pleasure boat harbor for the Newport News area.

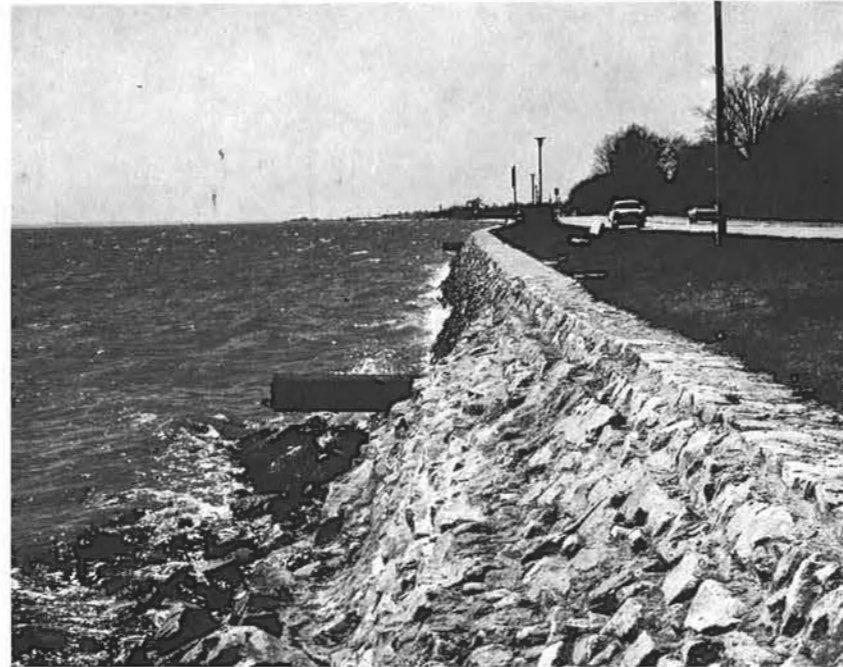
Figure 4

Figure 4: Seawall on Hampton Roads along Chesapeake Avenue near the Newport News - Hampton boundary. The pipes emerging through the wall are storm drains.

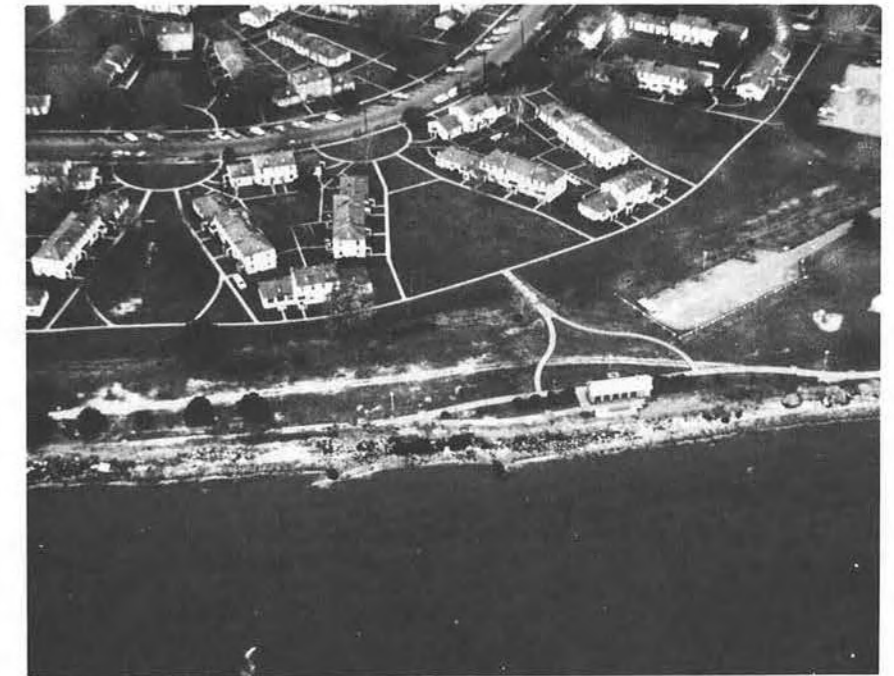
Figure 5

Figure 5: The virtually unprotected shoreline of Anderson Park in the Stuart Gardens area of the city. The groins and dumped rubble riprap contribute little to the defense of the shoreline.

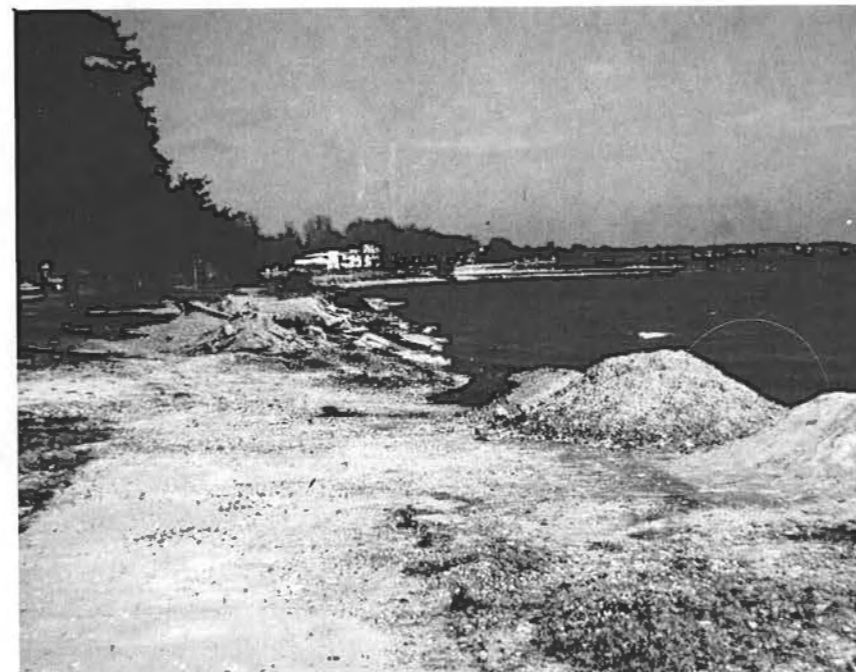
Figure 6

Figure 6: Ground view of the area shown in Figure 5. Shoreline erosion is threatening the paved walkway.

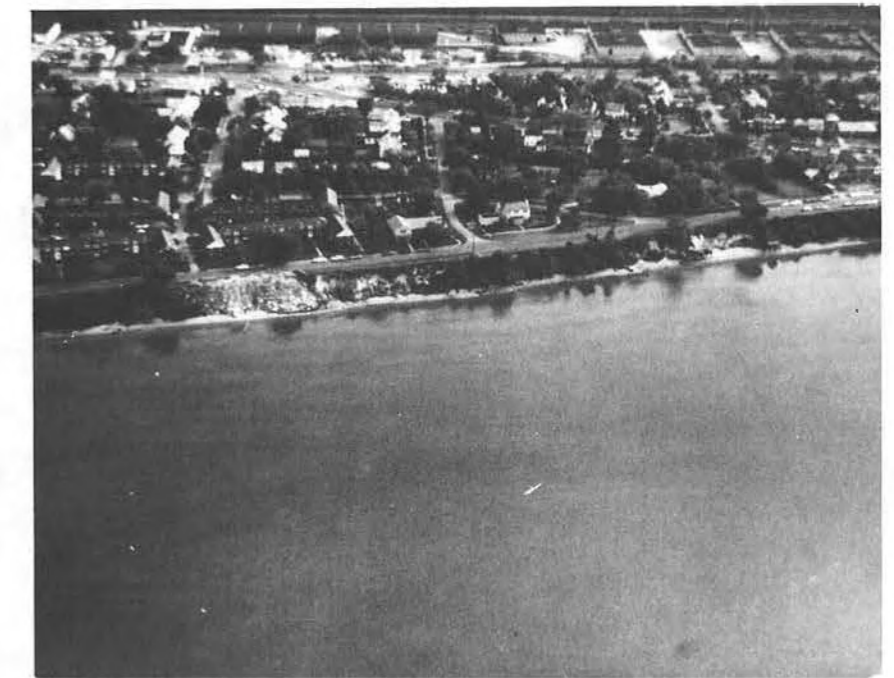
Figure 7

(Figures 7 and 8). At present rubble riprap and dumped fill is slightly hindering the erosional processes. The problem is not now severe and the construction of the new extension to the shipyard may alter the local conditions enough to change the nature of the problem. There is a similar small problem in Huntington Park.

Figure 7: River Road near 70th Street. Erosion is cutting the bluff and threatening the road.

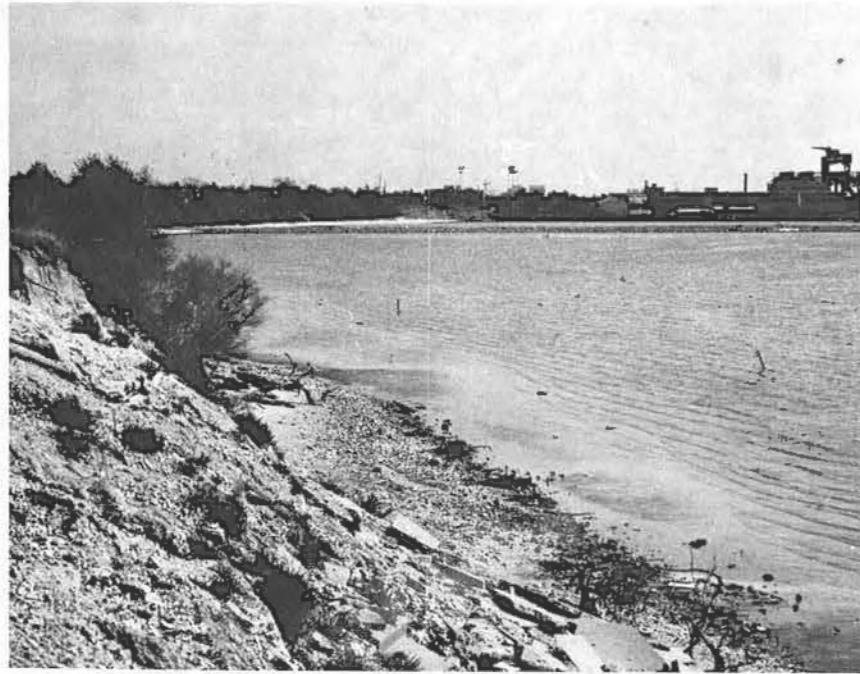
Figure 8

Figure 8: Ground view of Figure 7. North extension of the Newport News Shipbuilding and Drydock Company is in the background.

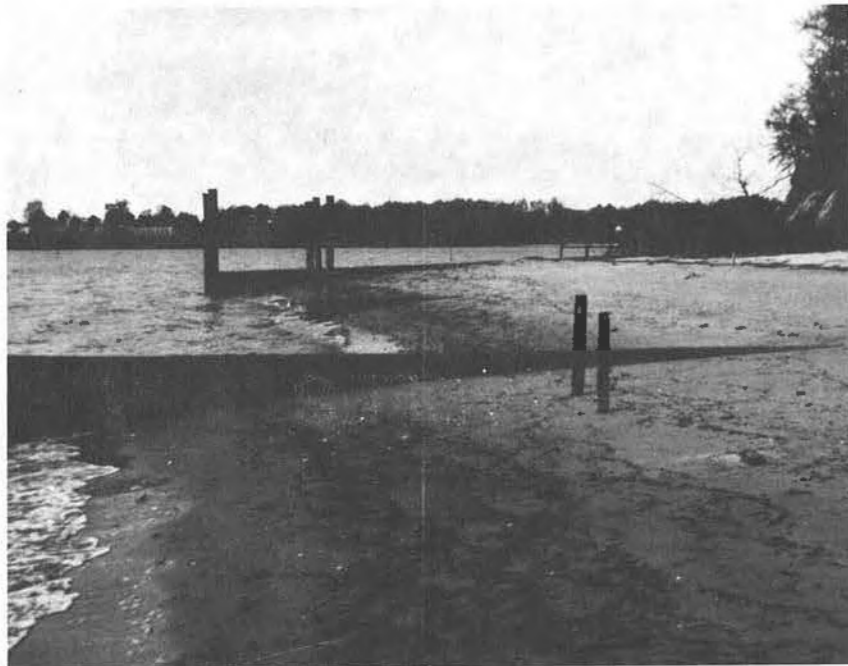
Figure 11

Figure 11: The two long, high, impermeable groins in Figure 9. These two major groins and the lesser intermediate groin have trapped a significant fillet and are protecting the fastland.

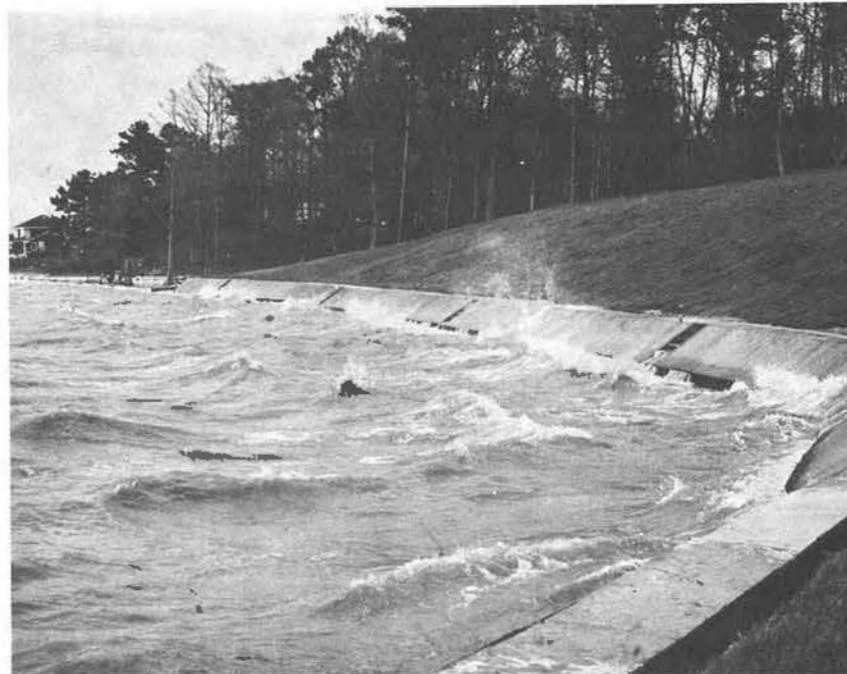
Figure 12

Figure 12: Seawall and graded upland near the foot of Blount Point Road. The seawall is satisfactory except that it can be overtopped by moderate waves. The overtopping allows water to flow behind and to undermine the seawall. The graded upland eases problems of slope maintenance. Note the reflected waves near the wall and the resulting confused sea.
