Shoreline Situation Report New Kent, King William, and King and Queen Counties

Shoreline Situation Report NEW KENT, KING WILLIAM, AND KING and QUEEN COUNTIES

VIRGINIA INSTITUTE OF MARINE SCIENCE Gloucester Point, Virginia 23062 1975

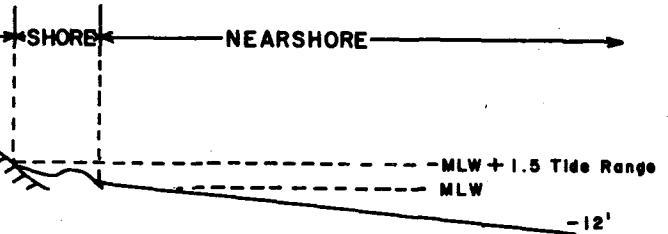
FIGURE 1: An illustration of the definitions of the three components of the shorelands.

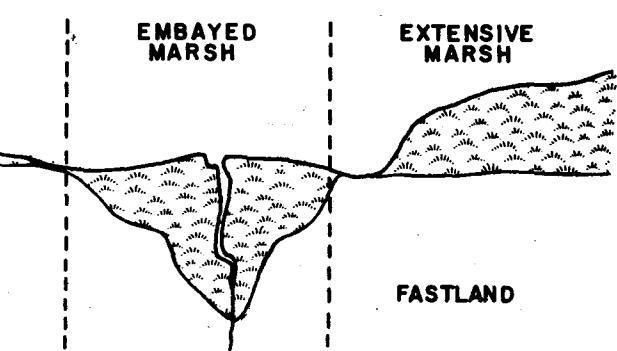
The physiographic character of the marshes has also been separated into three types (see Figure 2). Fringe marsh is that which is less than 400 feet in width and which runs in a band parallel to the

shore. Extensive marsh is that which has extensive acreage projecting into an estuary or river. An embayed marsh is a marsh which occupies a reentrant or drowned creek valley. The purpose in delineating these marsh types is that the effectiveness of the various functions of the marsh will, in part, be determined by type of exposure to the estuarine system. A fringe marsh may, for example, have maximum value as a buffer to wave erosion of the fastland. An extensive marsh, on the other hand, is likely a more efficient transporter of detritus and other food chain materials due to its greater drainage density than an embayed marsh. The central point is that planners, in the light of ongoing and future research, will desire to weight various functions of marshes and the physiographic delineation aids their decision making by denoting where the various types exist.

FIGURE 2: A generalized illustration of the three

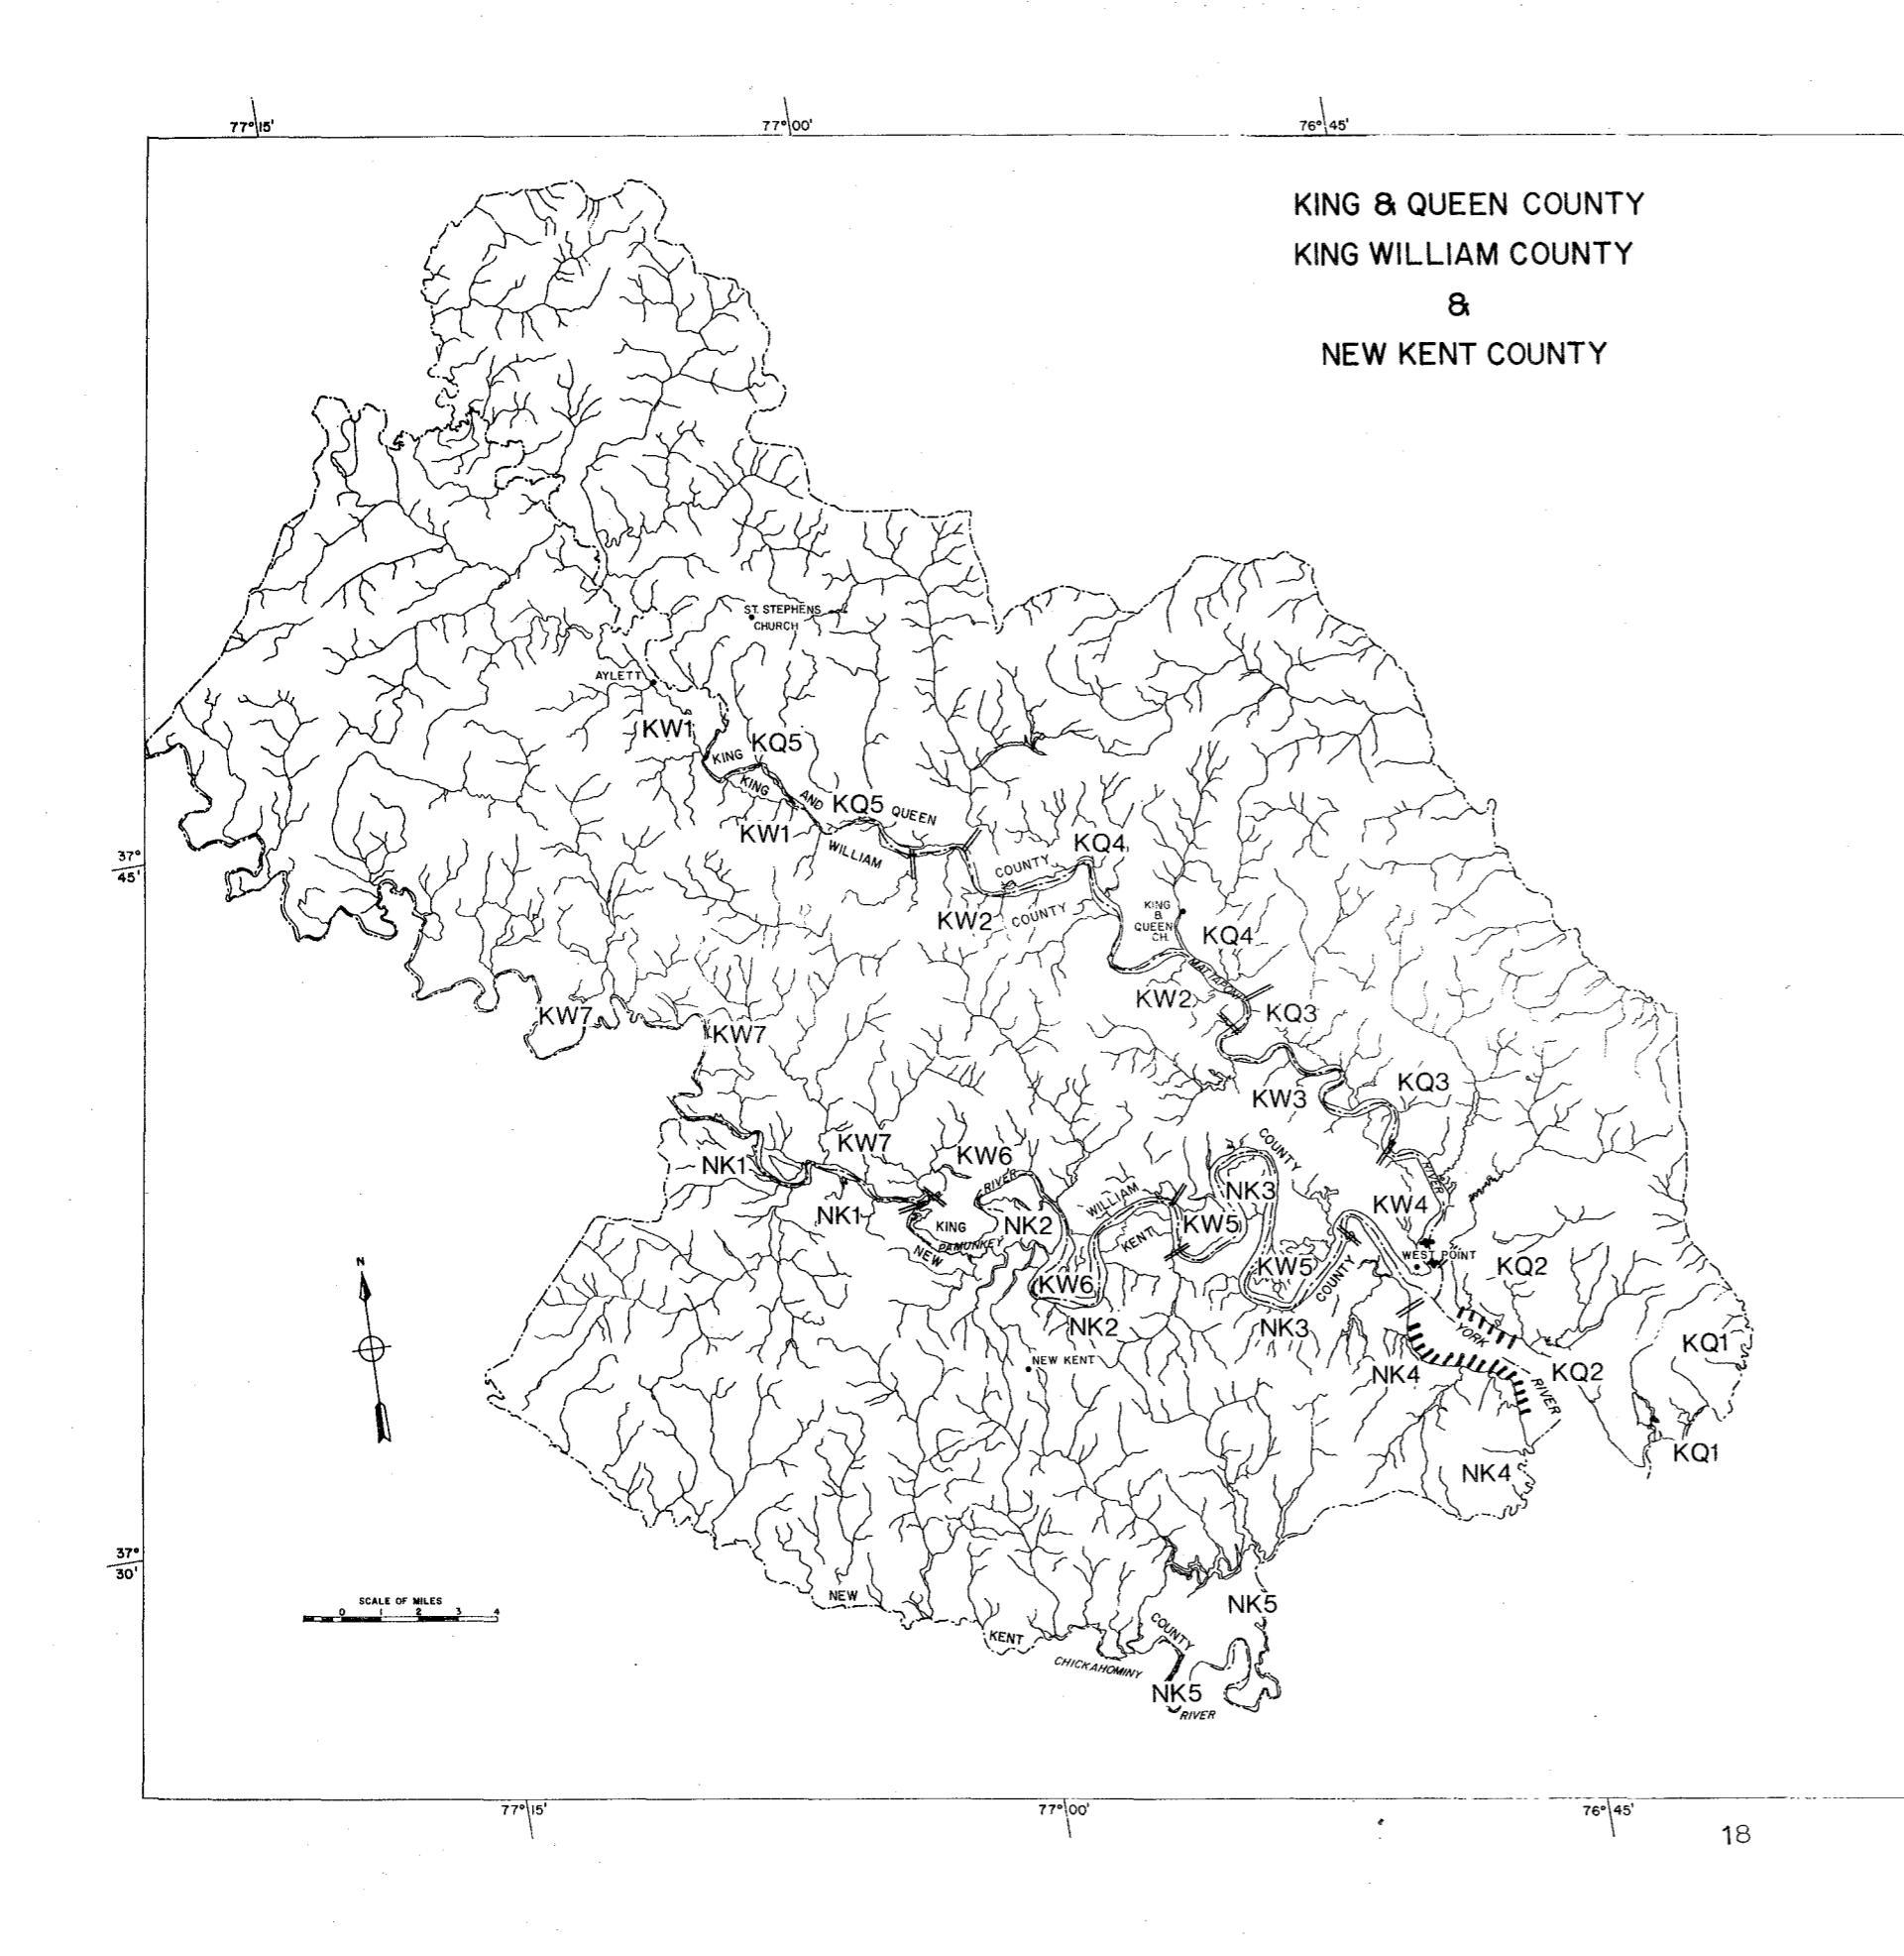
MAP 1E

EROSION

Moderate Slight or No Change Accretional

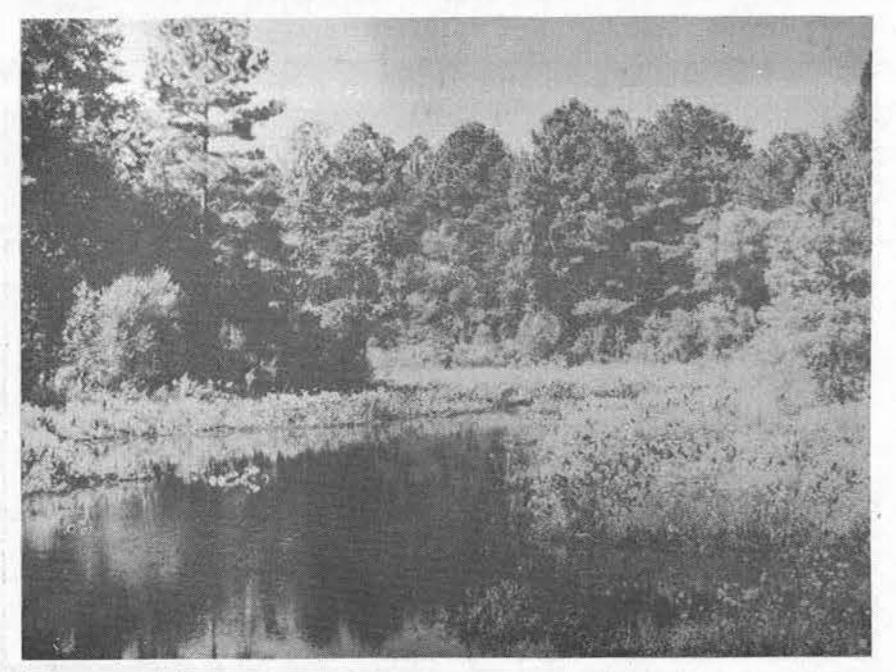
Figure 3

FIGURE 3: A portion of Diascund Creek in New Kent County. This is a very valuable area of fresh water wetlands.

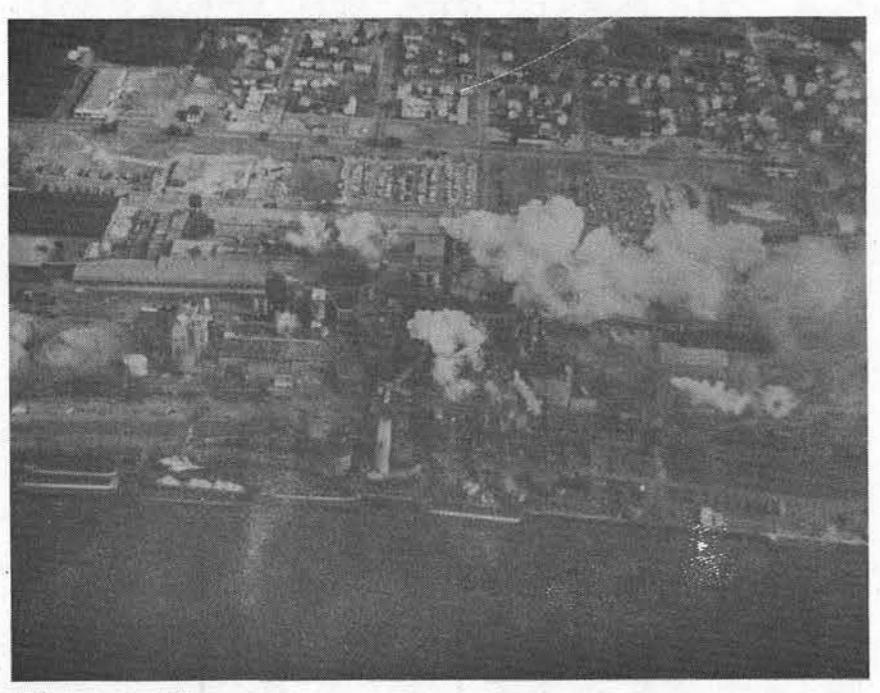
Figure 6

FIGURE 6: The Pamunkey River near its mouth at West Point. This is the only industrial area along the tri-county shore zone.
